TREE INVENTORY

Prepared for
LEISURE WORLD MUTUAL 15
SEAL BEACH

Prepared by
JAMES KOMEN – CLASS ONE ARBORICULTURE
ISA CERTIFICATION #WE-9909A
(818)495-5344
CLASSONEARBORICULTURE@GMAIL.COM
DECEMBER 1, 2013

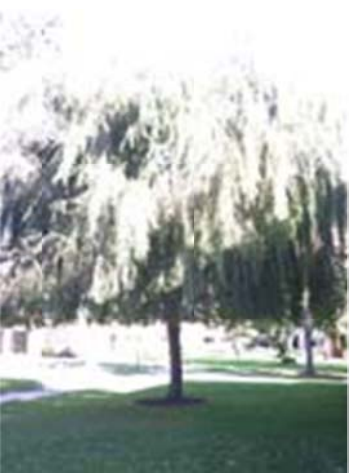
<p>Site 6 <i>Salix babylonica</i> - Weeping Willow</p> <p>This is a powerhouse tree, and it will likely cause problems with the hardscape nearby. The weeping willow is known for its aggressive roots, and it is already showing some evidence of root damage by lifting the edges of the planter next to the adjacent building. There also appears to have been some sidewalk repaving nearby, suggesting that the roots may have lifted the sidewalk.</p> <p>The weeping fringe will continue to grow into headspace, and maintenance is time-consuming to cut each whip individually. Previous practice on this tree has been to simply run a hedger through the fringe at head height. Though this practice is not conventional or according to ANSI A300 pruning standards, it appears to be cost effective and the tree appears to be handling it satisfactorily.</p> <p>Since the tree is an aggressive grower, it will need to be monitored for roof clearance. The tree could stand to have a minor trim soon. There are also some interior shoots that should be pruned out. These shoots are naturally being shaded out by the outer fringe, and the tree will be more aesthetic if they are removed.</p> <p>Maintenance: one hour with climber Priority: high Next Service: winter</p>

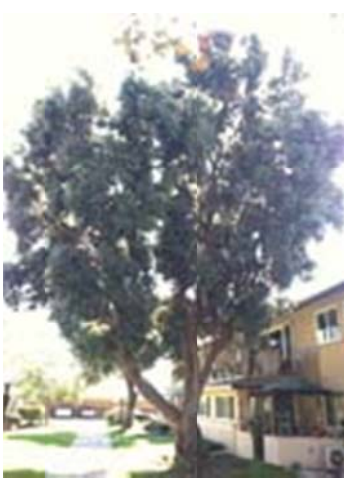
<p>Site 20 <i>Metrosideros excelsus</i> - New Zealand Christmas Tree</p> <p>This tree is growing very well in its location. It should be monitored for roof clearance with the adjacent building. The fibrous masses in the canopy are aerial roots that the tree has developed as an adaption to absorb more moisture from its surroundings. If left alone, these aerial roots will grow to the ground and provide additional anchorage and water supply for the tree. However, this is not recommended for this landscape because the aerial roots are not necessary for the tree's well-being, and they will obstruct the landscapers from caring for the turf grass around the tree, increasing the general cost of maintenance.</p> <p>Maintenance: 30 min. with climber Next Service: now Priority: medium</p>

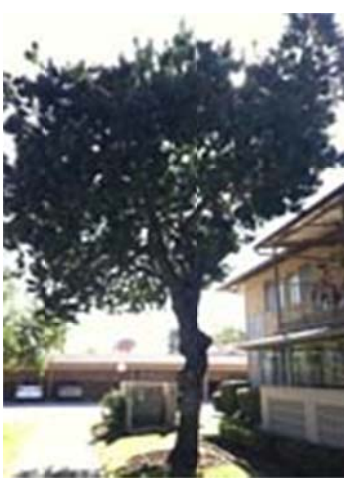
<p>Site 21 <i>Schinus terebinthifolius</i> - Brazilian Pepper</p> <p>The pepper tree is a fast grower that loves the Southern California climate. This tree will need to be maintained annually or even twice per year to maintain sidewalk and roof clearance. The bulges in the trunk of this tree are old wound sites that have healed up. There is a potential for decay to enter through these sites, but there is a low likelihood that it will affect the long-term health of the tree.</p> <p>Maintenance: 30 min. with climber Next Service: spring Priority: high</p>

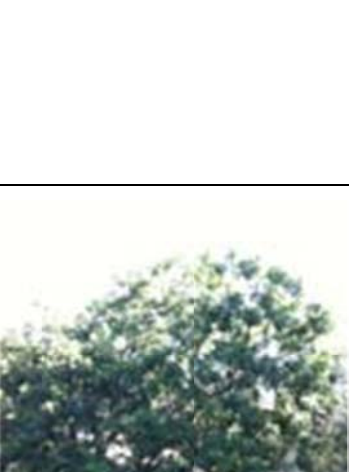
<p>Site 62 <i>Schinus terebinthifolius</i> - Brazilian Pepper</p> <p>This tree will have to be monitored annually for contact with the adjacent building. It is also growing into contact competition with the olive tree. Both of these issues will need to be addressed along with head height clearance and sidewalk clearance around the fringe. Since the Brazilian Pepper is a fast-growing species, this may need to be addressed every 6 to 12 months. The tree has good structure, but it will simply need to be maintained at its fringe.</p> <p>Maintenance: 20 min. Next Service: spring Priority: high</p>

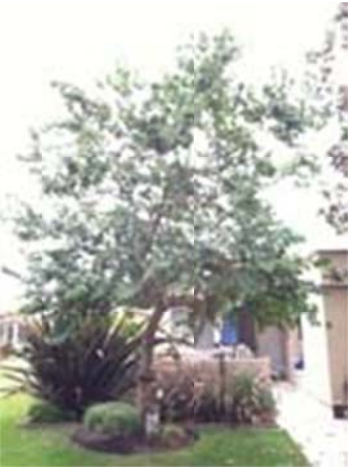
<p>Site 20 <i>Bauhinia x blakeana</i> - Hong Kong Orchid Tree</p> <p>This tree has a few structural defects that could be corrected to improve the long-term health of the tree. There is some minor deadwood that could be removed as well. This tree should be monitored annually for roof and sidewalk clearance. It is beginning to grow into the canopy of the nearby Magnolia, but it does not need to be pruned away from the Magnolia at this time.</p> <p>Maintenance: 20 min. Next Service: now Priority: medium</p>

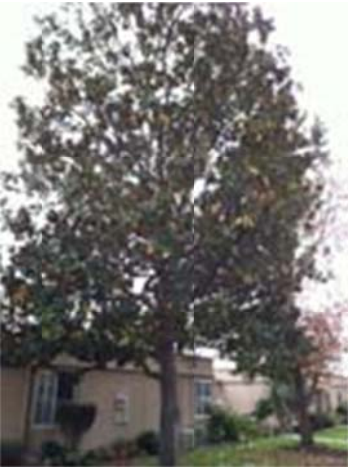
<p>Site 21 <i>Magnolia grandiflora</i> – Southern Magnolia</p> <p>This Magnolia has good structural form and plenty of space to grow. It should be monitored for roof and sidewalk clearance.</p> <p>Maintenance: 20 min. Next Service: fall Priority: medium</p>

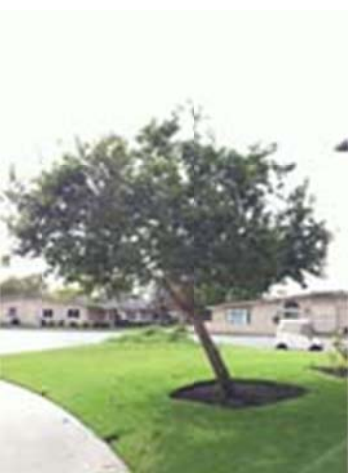
<p>Site 27 <i>Bauhinia x blakeana</i> - Hong Kong Orchid Tree</p> <p>There is some deadwood and some structural retraining that needs to be done on this tree. This tree should also be pruned for head height and sidewalk clearance. This tree was improperly pruned in the past, leaving stump cuts. These stumps need to be recut to the parent branch so that the tree will be able to heal them.</p> <p>This tree has a prevailing lean to the South and should be thinned on its southern side to encourage growth on the northern side to compensate for the lean. It has a nice full canopy, and can be a very attractive landscape tree if pruned correctly.</p> <p>Maintenance: 30 min. Next Service: now Priority: medium</p>

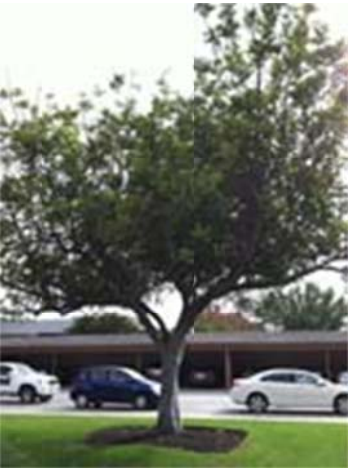
<p>Site 28 <i>Cupaniopsis anacardioides</i> - Carrotwood</p> <p>There are many interior shoots that are competing with each other and with the main structural canopy. These shoots should be thinned out over the next two years to train the tree into a more desirable structure. It is likely that the shoots originated as responses to the aggressive pruning in the past. The tree should be monitored for the sidewalk and head height clearance.</p> <p>Maintenance: 30 min. Next Service: now Priority: medium</p>

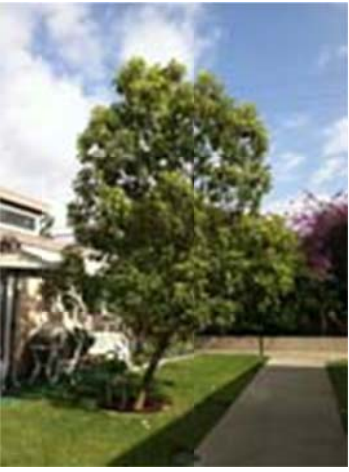
<p>Site 57 <i>Lophostemon confertus</i> – Brisbane Box</p> <p>The Brisbane Box is not an ideal choice for the proximity to the building and the hardscape. It is near a water access line and irrigation line. Its roots may cause damage to the patio and adjacent building in the next 5 to 10 years. Sidewalk clearance will need to be pruned.</p> <p>Maintenance: 10 min. Next Service: now Priority: high</p>

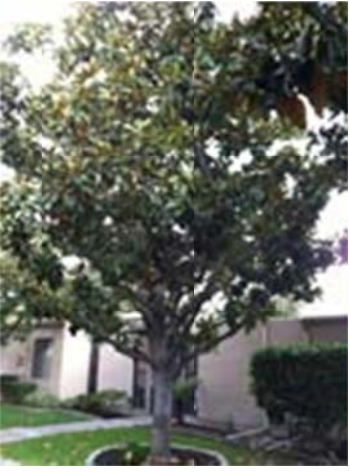
<p>Site 60 <i>Magnolia grandiflora</i> – Southern Magnolia</p> <p>This Magnolia is healthy, but it is a bit over-pruned. It should be allowed to recover its canopy. There are some wounds that appear to have decay, and these wounds should be monitored. If the wounded branches die back, then they should be removed before the decay spreads into the main trunk. This tree should be monitored for sidewalk and roof clearance.</p> <p>Maintenance: 20 min. Next Service: fall Priority: medium</p>

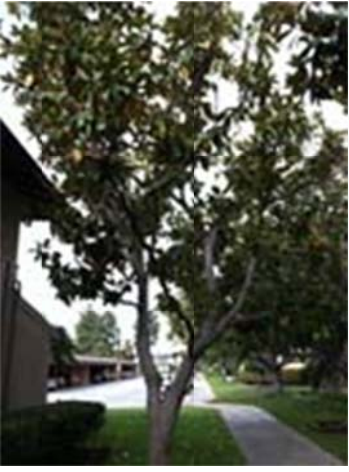
<p>Site 61 <i>Magnolia grandiflora</i> - Southern Magnolia</p> <p>This tree is looking a little sparse from the last pruning it received. There is a nearly dead branch over the sidewalk that should be removed. There is a wound low on the Eastern side of the trunk that has some decay. This wound should be monitored, and any advance of this decay should be a signal to remove the branch entirely before the decay advances into the rest of the tree.</p> <p>Maintenance: 10 min. Next Service: now Priority: medium</p>

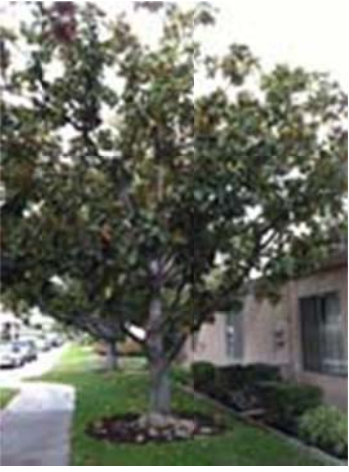
<p>Site 62 <i>Magnolia grandiflora</i> - Southern Magnolia</p> <p>There is some deadwood in this tree that should be removed, and some roof clearance cuts that should be made. Like its neighboring Magnolia, this tree should be allowed to recover from its previous pruning. Nearly all of the branches have been tipped, putting stress on the tree. It is beginning to get a little large for its planting site, and there may be problems in the next five years with the hardscape around it.</p> <p>Though it cannot be corrected at this point, this tree serves as a lesson for other trees in the mutual. When trees get large, they cannot simply be pruned to be small again; the pruning wounds would be too large and egregious. Rather, small trees should be selected for small sites, and they should be maintained annually at their intended size.</p> <p>Maintenance: 20 min. Next Service: now Priority: medium</p>

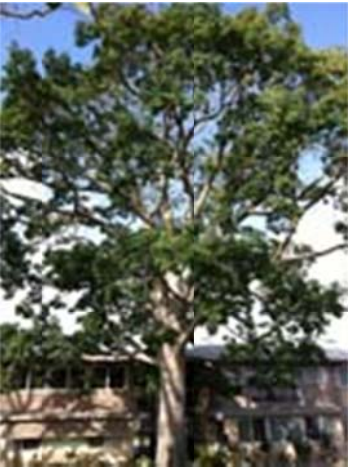
<p>Site 107 <i>Ceiba speciosa</i> - Floss Silk Tree</p> <p>This magnificent tree has ideal form, but the top of the canopy on the Eastern side is looking sparse. This is likely because the lower portion of the canopy was shaded and protected by the two Sycamore trees during the summer months. Now that the summer months are over, the sycamores have lost their leaves and are allowing more light through to the lower foliage of the floss silk tree. There is some deadwood that should be cleaned out of the floss silk tree before it becomes a hazard. This tree should also be monitored for sidewalk clearance and roof clearance.</p> <p>Maintenance: three hours with climber Next Service: now Priority: high</p>

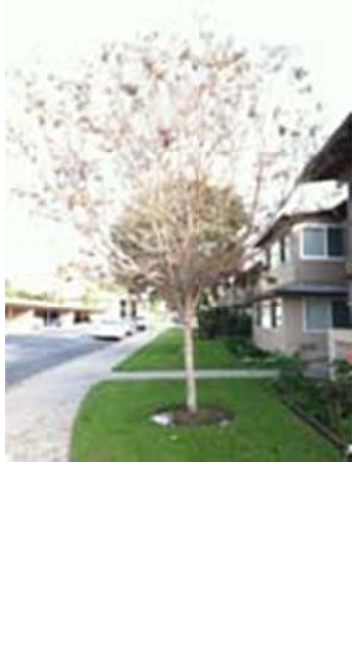
<p>Site 116 <i>Lagerstroemia indica</i> - Crape Myrtle</p> <p>The big problem with this tree is the drainage. There is a large puddle of water around the base of this tree 12 hours after the irrigation system has run. The irrigation needs to be reduced to compensate for the slowly draining clay soil. The tree is likely experiencing stress due to root drowning.</p> <p>Roots need both oxygen and water to survive, and if they do not receive oxygen, they die. When its roots drown, the tree paradoxically exhibits symptoms of drought stress because it is unable to uptake the water that the foliage needs.</p> <p>Some deadwood pruning can be done on this tree in the spring, but the highest priority is to fix the irrigation system.</p> <p>Maintenance: 20 min. Next Service: spring Priority: low</p>

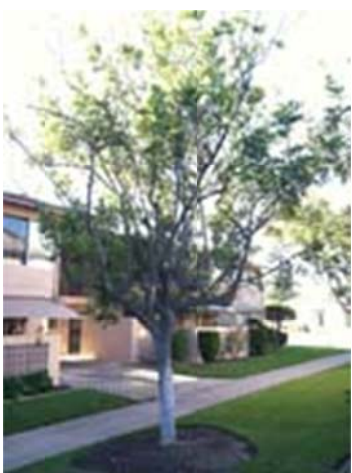
<p>Site 34 <i>Cupaniopsis anacardioides</i> - Carrotwood</p> <p>This Carrotwood is showing signs of stress on the branches that were pruned in the past. The dieback should be removed for aesthetic purposes. There is also some structural cleaning that can be done to remove rubbing and crossing structures.</p> <p>There is an irrigation line very close to the trunk of the tree that will probably suffer damage from the roots in time. This tree is likely to be the cause of an ongoing problem to shareholders because of its fruit drop over the adjacent sidewalk. Sidewalk and roof clearance should be maintained.</p> <p>Maintenance: 20 min. Next Service: spring Priority: medium</p>

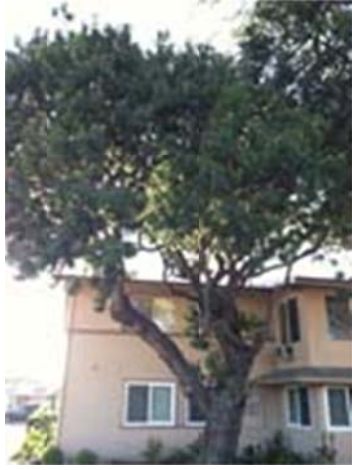
<p>Site 39 <i>Schinus terebinthifolius</i> - Brazilian Pepper</p> <p>This pepper tree is slightly lopsided away from the adjacent building. The canopy should be allowed to grow over the building with at least 5 feet of clearance. Some of the foliage on the East side of the tree should be thinned to reduce its cantilever to the East. The foliage is healthy and dense, and the tree will be able to handle a thinning on the East side of the canopy. The soil around the base of the tree is dense and compacted, but the roots of this tree will not have a problem growing in that soil condition. There may be a concern for damage to the foundation of the adjacent building, and this tree should be monitored annually.</p> <p>Maintenance: one hour with climber Next Service: now Priority: medium</p>

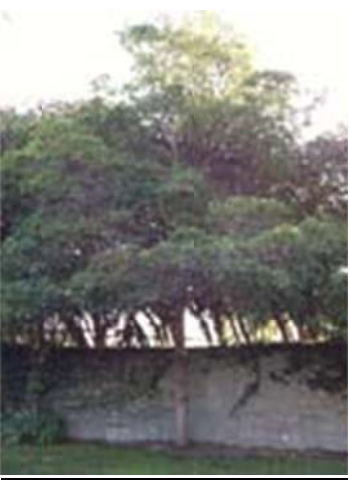
<p>Site 8 <i>Pittosporum undulatum</i> - Victorian Box</p> <p>This tree has a significant amount of deadwood that can be cleaned out for aesthetic purposes. There are high-voltage power lines that run through the canopy of this tree, and extra care should be taken while pruning. It receives heavy shade from the hedge to the East, and most of the canopy is on the Western side. This tree receives filtered afternoon sun through the neighboring London Plane Tree.</p> <p>Recently, work was done on the wall immediately behind the tree. It was likely that 30% to 40% of the root system of this tree was removed when a trench was dug for construction. Therefore, this tree should be observed for the next 2 to 5 years for signs of decline due to root cutting. It may not be a wise investment of time to prune it aesthetically if it will end up declining and dying in the next 2 to 5 years.</p> <p>Since the tree is not very large, it does not pose a hazard if it were to fall to the West from the loss of anchorage roots. The most cost effective course of management for this tree is to allow it to grow until it declines and dies, and then remove it. This strategy of management is also known as benign neglect.</p> <p>Maintenance: 60 min. Next Service: now Priority: low</p>

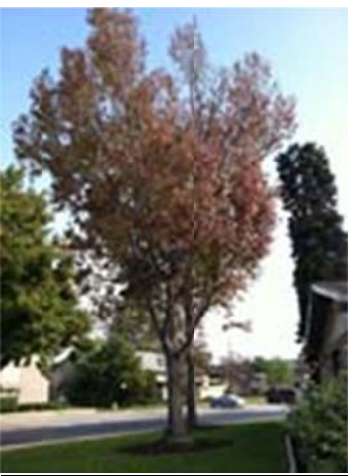
<p>Site 43 <i>Liquidambar styraciflua</i> - Sweet Gum</p> <p>This tree has two co-dominant trunks beginning at approximately 8 feet up the main trunk. The angle of attachment is large enough that they do not pose an immediate hazard, but I recommend installing a safety line to reduce the amount of damage that would occur if a tearout were to happen.</p> <p>This tree should be monitored for roof clearance.</p> <p>Maintenance: 30 min. with climber Next Service: now Priority: medium</p>

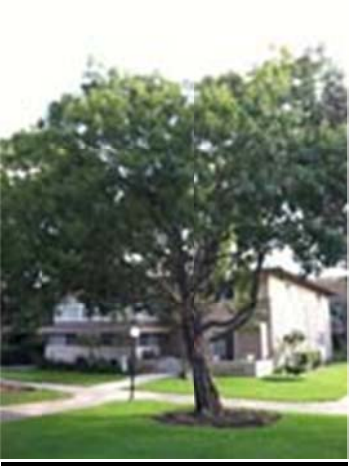
<p>Site 70 <i>Schinus terebinthifolius</i> - Brazilian Pepper</p> <p>This pepper tree is in good form, but the foliage at the top of the canopy is looking a bit sparse from the previous pruning. The top of the canopy should be allowed to fill in. The fringe will need to be maintained every 6 to 12 months for head height and sidewalk clearance. Since this tree is relatively evenly matched with its two neighboring pepper trees, it can be allowed to grow into their canopies and compete for space, creating a dense canopy cover over the sidewalk.</p> <p>Maintenance: 20 min. Next Service: now Priority: high</p>

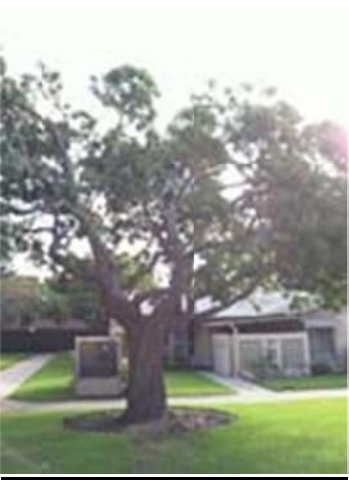
<p>Site 71 <i>Schinus terebinthifolius</i> - Brazilian Pepper</p> <p>Like its neighbor to the North, this tree was over-pruned at the top of its canopy, and it should be allowed to recover. There is a tearout injury on one of the northern trunks, and it should be allowed to recover as well. This tearout injury should be monitored for signs of decay, and if signs of decay appear, then the entire limb should be removed before the decay advances to the main trunk. This tree should be maintained every 6 to 12 months for roof and sidewalk clearance.</p> <p>Maintenance: 20 min. Next Service: spring Priority: high</p>

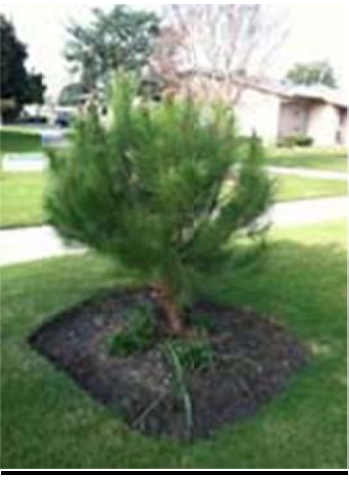
<p>Site 73 <i>Pinus pinea</i> - Italian Stone Pine</p> <p>This young tree needs to have its stakes removed before they cause damage to the root crown. There are also several stumps that should be cut back to the parent stem so that they can begin to heal. Pines are good healers, but branch stubs need to be removed before the tree can roll a cambium callous over the wound site. This tree will grow very large and may cause damage to the irrigation system and sidewalk in 10-20 years.</p> <p>Maintenance: 10 min. Next Service: now Priority: high</p>

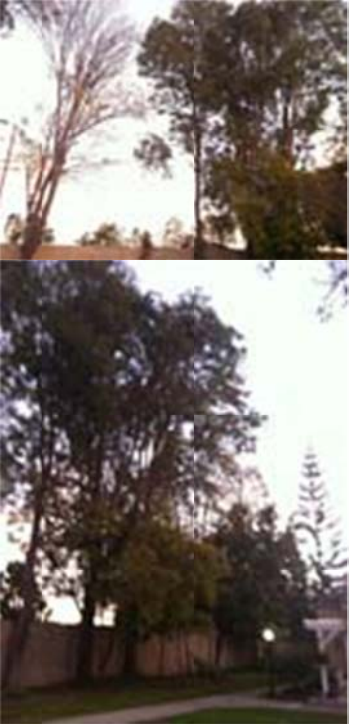
<p>Sites 62, 67, 68, 69, 70, and 73 <i>Fraxinus velutina</i> - Modesto Ash</p> <p>These ash trees have significant height, and they now pose a hazard to the building to the South because 40% of their anchorage roots have been cut due to the installation of the wall behind them. If these trees were to fall over in a windstorm, they would reach the building and cause significant damage.</p> <p>I recommend the removal of the two ash trees closest to building 35. The ash trees at site 73 and site 70 can stay temporarily because if they were to fall they would not cause significant damage. However, when there is money in the budget, these trees should also be removed.</p> <p>In the short term, the ash tree at site 67 has some large dead branches in the canopy that should be removed before they fall on the sidewalk. It is already showing signs of decline from the root cutting.</p> <p>Removal recommended. Priority: High</p>

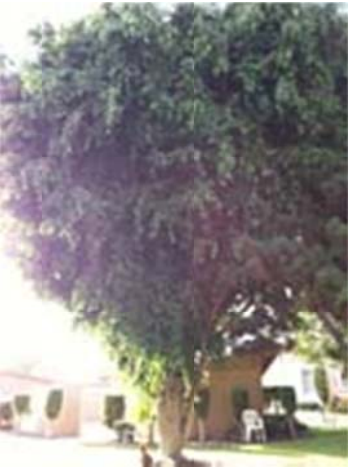
<p>Site 12 <i>Ficus benjamina</i> - Weeping Fig</p> <p>This fig tree has the same problems as its neighbor at site 9. It is a root-aggressive tree that is going to cause damage to the sidewalk and building foundations. The fringe should be pruned annually to maintain sidewalk clearance. This high maintenance tree will end up costing a lot to maintain over the years. It is crowding out the neighboring pine to the East.</p> <p>If the tree is to be retained, it should be pruned back to allow clearance for its neighboring trees. Otherwise, this maintenance should be skipped because it would be a waste of funds to prune and then remove the tree.</p> <p>Maintenance: two hours Next Service: now Priority: medium</p>
