TREE INVENTORY

Prepared for
LEISURE WORLD MUTUAL 15
SEAL BEACH

Prepared by
JAMES KOMEN – CLASS ONE ARBORICULTURE
ISA CERTIFICATION #WE-9909A
(818)495-5344
CLASSONEARBORICULTURE@GMAIL.COM
DECEMBER 1, 2013

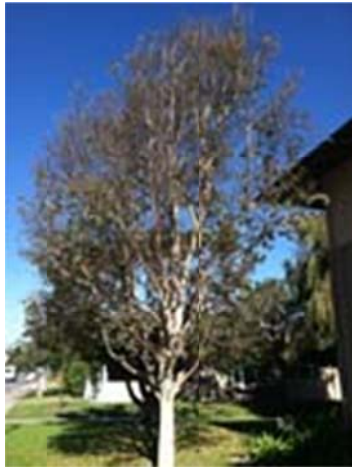
Site 4

Lagerstroemia indica - Crape Myrtle

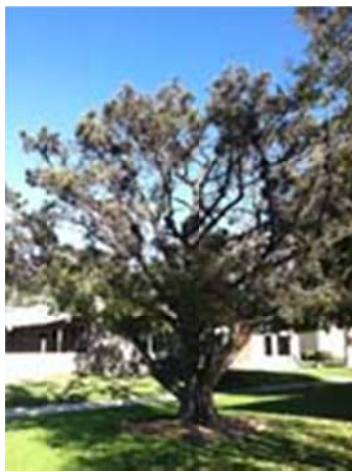
Site 5

Pinus radiata - Monterey Pine

This tree is extremely stressed from the pruning it has had in the past. Nearly every branch has been tipped, and excurrent species such as the pine do not respond well to tipping cuts. If the apical meristem is removed from a branch, then it has no point to expand growth from, and eventually dies back to the main stem. If this happens on every branch, the tree eventually dies all the way back. This tree is currently in a decline spiral and should be monitored. When the tree finally dies it can be removed and replaced.

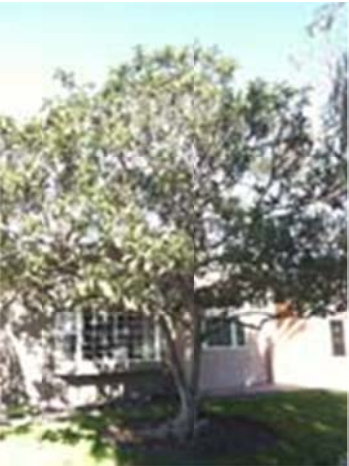
<p>Site 7 <i>Eriobotrya japonica</i> - Loquat</p> <p>This tree is suffering a bit from the stress of the pruning it has undergone over time. Nearly every interior shoot has been removed, and the entire fringe lies at the branch tips. This pruning strategy is known as Lions-Tailing and is not a recommended practice. Lions tailing reduces the tree's health by reducing its potential to photosynthesize, and it also increases its susceptibility to limb breakage in windstorms. The tree has enough potential to recover, and should be left alone as much as possible. The only two pruning issues are sidewalk clearance and roof clearance.</p> <p>Maintenance: 30 min. Priority: medium Next Service: summer</p>

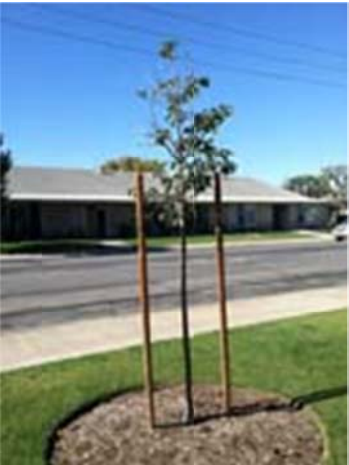
<p>Site 8 Unknown Species</p> <p>This recent installation is being choked by its ties. The ties are secured too tightly, causing a constriction similar to a tourniquet. This nursery stock was poorly selected because it only has foliage in the upper one third of the canopy, leaving a long spindly trunk that is susceptible to breakage in the wind. The tree is stake dependent, and if the stakes were to be removed, it would surely fall over in the wind. However, if the stakes are not removed the tree will never develop trunk taper which is necessary for it to be able to stand on its own. The tree should be correctly staked to remove the pressure from the ties.</p> <p>Maintenance: 20 min. Next Service: now Priority: high</p>

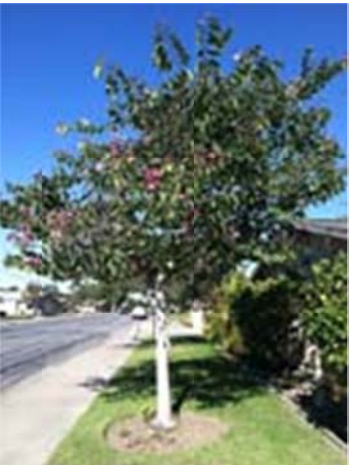
<p>Site 9 <i>Bauhinia x blakeana</i> - Hong Kong Orchid</p> <p>This Hong Kong Orchid Tree is flowering nicely, but it has many incorrect pruning cuts. There are many stumps that are leaving the tree slightly disfigured and stressed. These stumps should be recut so that the tree can roll a cambium callous over the wound sites and heal them to protect from decay organisms entering. There are some rubbing and crossing branches that should be addressed for the long-term health of the tree. This tree will take some time to clean out initially, but it should be a relatively low maintenance tree thereafter.</p> <p>Maintenance: 30 min. Next Service: winter Priority: medium</p>

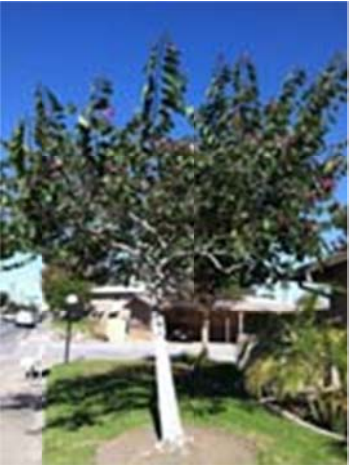
<p>Site 10 <i>Bauhinia x blakeana</i> – Hong Kong Orchid Tree</p> <p>This tree has similar characteristics to its neighbor at site 9. There are stumping cuts and crossing branches. The structure of the tree could be cleaned out in dormancy, and then the tree would be a relatively low maintenance specimen.</p> <p>Maintenance: 30 min. Next Service: winter Priority: medium</p>

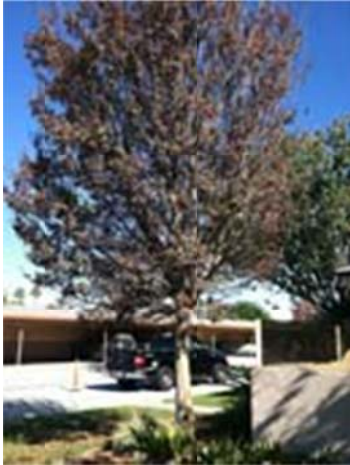
Site 11

Lagerstroemia indica - Crape Myrtle

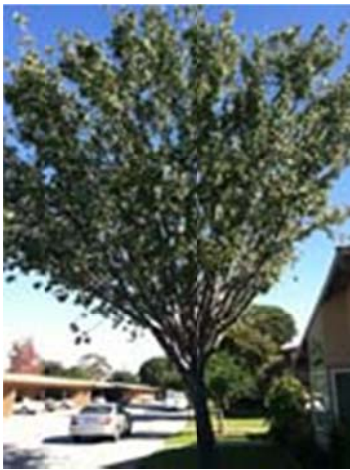
Site 12

Pyrus kawakamii - Evergreen Pear

This tree is healthy, but it has an undesirable structure. Nearly all of the branches are emanating from a single point, making it extremely susceptible to tearout in a windstorm. The problem with this tree originated with the nursery practice of heading off the top of the young nursery stock and forcing it to grow many shoots emanating from that resprouting cut. The long-term consequence is the tree has many shoots that all compete with each other and that have little to no lateral branching. Ultimately this poor structure will cause further problems with the tree.

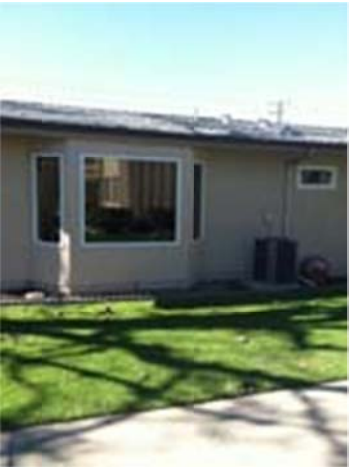
<p>Site 16 Vacant Planting Site</p> <p>This site gets protection from the afternoon sun and shade from its neighboring Sycamore in the summertime. It would be a good site for a diminutive species such as the Purple Leaf Plum or the Japanese Maple.</p>

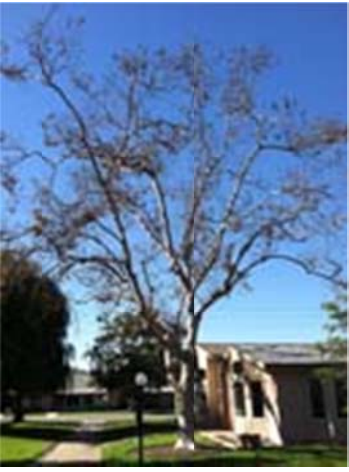
<p>Site 17 <i>Platanus acerfolia</i> - London Plane Tree</p> <p>This tree has good structure, but it should be monitored for the limbs that are overhanging the roof of the adjacent building. There is one co-dominant leader immediately over the corner of the building that should be addressed in the winter. The smaller and lower of the two leading branches should be removed. Co-dominant leads are susceptible to tearout in windstorms. There is also some minor deadwooding in the tree that could be done.</p> <p>Maintenance: 90 min. Next Service: winter Priority: medium</p>

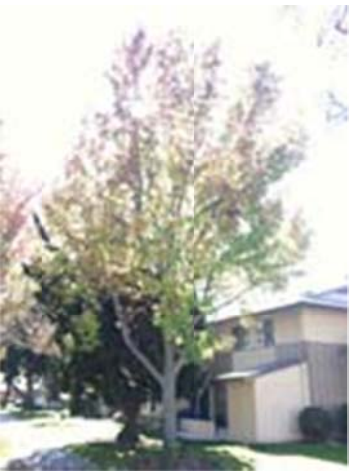
<p>Site 18 <i>Liquidambar styraciflua</i> - Sweet Gum</p> <p>This tree has very good form and it does not need much pruning in the short run. There is some competition with the neighboring Juniper that should be addressed, and a few of the leaders that are going into the Juniper should be reduced to subordinate branches. Sidewalk clearance should be maintained. Homeowners may have issues with this tree because of its fruit drop on the sidewalk.</p> <p>Maintenance: 30 min. Next Service: now Priority: medium</p>

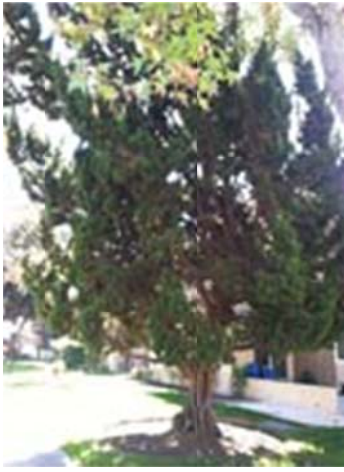
<p>Site 19 <i>Juniper chinensis</i> – Hollywood Juniper</p> <p>The Juniper is a great species because it is extremely low maintenance. It only needs about half an hour of internal deadwood cleaning every 3 to 5 years. This tree has some minor competition with the Liquidambar to the North, but the pruning cuts should be made on the Liquidambar and not on the Juniper. There is only a little bit of deadwood cleaning that can be done in this tree at this time.</p> <p>Maintenance: 30 min. Next Service: now Priority: low</p>

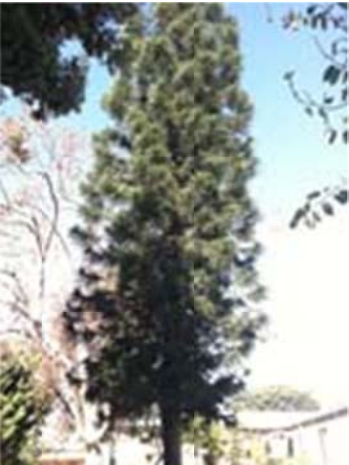
<p>Site 25 <i>Araucaria heterophylla</i> - Norfolk Island Pine</p> <p>This tree has a good, solid leading trunk with very little perceptible lean. The foliage is full and green, and this tree will continue to grow skyward. It should be noted that there is some out-sapping at the base of the trunk on the Western side. This out-sapping could be due to a variety of causes, and it should be monitored over time. One possibility is damage from the planting of the flowers around the base of the tree. Another is torsional wind loads on the tree concentrated at the base of the trunk. There are scrape marks, and this suggests mechanical damage. The wound site does not appear to be serious enough for alarm.</p> <p>Maintenance: 20 min. Next Service: fall Priority: low</p>
 	<p>Site 26 <i>Platanus acerfolia</i> - London Plane Tree</p> <p>This tree has good branching structure and its hazards have been mitigated in 2012. There are some branches that are gracefully arcing over the Greenbelt, but there is plenty of space between them and the adjacent building. This tree should be monitored when it is in leaf and the deadwood should be cleaned from the canopy.</p> <p>Maintenance: two hours with climber Next Service: fall Priority: low</p>

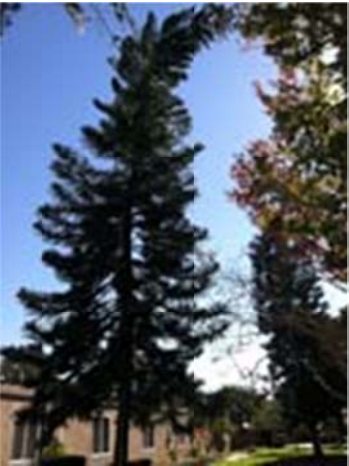
<p>Site 29 <i>Araucaria heterophylla</i> - Norfolk Island Pine</p> <p>This tree is tied to a metal stake that is immediately adjacent to the trunk. The tie on this stake is causing damage to the trunk and should be removed. If the tree needs additional support, proper guy wires should be installed by staking them into the ground. The top of the tree has developed a severe lean to the West into the canopy of the neighboring Liquidambar tree. If the tree continues to grow in this way, it will eventually be detrimental to its own health because the cantilever of the weight distribution will predispose it to failure. The tree does not appear to be a hazard because its prevailing lean is away from the adjacent building. The tree stakes should be removed in the short term, and the growing tip should be monitored over the next year.</p> <p>Maintenance: 20 min. Next Service: now Priority: high</p>

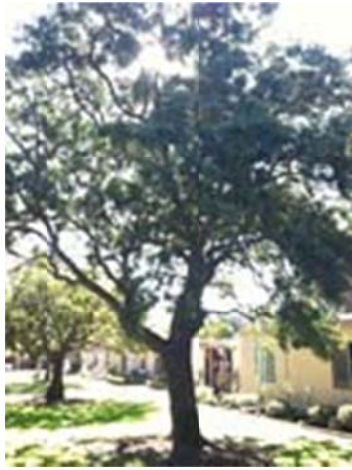
<p>Site 34 <i>Schinus terebinthifolius</i> - Brazilian Pepper</p> <p>This tree has plenty of space to grow, but it will need to be maintained for roof and head height clearance. There is also some deadwood in the upper canopy that can be removed for aesthetic purposes.</p> <p>Maintenance: 30 min. Next Service: now Priority: high</p>

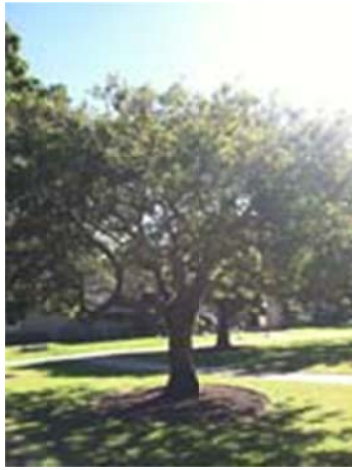
<p>Site 35 <i>Schinus terebinthifolius</i> - Brazilian Pepper</p> <p>This tree's lower fringe is a little ragged because it was pruned by an aggressive landscaper using either loppers or shears. The stumps that are left should be cut back to the parent stem. The tree is also in competition with the Fern pine to the East, and clearance should be pruned. Generally, this tree's fringe should be addressed every 6 to 12 months.</p> <p>Maintenance: 30 min. Next Service: now Priority: high</p>

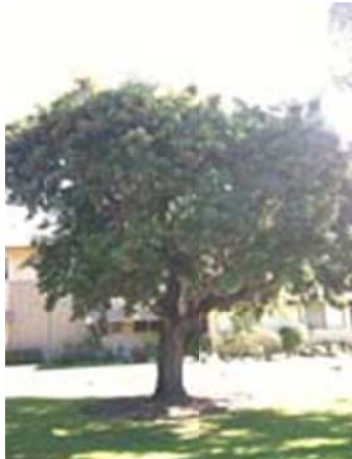
<p>Site 36 <i>Schinus terebinthifolius</i> - Brazilian Pepper</p> <p>This tree is in competition with the pine to the South, and clearance should be pruned. The fringe of this tree should also be raised for head height clearance. This tree's fringe will need to be maintained every 6 to 12 months, but it only needs to be pruned around the low fringe and on the South side where there is competition with the pine tree.</p> <p>Maintenance: 30 min. Next Service: now Priority: high</p>

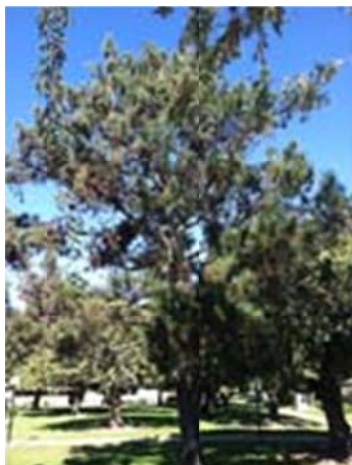
Site 37
Pinus radiata - Monterey Pine

The most notable feature of this tree is its co-dominant lead. This feature creates a hazard because the two trunks press up against each other and do not develop a branch union that increases in diameter as they grow. This makes the attach points susceptible to wind throw because the two trunks will oscillate much like a tuning fork in the wind. If one of the two trunks were to fail, it would likely be the southern one. This trunk could potentially reach the adjacent building and cause significant damage. A recommended mitigation for this structure is to install a safety line in the canopy. This will not prevent the trunk from tearing out, but it will limit any damage because the trunk will remain secured to the rest of the tree rather than falling onto adjacent building. The tree is also showing signs of weeping sap on the underside of some of the limbs. This exudation of sap could be indicative of torsional stress, or it could be cracks from rapidly expanding bark from aggressive growth. This tree should be monitored for sap flow. If the sap flow increases, then it is likely an injury which could be indicative of a problem. If the sap flow goes away, then the tree will likely have healed itself. Some of the branches have been tipped in the past causing them to slowly die back. Pines should never be tipped because they are excurrent species that cannot recover when they have their growing tips removed. This tree is in competition with the Brazilian Pepper to the North, but the Brazilian Pepper should yield to the pine tree because the pine is more valuable.

Maintenance: one hour with climber
Next Service: now
Priority: hazard

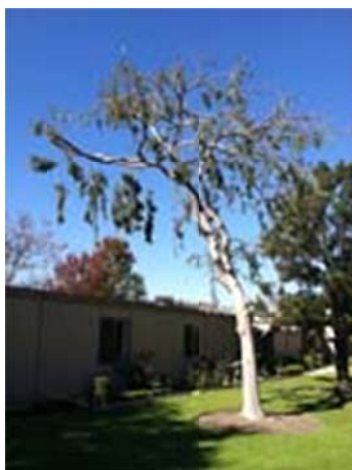
Site 38
Ulmus parvifolia - Chinese Elm

This tree has been very aggressively pruned recently. The tree will need to have time to recover. Nearly every branch in the upper canopy has been tipped, and the fringe that remains may or may not be enough to sustain the tree. The only pruning that needs to be done on this tree is maintenance of the low fringe for head height and roof clearance.

Maintenance: 30 min.
Next Service: fall
Priority: medium

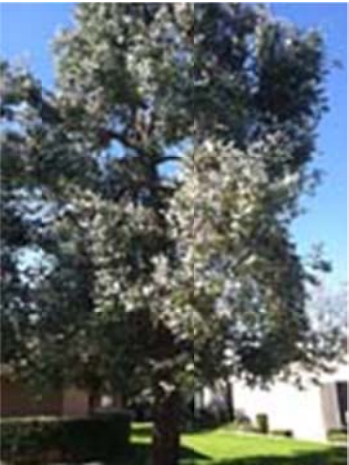
<p>Site 39 <i>Eucalyptus pulverulenta</i> – Silver Leaf Mountain Gum</p> <p>This Eucalyptus has an odd structural defect at about 8 feet up its trunk. A lateral branch is twisted around the main trunk causing a constriction point. At this point in the tree's life, this branch is far too large to remove without causing further damage to the tree. The tree should simply be monitored for this weak point in its structure. If fungal blooms or dieback begin to occur around this contact zone, then the tree should be evaluated for being a hazard. The tree is currently not a hazard because the leaves are healthy and the trunk appears to be sturdy and decay-free. The only pruning that is necessary on this tree is roof clearance from the adjacent building and a harmony trim with the adjacent New Zealand Christmas Tree.</p> <p>Maintenance: one hour with climber Next Service: spring Priority: medium</p>

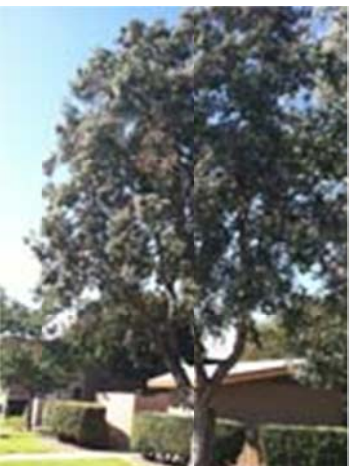
<p>Site 40 <i>Metrosideros excelsus</i> - New Zealand Christmas Tree</p> <p>This tree is in good form and needs very little pruning at this time. The competition with its neighboring Eucalyptus should be addressed in the short run, and sidewalk and head height clearance should be maintained annually.</p> <p>Maintenance: 40 min. with climber Next Service: spring Priority: medium</p>

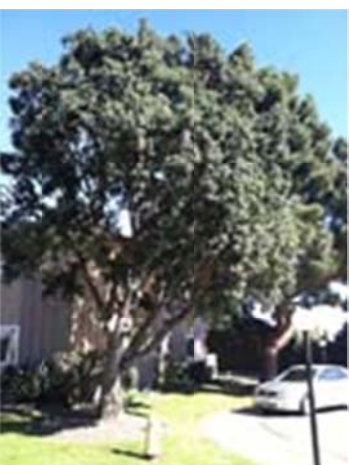
<p>Site 41 <i>Metrosideros excelsus</i> - New Zealand Christmas Tree</p> <p>This tree is in good form, and it needs very little pruning at this time. It should be monitored for roof clearance with the adjacent building. Some of this tree's limbs have been tipped in the past, and they will need to be restored. As the tree develops shoots in response to this pruning, the strongest shoots should be retained and the weaker ones should be removed.</p> <p>Maintenance: 30 min. Next Service: fall Priority: medium</p>

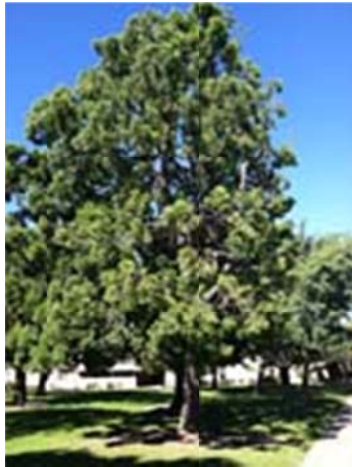
Site 42

Afrocarpus falcatus – African Yew Pine

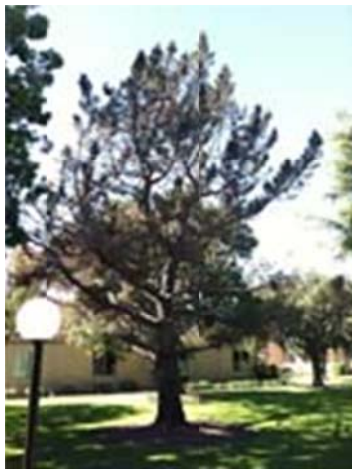
Site 43

Pinus radiata - Monterey Pine

This pine tree has begun its decline spiral, and it only has a few more years of life left. When there is money in the landscaping budget, this tree should be considered for removal and replacement. In the short run, the dead limbs can be removed, and the live foliage can be sprayed with a hose to reduce the dust buildup and eliminate the dead needles from the canopy. This will open it up for more exposure to light and increase photosynthesis in the tree.

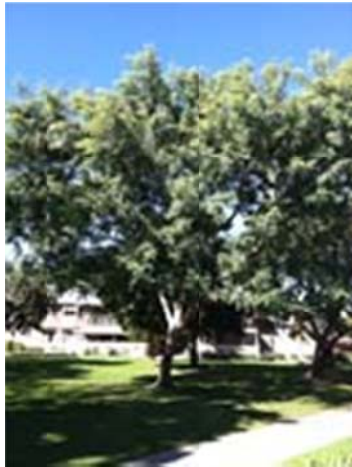
Site 44

Tipuana tipu - Tipu Tree

In the past, this tree was climbed with spikes, and these Spike wounds still remain in the trunk of the tree. Live trees should never be climbed with spikes because they create wounds that the tree will have to heal. These wounds are entry points for decay organisms and can cause long-term damage to the health of the tree.

The foliage of this tree is full and healthy. It should be addressed for sidewalk clearance and competition with the neighboring Liquidambar and Fern pine. There are some minor weeping sites on the trunk that should be monitored annually. If the sap exudation increases, then it may be a sign of a more serious condition.

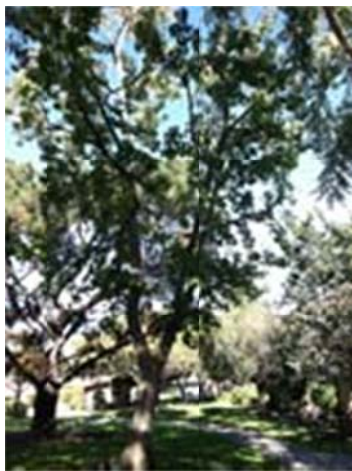
Site 45

Liquidambar styraciflua – Sweet Gum

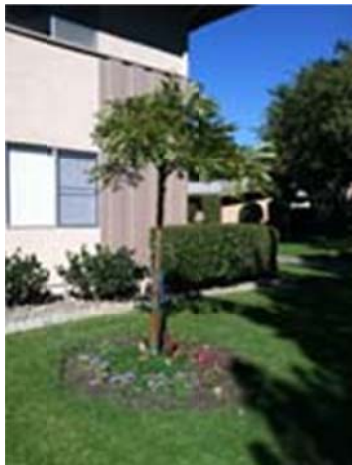
Site 49

Cassia leptophylla - Gold Medallion Tree

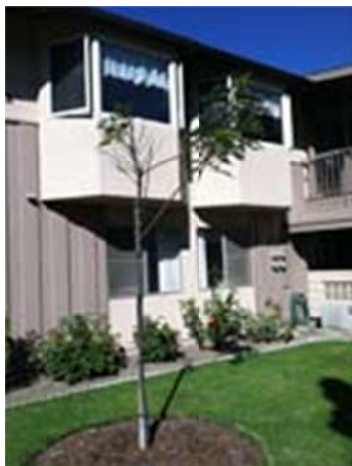
Site 50

Cassia leptophylla - Gold Medallion Tree

This tree has similar problems to the gold medallion tree at site 49. It was a poorly chosen nursery stock with only a small sprig of foliage at the top and a long spindly trunk that is susceptible to wind throw. It was planted in a similar manner with a stake up against the trunk of the tree tied very tightly to the trunk. As a result, this tree has already begun to decline and die. In the short term, it should be re-staked so that if it is able to pull out of its stressed condition, it will stand a better chance at survival. However, this tree may end up declining and dying and needing to be replaced.

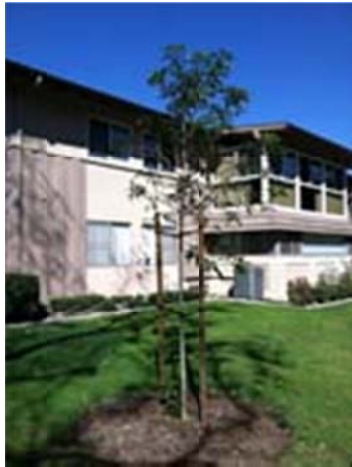
Site 51

Pittosporum undulatum – Victorian Box

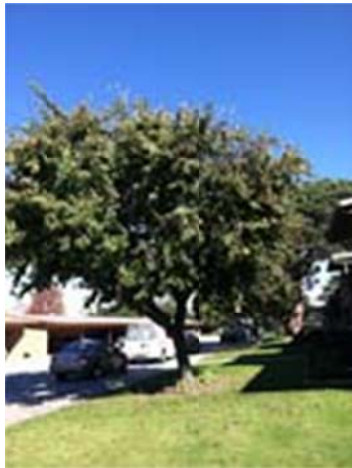
Site 52

Pyrus kawakamii - Evergreen Pear

This tree has fire blight which is a systemic disease that has already spread throughout the tree's vascular system. Removal of the symptomatic tissue provides aesthetic relief temporarily, but eventually this tree will begin a decline spiral. However, the tree can be retained for several more years, and the fire blight can be removed annually. The tree will not need to be removed and replaced until it dies, and it may not die for another 5 to 7 years. If symptomatic tissue is removed, pruning tools need to be sterilized in bleach between every cut. This is more time-consuming, but it will prevent the spread of fire blight through pruning tools to other trees.

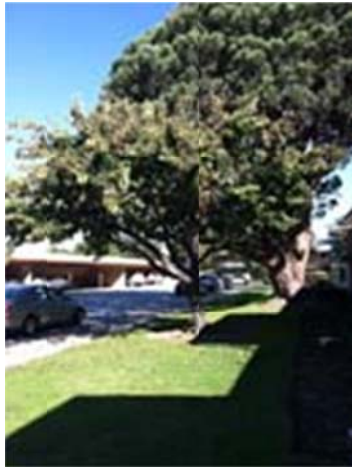
Site 53

Pyrus kawakamii - Evergreen Pear

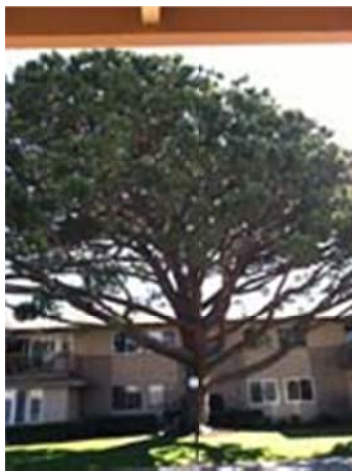
Site 54

Pinus pinea - Italian Stone Pine

This tree has beautiful healthy foliage, but it is only at the tips. Previous pruning has removed interior shoots and has caused the foliage to only grow at the extreme tips of each branch. The tree is therefore in stable condition, but is not going to be able to heal large wounds.

This tree is known to have aggressive roots, and there may be some problems with the roots invading the foundation of the adjacent building. If this is the case, these roots should not be severed without the supervision of an arborist because incorrect root cutting could damage the tree's ability to anchor itself and stay upright. Improper root cutting also serves as an entry point for decay organisms and can kill the tree from the bottom up.

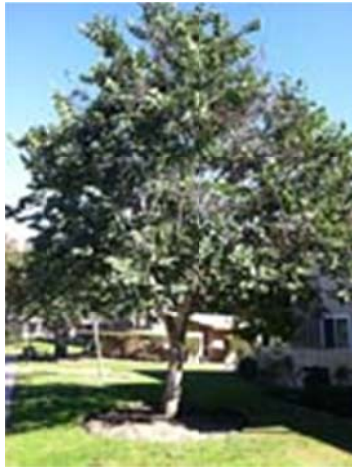
Site 55

Bauhinia x blakeana - Hong Kong Orchid Tree

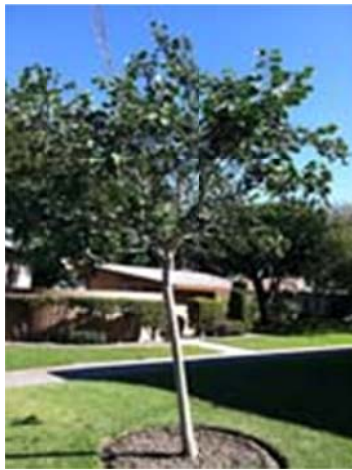
Site 56

Bauhinia x blakeana - Hong Kong Orchid Tree

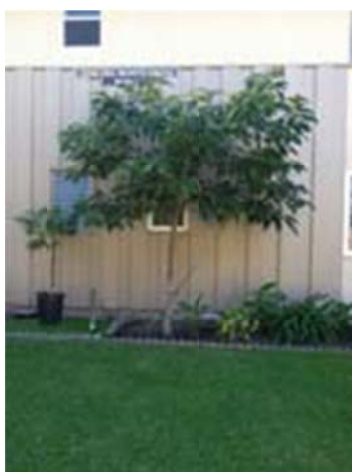
Site 57

Vacant Planting Site

This site should remain empty as long as the avocado tree grows in the private zone adjacent to it. The avocado tree behind this vacant planting site may pose problems to the building because it was planted so close. When this tree is removed, this planting site could be considered.

Furthermore, this planting site on the map is immediately adjacent to a storm drain. I recommend splitting the site into two separate sites to the North and South of the storm drain and planting diminutive species that are shade tolerant. This will avoid causing any damage to the storm drain or surrounding infrastructure.

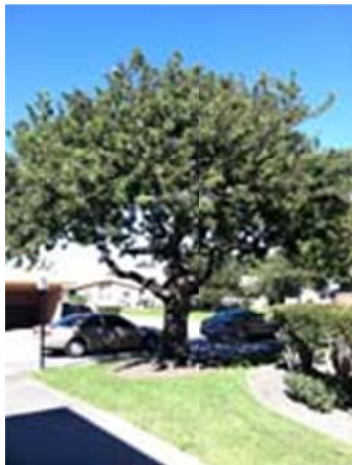
Site 58

Schinus terebinthifolius - Brazilian Pepper

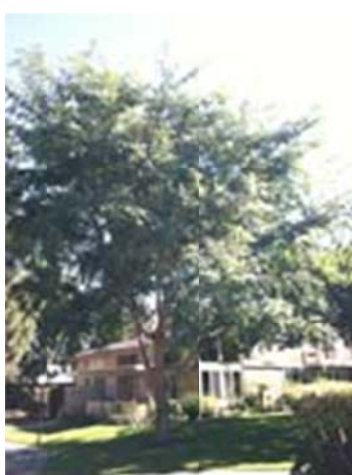
Site 59

Tipuana tipu - Tipu Tree

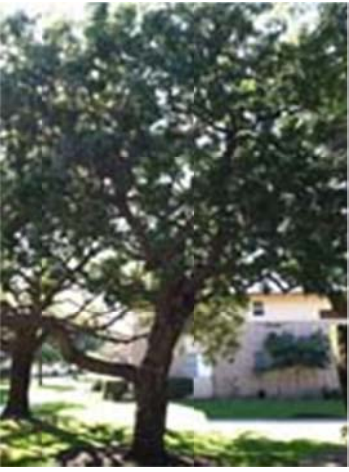
<p>Site 60 <i>Schinus terebinthifolius</i> - Brazilian Pepper</p> <p>This tree has good structure and is healthy, but it is growing in competition with its neighboring pepper tree. This tree should be pruned to leave a little space for its neighbor, and it should also be addressed for roof clearance with the adjacent building.</p> <p>Maintenance: 30 min. Next Service: spring Priority: medium</p>

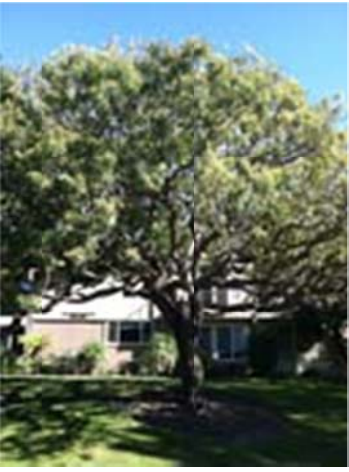
<p>Site 61 <i>Schinus terebinthifolius</i> - Brazilian Pepper</p> <p>The canopy of this tree is looking a little sparser than its neighbor because many of the interior shoots have been pruned out. This tree should be allowed to grow more foliage in its upper canopy to recover from its stress. There is some deadwood that could be removed for aesthetic purposes and some rubbing and crossing structures that can also be addressed. This tree should not have to yield to its stronger neighbor. Rather, the neighbor tree should be pruned back to allow more space to grow.</p> <p>There is also some drought stress in the leaves which could be indicative of root cutting. There may have been root cutting in the past 2 to 5 years that is now manifesting itself as yellowing foliage. This tree should recover because the Brazilian Pepper is a very vigorous species.</p> <p>Maintenance: 20 min. Next Service: spring Priority: medium</p>

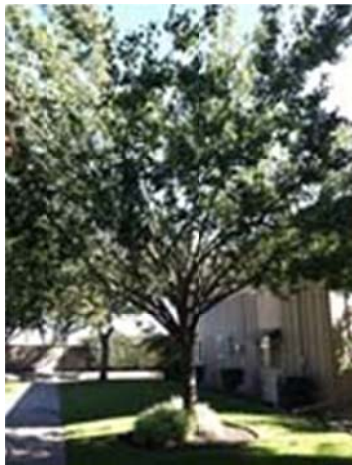
Site 65

Pyrus kawakamii - Evergreen Pear

This tree's form is a problem that originated at the nursery. It has many shoots all originating from the same point. This phenomenon was caused by the nursery heading back the tree to a height of approximately 6 feet and then allowing all of the new sprouts to grow into respective branches. These branches have relatively little lateral branching because they've had to compete with each other for light. That created a structure that is very susceptible to tearout and wind throw.

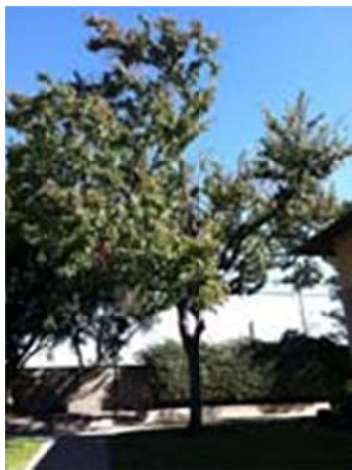
Site 66

Pyrus kawakamii - Evergreen Pear

This tree is also affected by fire blight that will likely be the cause of death of the tree. Aesthetically, the tree can be pruned annually to remove the symptomatic tissue. Eventually this tree should be considered for removal and replacement.

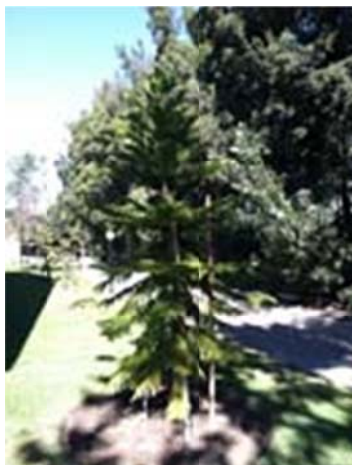
Site 67

Araucaria heterophylla - Norfolk Island Pine

This is a multi-trunk specimen of *Araucaria*. If left in its current multi-trunk form, this tree cannot be allowed to have a long lifespan. These multiple trunks will compete with each other, and they will be susceptible to tearout in a windstorm. In as early as five years, this tree could become a hazard to the adjacent building. This tree has been improperly staked and tied with a tight string around the trunk creating a constriction point similar to a tourniquet. These stakes and ties should be removed. If the tree cannot stand on its own, it can be staked correctly using wire and hose tubing that allow some movement for the tree to develop trunk taper. However, if a longer life is desired for this tree, one single leading trunk should be selected and the remaining trunks should be pruned out before they grow any larger. If the remaining trunks are removed now, the wound sites will be small and easy for the tree to heal. If they are pruned later, then the wound sites will be large and take a longer time to heal, making the tree more susceptible to disease and decay. Ultimately, this is not the best choice of tree for the site because if the tree were to mature for 20 or 30 years, it would pose a significant hazard to the adjacent building.

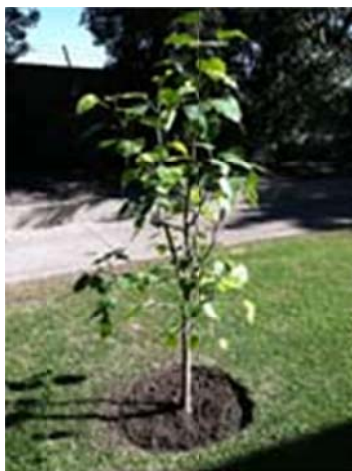
Site 68

Unknown Species

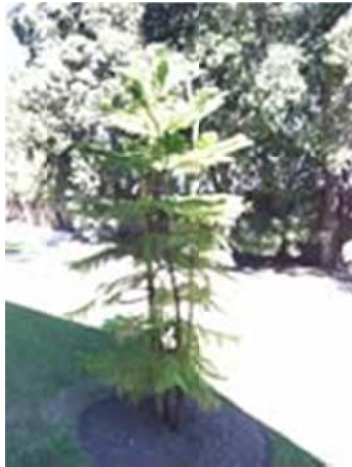
Site 69

Araucaria heterophylla - Norfolk Island Pine

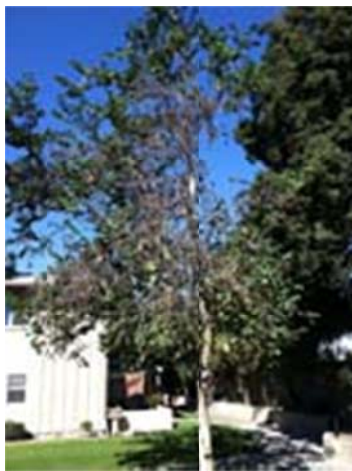
Site 70

Bauhinia x blakeana - Hong Kong Orchid Tree

This tree has some significant deadwood in the canopy that will need to be pruned out for aesthetic purposes. The best time of year to prune this deadwood is while the tree is in leaf so the deadwood can be easily identified. There are also some minor structural cracks that should be monitored. The soil around the base of this tree also appears to be fairly dry, and the irrigation should be checked so that this tree does not suffer drought stress.

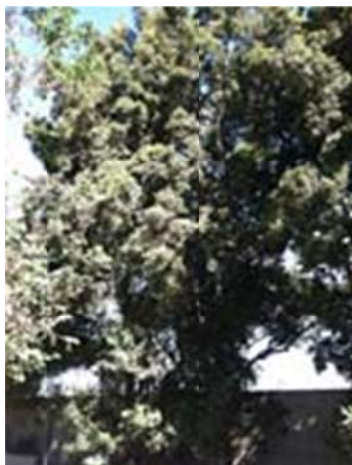
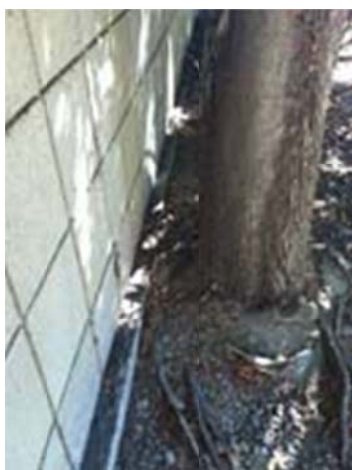
Site 71 through 82

Syzygium paniculatum – Brush Cherry

This stand of brush cherry plays an important role of creating a privacy screen for the homeowners that live at the edge of Leisure World. They also aesthetically block the power lines on the opposite side of the wall. They are growing nicely with the understory oleanders that will need to be pruned annually for sidewalk clearance.

The big problem that these trees are facing is the recent installation of the wall. The wall's installation necessitated cutting many roots which ultimately caused a great deal of stress on these trees. Furthermore, the roots that were cut were the anchorage roots to the East that prevent the trees from falling to the West towards the adjacent buildings. Currently, approximately 55% to 60% of the root plates of each of these trees remain. The foliage of these trees appears healthy, and if not for the prior knowledge of the wall's installation, I would not have considered them a hazard.

These trees should be monitored quarterly for signs of decline. If they brown out and decline, they should be removed and replaced. However, since the trees are currently green and healthy and still serving their intended purpose, they can be retained. Although there are pruning cuts that could be made on these trees, the intended lifespan of these trees is likely not more than two years. Therefore my recommendation is to not prune them at this time and to wait to see how they respond to the root cutting. Inspections should be done quarterly for the next two years.

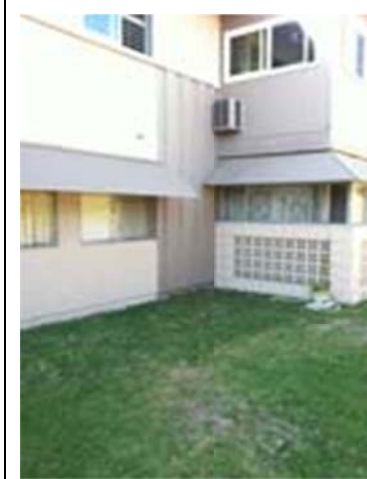
Site 85
Vacant Planting Site

This planting site would be ideal for a shade tolerant tree such as the Japanese Maple. It is also close to the building, so care should be taken to select a species that is not root aggressive.

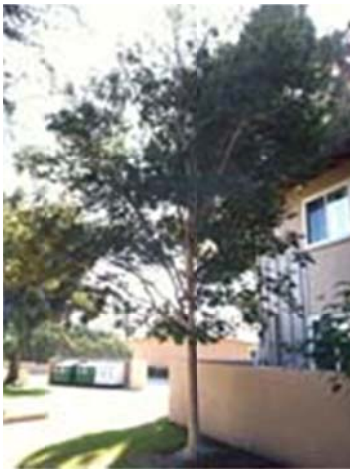
Site 86
Lagerstroemia indica - Crape Myrtle

This tree has excellent structural form. The Crape Myrtle is known to not be root aggressive; however, it is planted a bit too close to the hardscape, so there is still a possibility that it may eventually cause damage to the adjacent patio. The foliage should be monitored for roof clearance and sidewalk clearance annually.

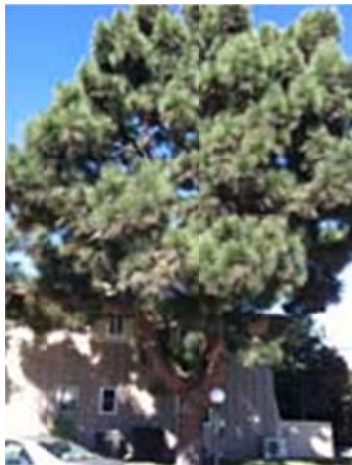
Site 87

Pinus canariensis - Canary Island Pine

This species is known to get very tall, and it may not be the best choice next to a building. Complicating this tree's health is its structure of having three co-dominant stems emanating from eight-feet up the tree. At some point in the distant past the leading tip of the young tree must have been pinched or broken and lateral branches assumed apical dominance. This is what created the form that the tree is in today.

The angle of branch attachment is sufficiently large that there is not a hazard of included bark. The branch union points are still expanding in girth as the trunks expand so there is additional support as the tree grows. However, there still remains the possibility of large-scale wind throw when the wind causes the trunks to oscillate like a tuning fork. I see no signs of stress or failure at these branch union points, and so I feel this tree is not an imminent hazard to the building. This tree should be monitored annually with a climbing inspection for any signs of stress in the trunk. Early signs of stress may indicate a greater likelihood of failure.

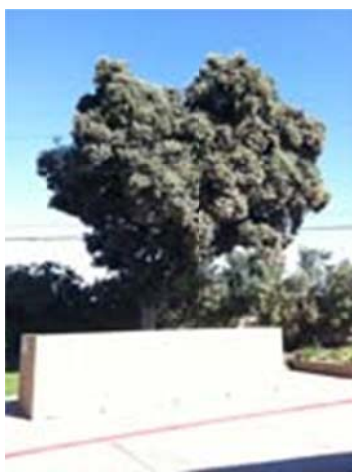
Site 88

Metrosideros excelsa – New Zealand Christmas Tree

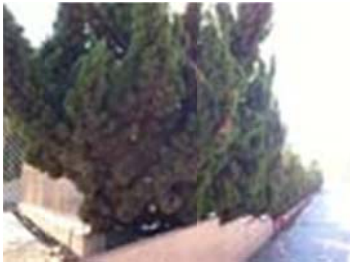
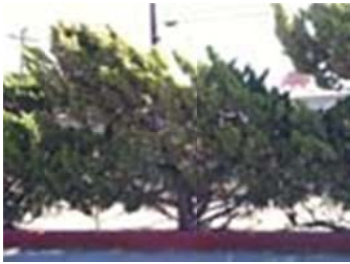
Site 89 through 109
Juniperus chinensis – Hollywood Juniper

This species is an excellent choice for this hedge because it is low maintenance and heat tolerant. This hedge will require minimal maintenance: only the occasional street clearance. There is little growing space for the trunk of these trees, and this will limit their size naturally.

There are some volunteer Brazilian Pepper trees growing in the soil space that should be removed to retain uniformity of the hedge. There are also some dead branches that can be removed from this hedge for aesthetic purposes.

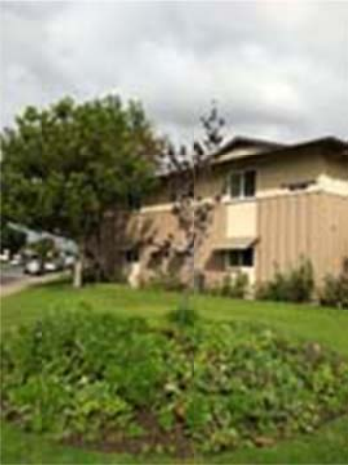
<p>Site 1 <i>Prunus cerasifera</i> - Purple Leaf Plum</p> <p>This is a large site, better suited to a shade tree than a tiny ornamental. There is considerably more room than is needed for the Plum tree that is planted here. I recommend transplanting this plum tree to a more appropriate site and planting a larger specimen in this key landscape site.</p> <p>Maintenance: 3 hours to transplant Next Service: now Priority: low</p>

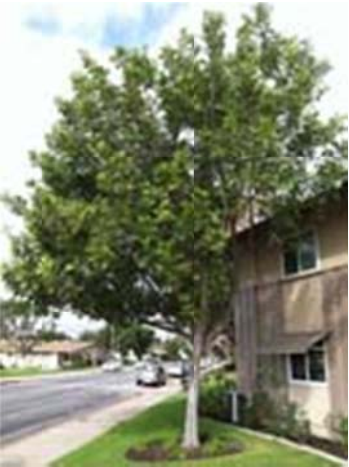
<p>Site 2 <i>Cupaniopsis anacardioides</i> – Carrotwood</p> <p>This tree has several trunks emanating from the same point at about 6 feet up the trunk. This is not an ideal form, but it is too late in the tree's development to make correctional cuts. There is a bit of tubing that is impounded in the bark from when the tree was smaller and tied to a stake.</p> <p>The tree should be monitored annually for roof and sidewalk clearance but does not need pruning now. There are a few rubbing branches in the upper canopy that could be corrected, but these can wait until the clearance pruning.</p> <p>Maintenance: 30 min. Next Service: fall Priority: medium</p>

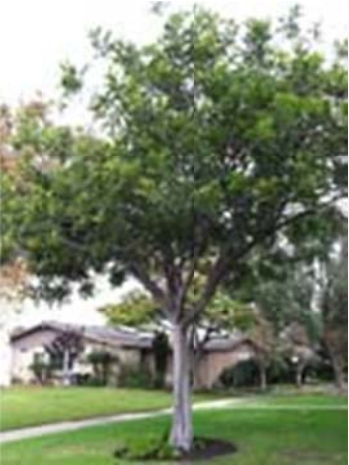
<p>Site 3 <i>Cupaniopsis anacardioides</i> - Carrotwood</p> <p>This tree has a bit of a chaotic interior and could have some slight reduction in its complexity. It should be monitored for roof and sidewalk clearance. The structure of the tree is not ideal because many trunks are emanating from the same point at 6 feet up the tree, but no action should be taken because it is too late in the tree's development.</p> <p>Some severe fluting has occurred near the root crown indicating some internal decay. It is possible that this tree has internal defects that will cause structural weakness. Since the tree is relatively small, it would not cause significant damage to the nearby buildings if it were to fail. Therefore this tree is currently not a hazard, but it should be monitored as it grows.</p> <p>Maintenance: 20 min. Next Service: fall Priority: medium</p>

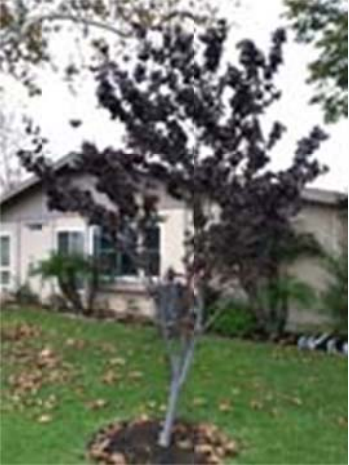
<p>Site 4 <i>Prunus ceracifera</i> - Purple Leaf Plum</p> <p>This plum tree seems to be faring well given its protection by the neighboring Sycamore and Golden Rain Tree. It still receives full afternoon sun, and its Western canopy is showing signs of scorch. This tree is acceptable as an understory tree and can be allowed to grow in the site.</p> <p>Maintenance: zero Next Service: fall Priority: low</p>

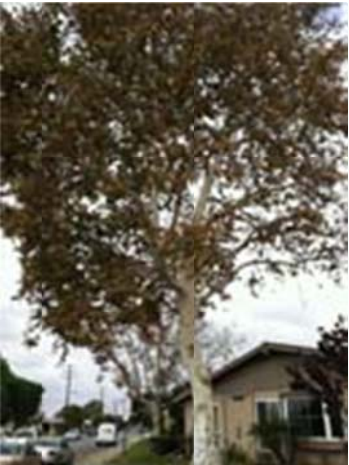
<p>Site 5 <i>Platanus acerfolia</i> - London Plane Tree</p> <p>This beautiful London Plane Tree has an excellent scaffold. It is leaning slightly to the North-East, towards the adjacent building. It should be monitored annually and thinned on its Eastern side to allow more growth on the Western side to compensate for its lean. There do not appear to be any major defects in the trunk or the major scaffold branches at this time. Even though this tree is a large specimen, it appears to be safe and does not need any major pruning at this time. It should be monitored for roof and sidewalk clearance annually in addition to canopy rebalancing.</p> <p>Maintenance: four hours with climber Next Service: fall Priority: medium</p>

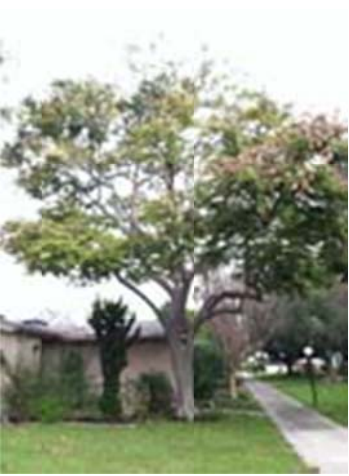
<p>Site 6 <i>Koelreuteria paniculata</i> - Golden Rain Tree</p> <p>This is one of the few remaining specimens of the Golden Rain Tree in leisure world. It is a healthy tree, and it should be monitored annually for roof and sidewalk clearance.</p> <p>Maintenance: 60 min. Next Service: fall Priority: medium</p>

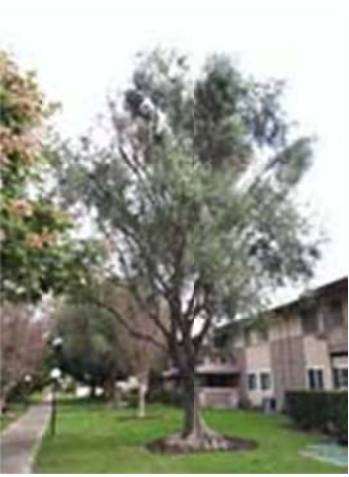
<p>Site 7 <i>Olea europaea</i> - Olive Tree</p> <p>This olive tree has been severely headed back in the past. Nearly every one of its branches has been tipped. There is a load of deadwood in the tree that should be removed for aesthetic purposes. The olive tree can be a long-lived species if it is pruned correctly. However, it is a poor healer, so injuries that it acquires now will be retained for the rest of its life.</p> <p>Maintenance: 30 min. Next Service: now Priority: medium</p>

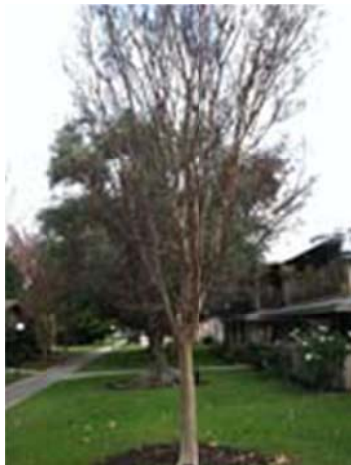
Site 8

Lagerstroemia indica - Crape Myrtle

It is difficult to improve drainage at this site while still retaining the tree because most drainage improvements involve excavation, which can damage roots. Rather, it should simply be noted that this site has poor drainage, and if this tree dies and is removed, then the problem can be addressed before a new tree is planted.

Maintenance: zero
Next Service: fall
Priority: low

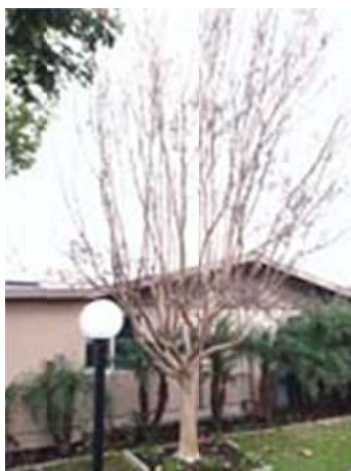
Site 9

Lagerstroemia indica - Crape Myrtle

This tree has many trunks emanating from the same point about 4 feet up the trunk, making it slightly more susceptible to tearout in a windstorm. The branches that form the canopy have very little lateral branching, and it will be difficult to retrain the canopy of this tree into a healthy structure. For now, a few up-pointing branches can be thinned to make room for the stronger branches. This tree should be monitored annually for sidewalk and roof clearance.

Maintenance: 20 min.
Next Service: fall
Priority: medium

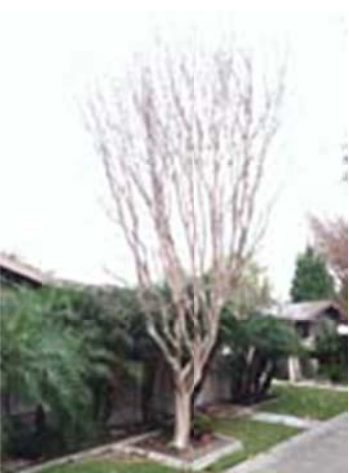
<p>Site 10 <i>Lagerstroemia indica</i> - Crape Myrtle</p> <p>This tree has similar characteristics to the Crape Myrtle at site nine. It has multiple trunks emanating from a single point making it more susceptible to wind throw. The angle of branch attachment is large enough that it is not a significant problem, but it is not an ideal form for the tree.</p> <p>There is some minor bark loss on the North Western side of the trunk and the Eastern side of the trunk as well. This could be indicative of root injury or root loss. This injury should be monitored quarterly. The cambium layer appears to be advancing and healing the wound. If the cambium continues to advance, then the wound will heal and the tree will not need any mitigation. If the cambium begins to retreat and the wound increases in size, then the tree may become a removal.</p> <p>Maintenance: 5 min. Next Service: winter Priority: low</p>

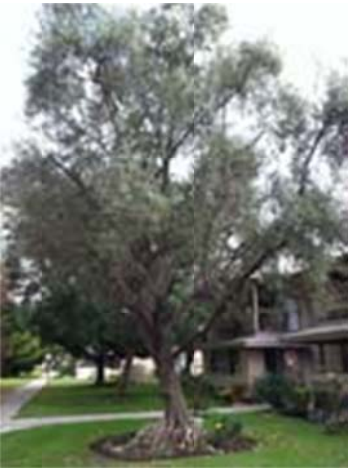
<p>Site 11 <i>Olea europaea</i> - Olive Tree</p> <p>The olive tree is a desirable species because it is long-lived, but the downside is the tree is a poor healer. There are some wounds on the trunk and on the underside of limbs in the upper canopy that may not heal for the rest of the tree's life. There is a minor amount of deadwood that can be removed for aesthetic purposes. There appears to be significant digging in the root zone of this tree to plant flowers. This digging should not be allowed, because it involves root cutting which causes long-term damage to the more desirable and more valuable olive tree. This tree should be monitored for roof and sidewalk clearance.</p> <p>Maintenance: 30 min. Next Service: now Priority: low</p>

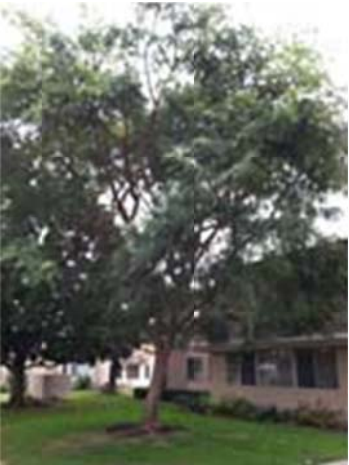
<p>Site 12 <i>Tipuana tipu</i> - Tipu Tree</p> <p>This Tipu tree has a couple of crossing branches that should be removed before they cause abrasions to the other trunks. There are a few sites on the trunk where boring insects have entered through the bark. These entry points are now weeping sap and showing early signs of the Fusarium fungus. Since the Fusarium fungus is localized, these wounds may not directly impact the health of the foliage for a while. However, if the tree acquires enough of them that they girdle the trunk, then the tree could decline and die in a matter of months or weeks.</p> <p>Maintenance: 20 min. Next Service: now Priority: medium</p>

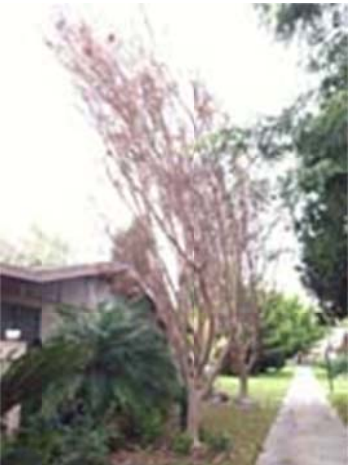
<p>Site 13 <i>Lagerstroemia indica</i> - Crape Myrtle</p> <p>This Crape Myrtle has the same structural issues that its neighbor at planting site 10 has. There are many trunks emanating from a single point creating a structure that is more susceptible to wind throw. Nearly all of the branches are leaning out towards the North, away from the shade of the neighboring Tipu tree. The tree does not appear to be in cantilever enough to cause a problem, but it should be monitored annually for roof clearance and cantilever.</p> <p>Maintenance: zero Next Service: fall Priority: low</p>

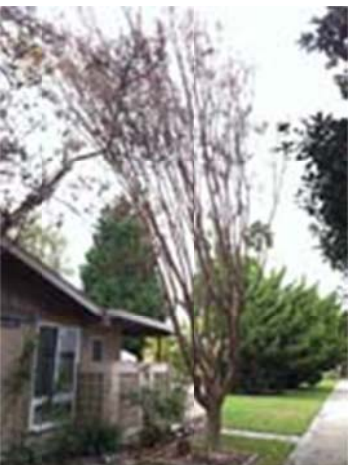
<p>Site 14 <i>Lagerstroemia indica</i> - Crape Myrtle</p> <p>This Crape Myrtle tree has similar characteristics to be Crape Myrtle at site 13. It is very slightly growing to the North over Building 20, away from the Magnolia to the South. These branches should be watched for roof clearance. Since the branches are relatively small and lightweight, they do not pose a major hazard to the building if one or two were to fail in a windstorm. Shoots that are lower on the tree should be retained because they will help the branches develop taper which will make them less susceptible to tearout.</p> <p>Maintenance: zero Next Service: fall Priority: low</p>

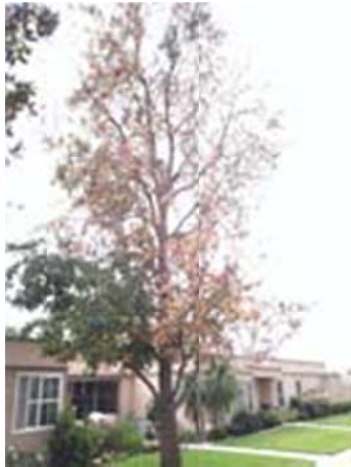
Site 22

Liquidambar styraciflua - Sweet Gum

Further up in the canopy, there is some need of lightning cuts to de-stimulate the leader over the building and the competing co-dominant leader 4 feet up the trunk from it. By making a few of these lightning cuts, more of the growth of the tree will be encouraged on the main leading trunk, creating a more stable structure for the future. If these cuts are not made, the co-dominant trunk structure will become a hazard to the adjacent building.

The outlook of this tree for the long-term is not good because its roots will continue to damage the nearby power box and irrigation lines. The homeowner in the adjacent unit tells me that one of the major structural roots on the Eastern side of the tree has been severed to access the irrigation line. The severing of this root will cause long-term structural issues with the tree, potentially predisposing it to fail to the West. This tree can remain in the landscape for now, but it should be inspected annually for signs of stress that could indicate imminent failure.

Next Service: now

Priority: medium

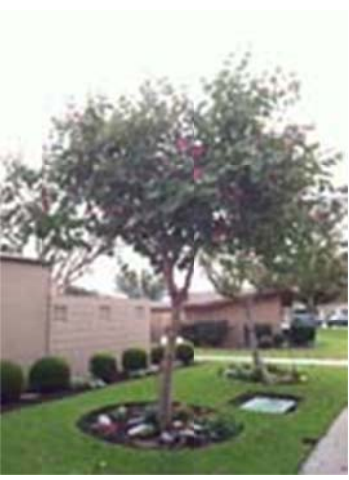
<p>Site 25 <i>Bauhinia x blakeana</i> - Hong Kong Orchid Tree</p> <p>This tree has some significant deadwood that should be removed. It should be monitored annually for sidewalk clearance. Since it is the same species and approximately the same size as the neighboring tree at site 24, it should be allowed to fight for space to create a denser canopy to shade the sidewalk.</p> <p>Maintenance: 20 min. Next Service: now Priority: medium</p>

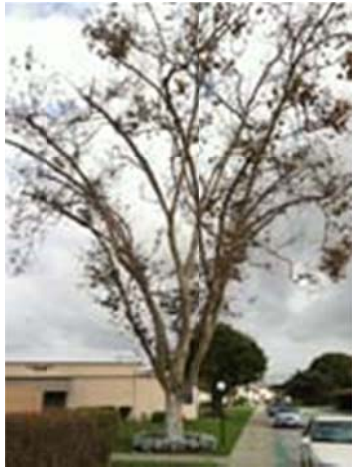
Site 29

Platanus acerfolia – London Plane Tree

Tree has been tipped in the past and is showing signs of stress. There is very little lateral branching in the upper canopy, which is a problem when trying to retrain the structure of this tree. It also makes the tree more susceptible to tearout in a windstorm. It is not a significant problem at this time, but the tree should be monitored for signs of stress. If there are signs of weakness in the lower trunk, then it may be rated as a hazard. Currently there are no visible defects in the lower trunk or root crown flare.

Priority: medium

Next Service: fall

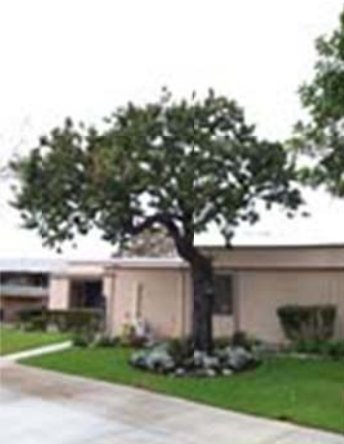
<p>Site 32 <i>Cupaniopsis anacardioides</i> - Carrotwood</p> <p>This tree was thinned in the past and is in recovery mode currently. No live foliage should be taken out of this tree at this time. There are some sprouts that are around wound sites and they should be allowed to grow to speed the healing of the pruning wounds. This tree should be addressed annually for sidewalk and roof clearance.</p> <p>Maintenance: 20 min. Next Service: fall Priority: medium</p>

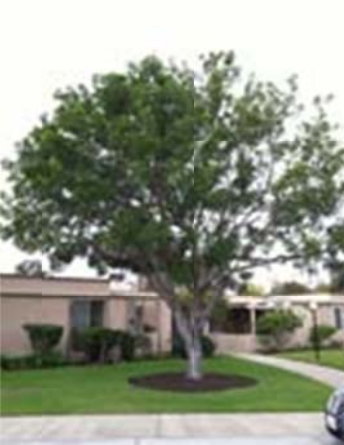
<p>Site 33 <i>Cupaniopsis anacardioides</i> – Carrotwood</p> <p>This tree has been tipped all the way around the fringe and is recovering. There are some internal sprouts that are responses to the pruning wounds. They should be thinned before they begin to compete with the rest of the mature canopy. There is one major aggressive sprout in the center of the canopy that should be removed before it becomes a tearout hazard. This tree should be monitored for head height clearance.</p> <p>Maintenance: 20 min. Next Service: now Priority: medium</p>
