TREE INVENTORY

Prepared for
LEISURE WORLD MUTUAL 15
SEAL BEACH

Prepared by
JAMES KOMEN – CLASS ONE ARBORICULTURE
ISA CERTIFICATION #WE-9909A
(818)495-5344
CLASSONEARBORICULTURE@GMAIL.COM
DECEMBER 1, 2013

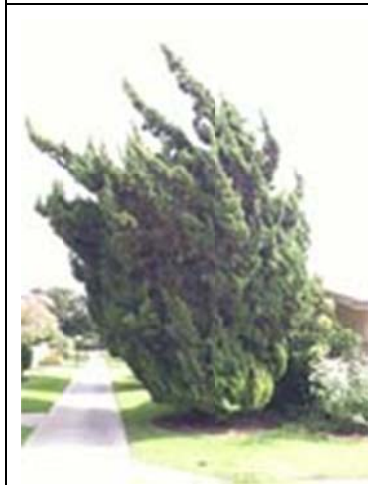
Site 42
Juniperus chinensis – Hollywood Juniper

This tree, like its neighbor at site 41, is an ideal choice of species for this site because it is very low maintenance. It only needs a minor interior deadwood cleaning every few years. There are no overhead obstructions, so the tree can be allowed to grow large. It just needs to be monitored for sidewalk clearance.

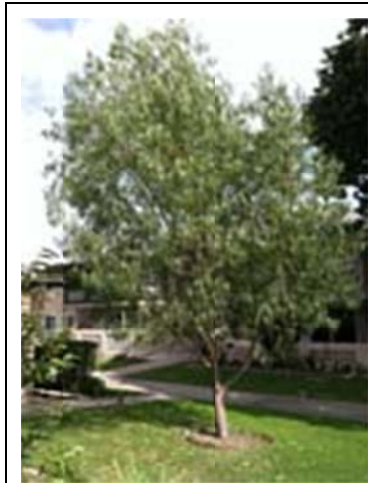
Site 50

Alnus rhombifolia – White Alder

This Alder has been topped in the past and is chaotically sprouting from the topping cuts. These sprouts should be thinned to train the tree to a stronger structure for the long-term. There are some significant surface roots that appear to have been damaged by the lawnmowers passing over them. There is also some bark loss on the South Western side of the root crown. It is likely that this damage is due to weed whip. The landscapers should be reminded to be careful around the base of these trees and not damage them with the weed whip or lawnmower. If weed whip damage completely girdles the trunk, then the tree will die quickly.

This tree does not have a mulch zone, and the turf grass goes up to the trunk of the tree. An absence of a mulch zone encourages the landscapers to bring their tools and landscaping machinery close to the trunk, causing mechanical damage and harming the tree in the long run. The damage is already done, but this tree can serve as a lesson for other trees. Good tips for reducing mechanical root crown injury include installing a small plastic weed whip protector around the root crown and increasing the size of the mulch zone around the root crown.

Next Service: now

Priority: low

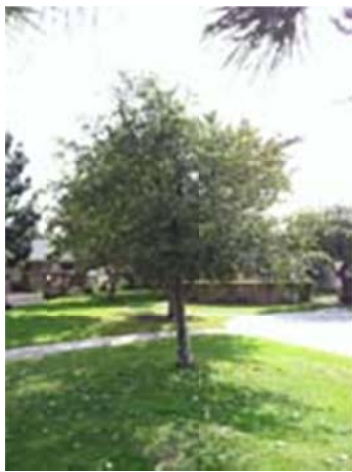
<p>Site 51 <i>Pyrus kawakamii</i> - Evergreen Pear</p> <p>This tree has fire blight. The fire blight was likely transmitted to this tree during the aggressive pruning in the past. Nearly every branch has been tipped and these tipping cuts serve as entry points for the disease. This tree will eventually decline and die due to the fire blight, but it can be retained for 2 to 5 more years and still retain its landscape function. For aesthetic purposes, the symptomatic and dead tissue can be removed on an annual basis. If this tree is pruned, all pruning tools should be sterilized with bleach to prevent the spread of the disease to other trees in the mutual.</p> <p>Maintenance: 60 min. Next Service: now Priority: low</p>

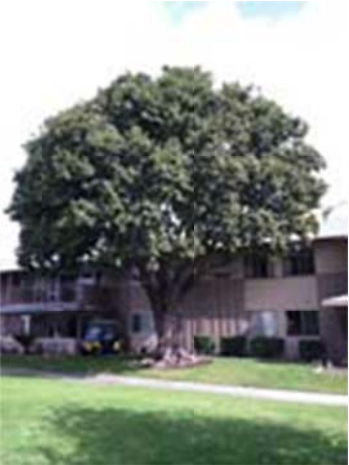
<p>Site 52 <i>Schinus terebinthifolius</i> - Brazilian Pepper</p> <p>This mature pepper tree is slightly lopsided away from the adjacent building. Though it should be monitored for roof clearance, there is room for the foliage to grow above the roof as long as the foliage has a clearance of at least 5 feet. Training the tree to grow above the roof will reduce its cantilever and likelihood of failing. This tree will not need to be pruned for sidewalk clearance for some time, but it may need regular maintenance every 6 to 12 months for roof clearance.</p> <p>Maintenance: 40 min. with climber Next Service: spring Priority: high</p>

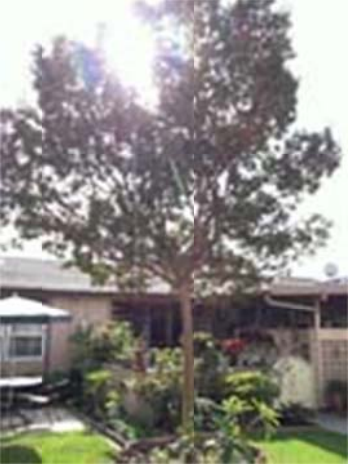
<p>Site 53 <i>Lagerstroemia indica</i> - Crape Myrtle</p> <p>This tree has some minor deadwood that should be removed for aesthetic purposes, but it does not need much pruning at this time.</p> <p>Maintenance: 10 min. Next service: now Priority: low</p>

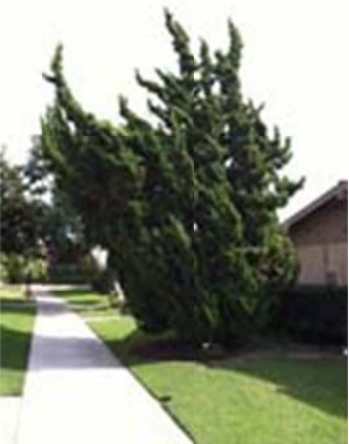
<p>Site 54 <i>Juniperus chinensis</i> - Hollywood Juniper</p> <p>This tree is an excellent choice for the landscape because it is very low maintenance. This tree should just be monitored for sidewalk clearance and clearance from the private zone of the adjacent building. Every 2 to 5 years it should have some minor interior deadwood cleaning.</p> <p>Maintenance: 30 min. Next Service: fall Priority: low</p>

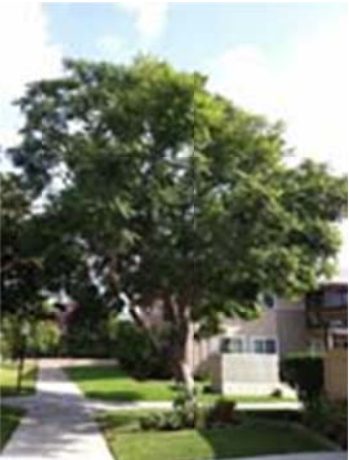
<p>Site 55 <i>Jacaranda mimosifolia</i> – Jacarandatree</p> <p>This Jacaranda has some interior sprouts that are beginning to compete with the main part of the crown. These sprouts should be removed. There is some light thinning that could be done around the fringe to raise it above the sidewalk. This tree is known to grow quickly and have brittle wood that is subject to breakage. This tree is also known for the mess it makes with its flower drop.</p> <p>Maintenance: 30 min. Next Service: now Priority: medium</p>

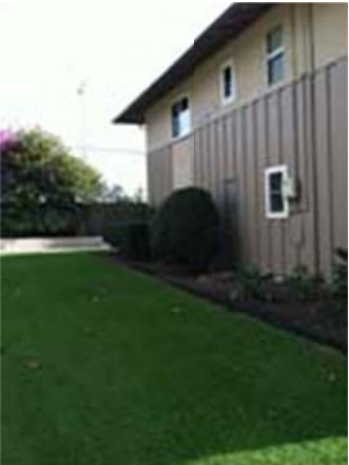
<p>Site 56 Vacant Planting Site</p> <p>This site receives a good deal of shade throughout the year because it is sheltered by the North side of a building. An ideal species would be shade tolerant and not root-aggressive.</p>

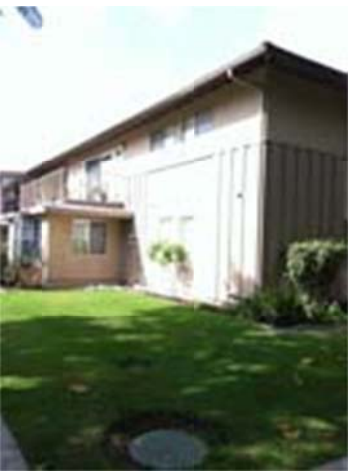
<p>Site 58 Vacant Planting Site</p> <p>This site should remain empty because of its proximity to the building, the water line, and the sewer. If a planting is desired in this location, it should be a shrub and not a tree.</p>

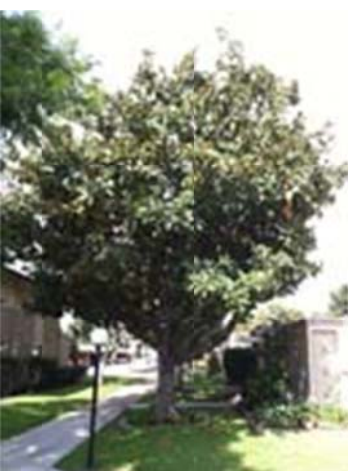
<p>Site 59 <i>Magnolia grandiflora</i> - Southern Magnolia</p> <p>This tree has decent structure, but there is relatively little lateral branching higher in the canopy, making it hard to retrain the structure in the future. The foliage is healthy, but some of the epicormic shoots should be pruned out before they compete with the rest of the canopy. This tree should also be monitored for sidewalk and roof clearance. It is getting to be too large for its site, and it may begin to cause problems with the surrounding hardscape.</p> <p>Maintenance: 30 min. with climber Next Service: now Priority: low</p>

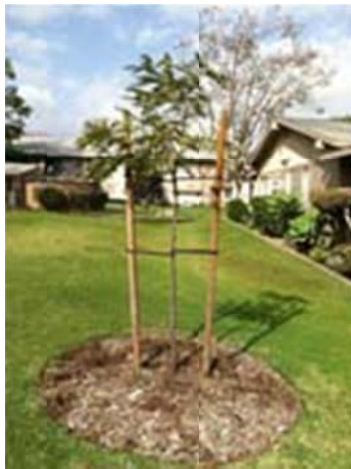
Site 70

Cassia leptophylla - Gold Medallion Tree

There is an excessive amount of mulch around the base of this tree, encouraging decay organisms to use up the available nitrogen in the soil, further stressing the tree. Lastly, nearly every one of the branches of this tree has been tipped, which has also stressed the tree. It is likely that this tree will not survive for much longer, and should be considered for removal and replacement.

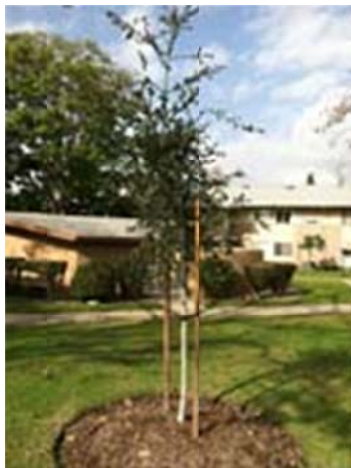
Quercus agrifolia - Coast Live Oak

Site 71 was a good choice of planting site for this tree because it receives some sun filtered through the neighboring Sycamore, and it is on a raised planting area that has good drainage. One concern is its proximity to the irrigation line. The irrigation should not spray the trunk of this tree. Oaks are particularly susceptible to armillaria root rot which is a fungus that tends to be found on the trunks of Oak trees that are periodically sprayed with irrigation.

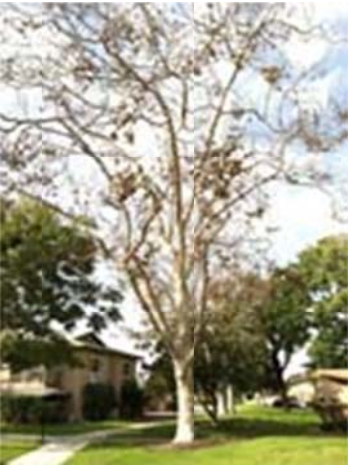
<p>Site 72 <i>Platanus acerifolia</i> - London Plane Tree</p> <p>This tree is showing signs of stress because there are many epicormic shoots up and down the main trunks. Usually profuse sprouting of these shoots is caused by a stressing agent elsewhere in the tree. These shoots should be thinned to the strongest leaders so that they do not begin to compete with the main structural armature of the tree. Previous pruning episodes on this tree have removed too much live wood and put this tree into a stressed condition.</p> <p>Maintenance: three hours with climber Next Service: fall Priority: medium</p>

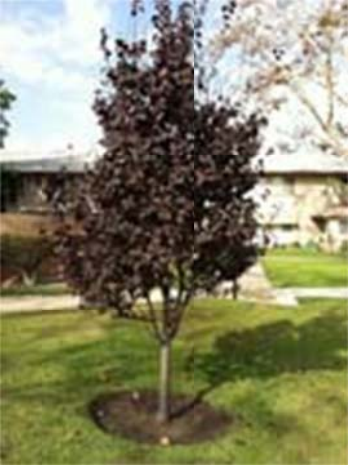
<p>Site 73 <i>Prunus cerasifera</i> - Purple Leaf Plum</p> <p>This plum tree is very healthy and is well-chosen for the site. It receives filtered light through the Sycamore that protected it through the heat of the summer. Some of the leaves have minor insect damage, but this is a foliar condition that is not serious. This tree does not need any maintenance at this time.</p> <p>Maintenance: zero Next Service: fall Priority: low</p>

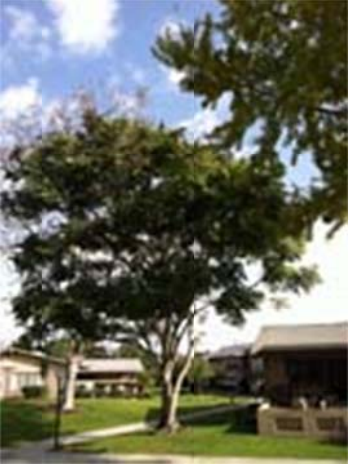
<p>Site 74 <i>Koelreuteria paniculata</i> - Golden Rain Tree</p> <p>This tree is beginning to have competition problems with the neighboring Sycamore. There are also some dead Sycamore branches that are hanging from this canopy that should be removed immediately. There are some interior shoots that should be removed before they compete with the rest of the canopy. The structure of this tree is almost ideal, but there is a bit of a void to the South East towards the building. New foliage in this area should be allowed to grow, while foliage on the North Western side of the tree can be thinned slightly.</p> <p>Maintenance: 30 min. Next Service: now Priority: medium</p>

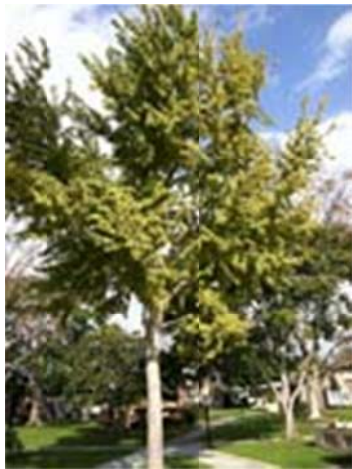
Site 75
Ginkgo biloba - Ginkgo Tree

This ginkgo tree has lovely structure and does not need much pruning. There is some minor deadwooding that can be done, but this tree is a relatively low maintenance species.

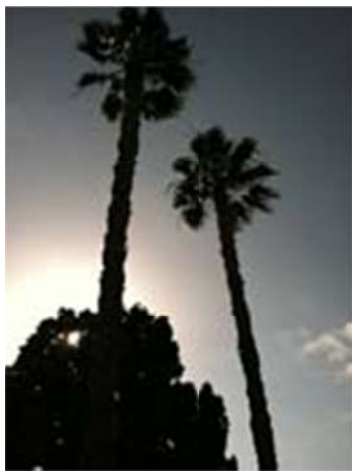
Sites 76 and 77
Washingtonia robusta - Mexican Fan Palm

These trees are in good form and only need to have dead fronds removed annually.

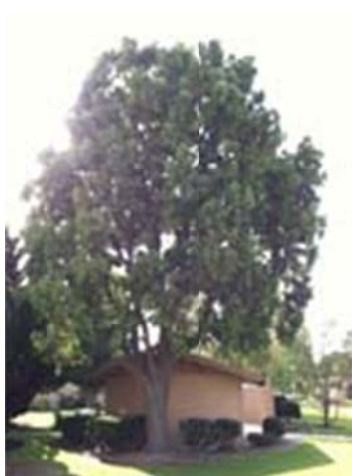
Site 78
Afrocarpus falcatus – African Yew Pine

The species is far too close to the building and will inevitably create problems for the infrastructure. Already, the main trunk is pressed up against the eave of the building. This tree is growing vigorously, and it shows no signs of decline. If it had more space to grow, it would be a valuable landscape tree. However, this tree will have to be removed in the next year or two to prevent major damage to the adjacent building. In the short term, it should be pruned for roof clearance.

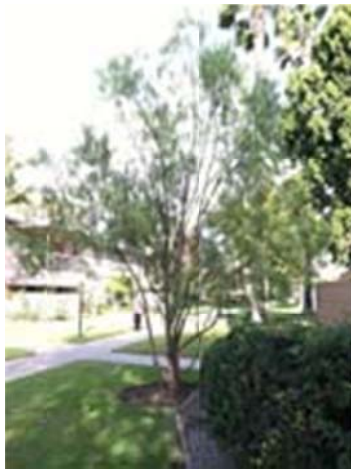
Site 82

Geijera parviflora - Australian Willow

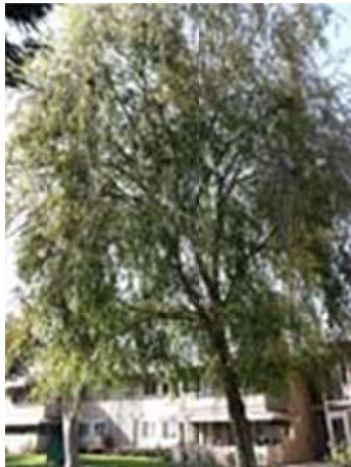
Site 83

Salix babylonica - Weeping Willow

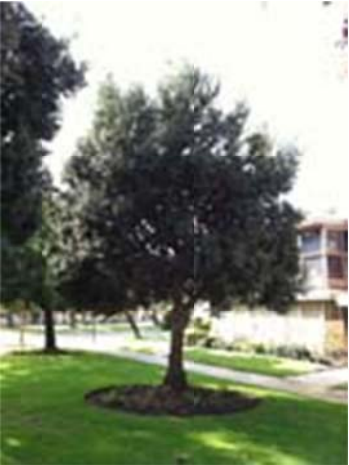
<p>Site 87 <i>Metrosideros excelsus</i> - the New Zealand Christmas Tree</p> <p>This tree is in good form and has good foliage. It does not need much pruning at this time. It should be monitored for sidewalk clearance. It is growing well with its neighbor to the South.</p> <p>Maintenance: 10 min. Next Service: spring Priority: medium</p>

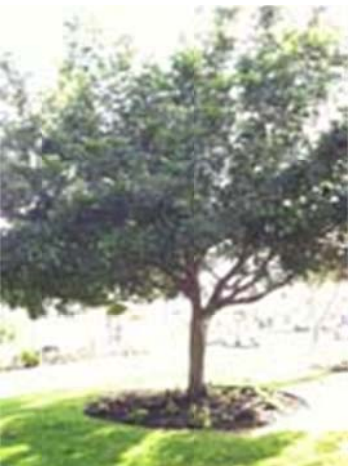
<p>Site 88 <i>Cupaniopsis anacardioides</i> - Carrotwood</p> <p>This tree has good structure, but there are some interior shoots that will soon begin to compete with the rest of the canopy. These shoots should be removed. This tree should also have a light crown-raising around the low fringe for head height clearance. There are some light injuries on the underside of some of the branches in the fringe. They were likely caused by the passing landscaper or other pedestrians underneath the tree. These wounds are not severe, and the tree will be able to heal them satisfactorily.</p> <p>Maintenance: 20 min. Next Service: now Priority: medium</p>

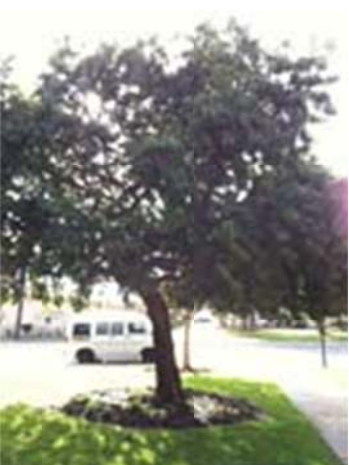
<p>Site 89 <i>Schinus terebinthifolius</i> - Brazilian Pepper</p> <p>This tree has good structure and only needs to be pruned for sidewalk and head height clearance. Since this tree is a fast-growing species, it may need to be pruned every 6 to 12 months.</p> <p>Maintenance: 30 min. Next Service: now Priority: high</p>

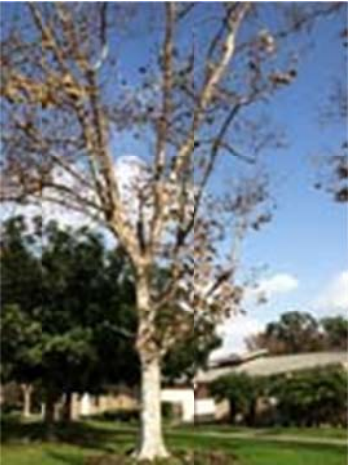
<p>Site 90 <i>Platanus acerifolia</i> - London Plane Tree</p> <p>This tree has an acceptable structure. It is showing some signs of stress with shoots emanating from the branches that have been heavily pruned in the recent past. These shoots should be allowed to grow for one season and then should be thinned to the strongest ones. This tree is also in minor competition with the pepper tree and the Carrotwood to the West, and the pepper tree and Carrotwood should be pruned back to make way for the London Plane Tree which is more valuable.</p> <p>Maintenance: three hours with climber Next Service: fall Priority: medium</p>
 	<p>Site 91 <i>Platanus acerifolia</i> - London Plane Tree</p> <p>This tree has similar attributes to the London Plane Tree at site 90. It is stressed and is creating small shoots up and down the trunk in response to the stress caused by the aggressive pruning in the past. The shoots should be thinned to the strongest ones to create a strong structure. The tree does not have a hazardous lean, and it can be allowed to remain in its current structural form.</p> <p>Maintenance: three hours with climber Next Service: fall Priority: medium</p>

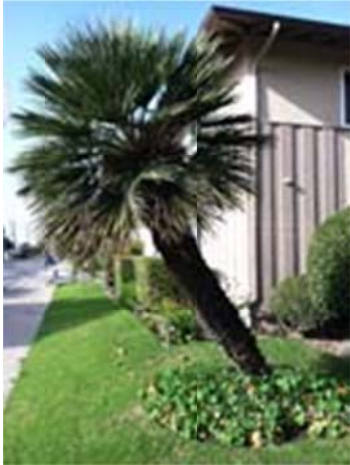
Site 93

Chamaerops humila – Mediterranean Fan Palm

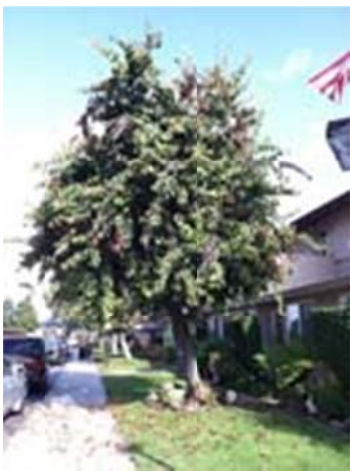
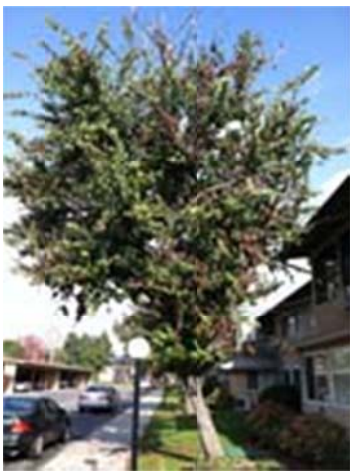
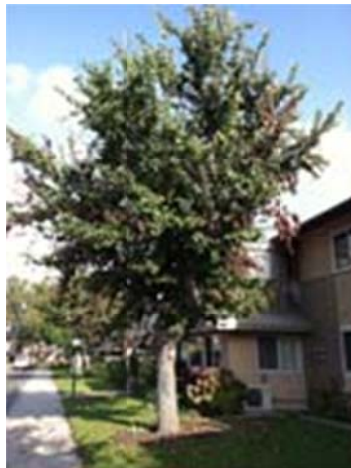
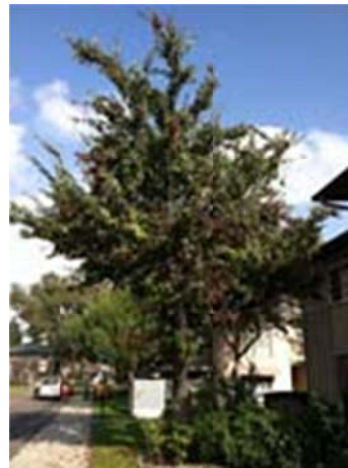
Site 94, 95, 97, and 98

Pyrus kawakamii - Evergreen Pear

These four pear trees are all infected with fire blight. This fire blight is systemic and will eventually cause the death of the trees. The trees can be retained temporarily by removing the symptomatic tissue. Pruning tools should be sterilized in bleach between cuts to prevent the spread of the disease.

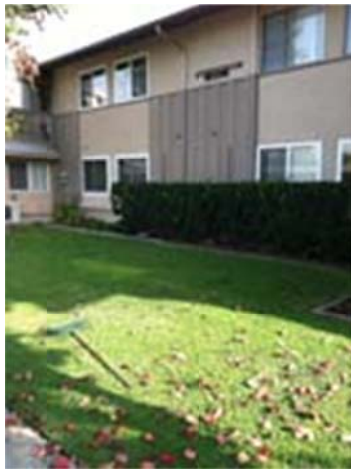
Site 96
Vacant Planting Site

This site should not be utilized as a planting site for a tree. Rather it should either be left empty or planted with a shrub because of its proximity to the irrigation line, electrical box, and sidewalk.

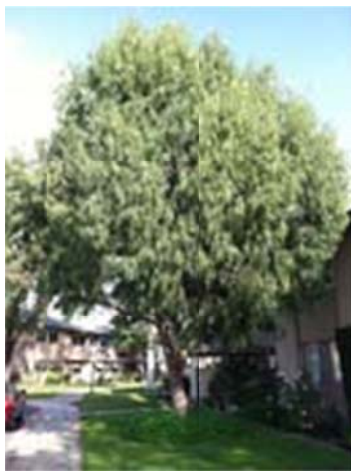
Site 99
Geijera parviflora - Australian Willow

This is a lovely specimen of this species. This tree should be pruned for roof clearance, and some deadwood in the canopy should be removed. Very little other pruning is needed at this time.

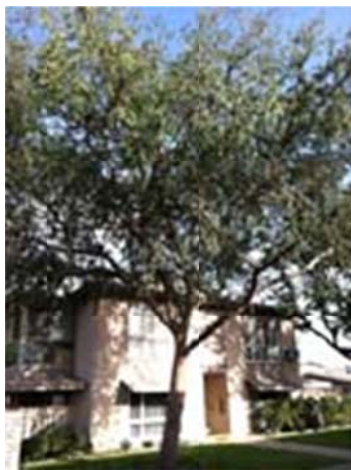
Site 100
Ulmus parvifolia - Chinese Elm

This tree had an aggressive pruning a few years ago, but it is recovering nicely. The low fringe should be pruned back while the shoots are small. This tree should be monitored for sidewalk and roof clearance.

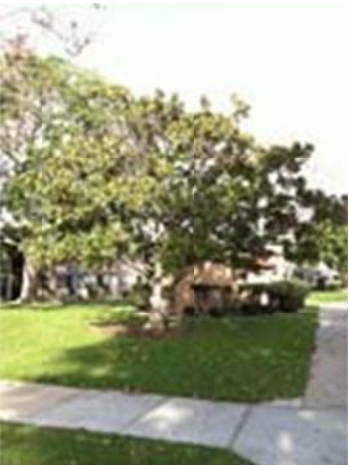
<p>Site 104 <i>Magnolia grandiflora</i> - Southern Magnolia</p> <p>This Magnolia is in excellent form and only needs a bit of deadwood cleaning and crown-raising. It was tipped in the past over the sidewalk, and these cuts should be recut back to the parent stem. The tree is currently recovering from the tipping cuts. The leaves appear to be showing some stress from yellowing, but it is not serious at this point in time. The tree should be monitored for any further decline in health.</p> <p>Maintenance: 20 min. Next Service: now Priority: medium</p>

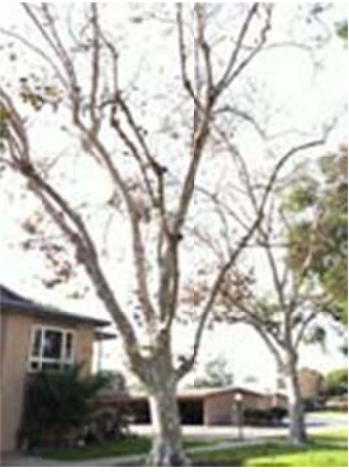
<p>Site 105 <i>Platanus acerifolia</i> - London Plane Tree</p> <p>This tree was aggressively pruned in the past and many of its leading branches have been tipped. The tree is showing signs of stress by growing many sprouts along the trunk. These sprouts should be thinned to the strongest leaders so that it can be re-cultured into a healthy canopy.</p> <p>Maintenance: three hours with climber Next Service: fall Priority: medium</p>

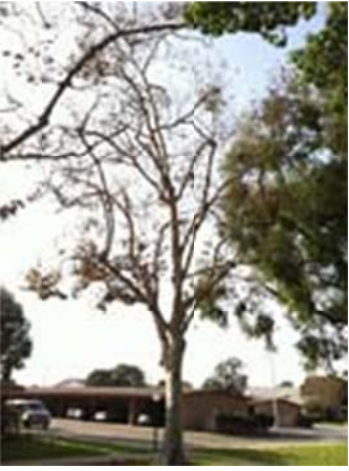
<p>Site 106 <i>Platanus acerifolia</i> - London Plane Tree</p> <p>This tree was pruned in a similar manner to its neighbor at site 105. The epicormic shoots are a sign of stress on the tree and they should be thinned to the strongest ones to re-culture a new canopy.</p> <p>Maintenance: three hours with climber Next Service: fall Priority: medium</p>

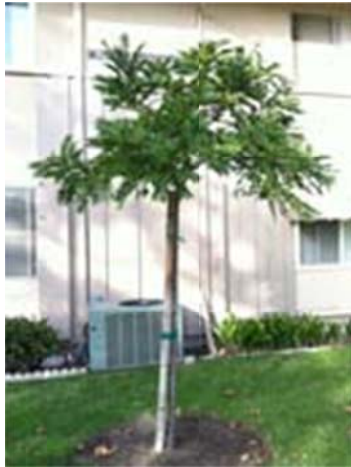
Site 108
Cassia leptophylla - Gold Medallion Tree

This tree needs to be re-staked immediately. The planting pole is too close to the trunk of the tree, and the ties are too tight around the trunk. There is also some minor deadwood.

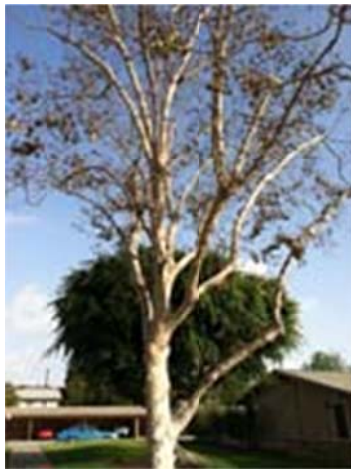
Site 109
Platanus acerfolia - London Plane Tree

This Sycamore has been aggressively pruned in the past and is showing signs of stress. The epicormic shoots that are sprouting out of the trunks should be thinned after one season to the strongest leaders. This will help re-culture the canopy that was taken away by the previous improper pruning.

Maintenance: three hours with climber
Next Service: fall
Priority: medium

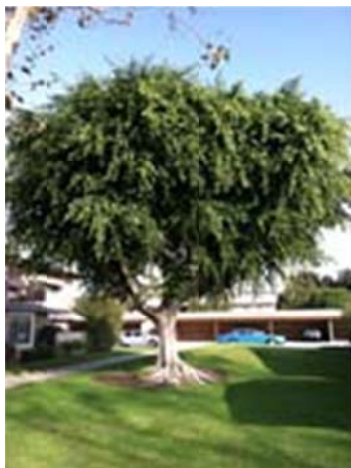
Site 110
Ficus benjamina - Weeping Fig

This tree was topped in the past. Since it is a *Ficus*, it continues to grow vigorously and put out new shoots. *Ficus* is known for its root aggressiveness, and there will likely be problems in the near future with the surrounding hard scape. This tree can be retained, but it is a very high maintenance tree because of the high growth rate and the number of shoots that it sprouts. When budget allows, I recommend its replacement.

Maintenance: 3 hours
Next Service: winter
Priority: medium

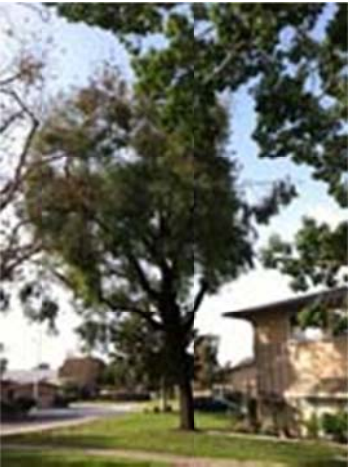
<p>Site 112 <i>Eucalyptus sideroxylon</i> – Red Iron Bark</p> <p>This Eucalyptus was planted too close to the building, and it may soon cause problems to its foundation. The tree's root flare should be monitored for any signs of stress or decay that could predispose it to falling.</p> <p>In the past, there was some aggressive pruning on the western side of the tree, and this has likely resulted in some bark loss on the leader that is pointed over the roof. This leader should not be removed because it compensates for the prevailing lean away from the building to the West. The foliage can be allowed to grow over the roof, as long as there is a 5 foot clearance.</p> <p>Maintenance: three hours with climber Next Service: fall Priority: medium</p>

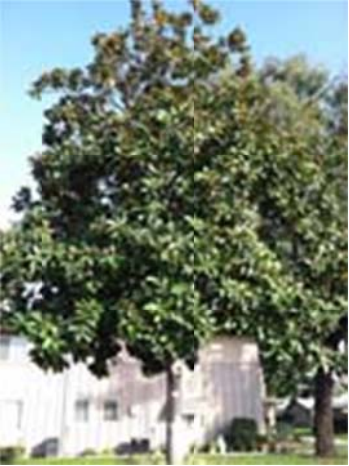
<p>Site 113 <i>Magnolia grandiflora</i> - Southern Magnolia</p> <p>This Magnolia is in good form and is on a good planting site. There is some minor deadwooding for aesthetic purposes that can be done.</p> <p>Maintenance: 30 min. Next Service: fall Priority: low</p>

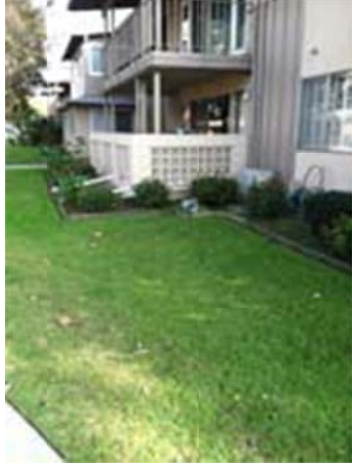
<p>Site 115 Vacant Planting Site</p> <p>This planting site receives a great deal of shade and only receives sun in the afternoon. It is a small planting area near a building and an irrigation line. I recommend choosing a tree that is more sensitive to the summer heat. It should also be noted that the ground on this site is soggy, and the irrigation should be adjusted before planting.</p>

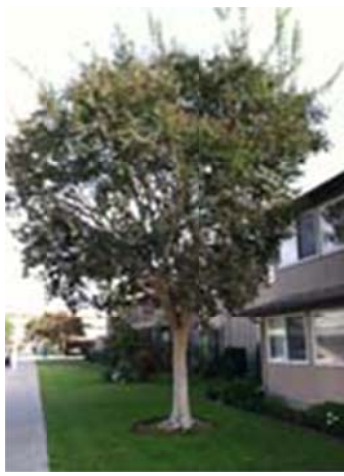
<p>Site 117 <i>Lagerstroemia indica</i> - Crape Myrtle</p> <p>This is a well-chosen species for the site because it is not root aggressive and it does not have a large crown at maturity. This tree should be monitored for roof and sidewalk clearance. It does not need pruning at this time.</p> <p>Maintenance: 30 min. Next Service: fall Priority: low</p>

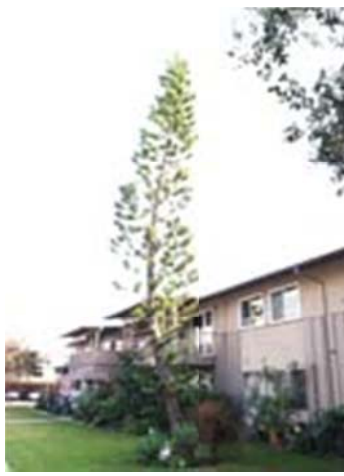
<p>Site 118 <i>Araucaria heterophylla</i> - Norfolk Island Pine</p> <p>This tree is stressed, and its lower canopy is dying back. There are sprouts low on the trunk that indicate stress around the base of the trunk. There are also some weeping sites along the southern side of the trunk. This could be due to several causes.</p> <p>One possible cause is root cutting due to the installation of the understory plants. When roots are cut, the bark on the same side of the tree dies back, and this can turn into a weeping site.</p> <p>Another possibility is the tree became stressed in a windstorm that cracked the bark low on the tree, causing the tree to exude sap. If this is the case, then the tree is a minor hazard. Fortunately, the tree's center of gravity is away from the building, and the tree can be retained until more serious symptoms appear.</p> <p>Aesthetically, the tree's deadwood should be removed in the lower canopy.</p> <p>Maintenance: 10 min. Next Service: now Priority: low</p>

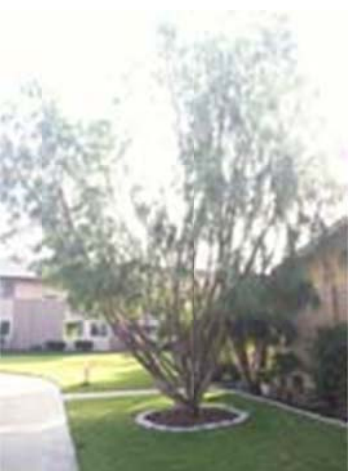
<p>Site 124 <i>Geijera parviflora</i> - Australian Willow</p> <p>This tree is a good selection for the site and is very low maintenance. It only needs a bit of interior deadwood cleaning. It should be monitored for roof and sidewalk clearance. There is a minor bark fungus on most of the trunks, but it is not serious at this time. If the fungus girdles the trunk, it will die back, and then the afflicted trunk can be removed. Until that time, the tree can still continue to add value to the landscape.</p> <p>Maintenance: 10 min. Next Service: now Priority: low</p>

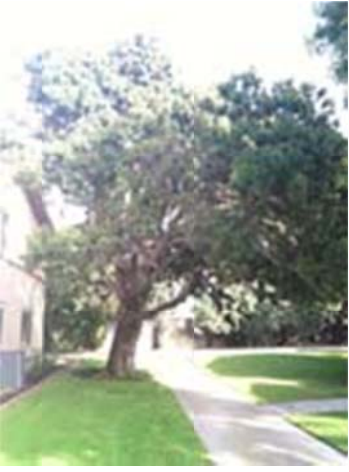
<p>Site 126 <i>Schinus terebinthifolius</i> - Brazilian Pepper</p> <p>This pepper tree is looking a little bit sparse because of the heavy pruning it received over the years. The canopy is slightly lopsided to the South away from the building. To compensate for its lean, the canopy should be allowed to grow over the building, provided that there is at least 5 feet of clearance from the roof. This tree will need to be maintained every 6 to 12 months around the fringe and should be monitored for roof and sidewalk clearance.</p> <p>This tree is in heavy cantilever to the South away from the building. Trenching, digging, or root cutting around the building would remove the anchorage roots that keep the tree standing which could predispose it to fall to the South. Therefore, all root cutting should be avoided. Any necessary root cutting should be supervised by an arborist.</p> <p>Maintenance: 30 minutes Next Service: spring Priority: high</p>

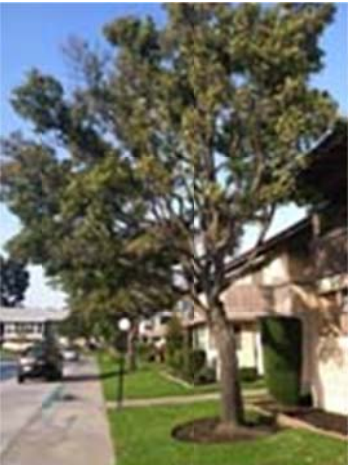
<p>Site 128 <i>Prunus spp.</i> - Ornamental Plum</p> <p>This tree is looking sparse from the pruning it has received over time. The structure is not ideal because many branches are emanating from a single point which makes the tree susceptible to tearout from wind. Over time, since these branches competed with each other for light, they did not develop lateral branching, and this makes them even more susceptible to tearout. Most of the branches have also been tipped, and this has further stressed the tree. Currently the tree is in guarded condition, and live foliage should not be removed at this time. The tree should be monitored for roof and sidewalk clearance.</p> <p>Maintenance: 20 min. Next Service: fall Priority: low</p>

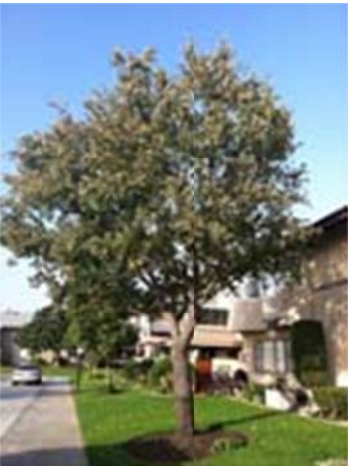
<p>Site 129 <i>Prunus spp.</i> - Ornamental Plum</p> <p>This plum tree has the same problems as its neighbor to the South. Its structure is not as bad, but it was tipped in the past, and these tipping cuts have caused the tree to become stressed. The tree does not need any pruning at this time, but it should be monitored for roof and sidewalk clearance.</p> <p>Maintenance: 20 min. Next Service: fall Priority: low</p>

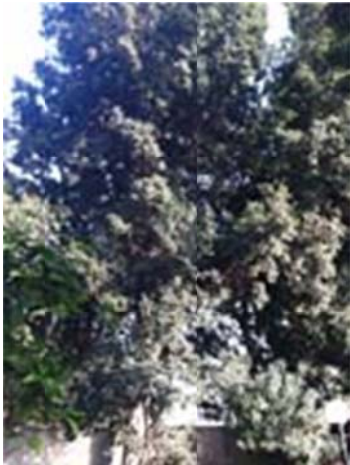
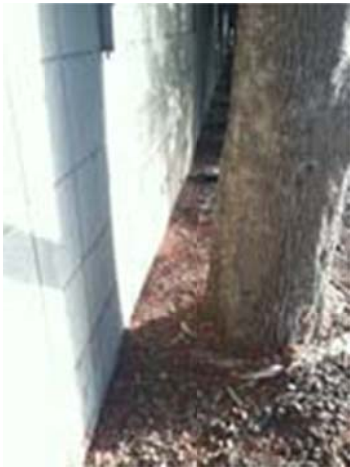
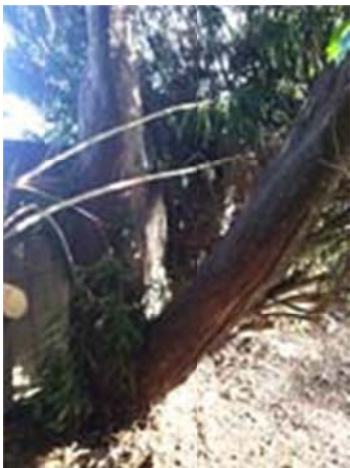
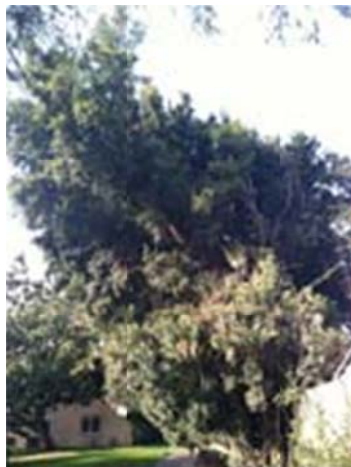
Sites 135 through 140
Syzigium paniculatum - Brush Cherry

These trees appear to be healthy currently, but it is known that there was major root cutting in the recent past for the installation of the wall behind the trees. Root cutting of this magnitude will eventually be the downfall of these trees. Nearly 40% of the anchorage roots that support these trees from falling to the West were severed in order to install the wall. The trees are not showing signs of decline yet, but they likely will in the next 2 to 5 years. Root damage can take up to five years to manifest itself the canopy.

To further complicate the issue, there are high-voltage power lines that run through the Eastern side of this stand of trees. These power lines will need to be kept clear. When the power company makes its pruning cycle, they are concentrating on clearing the right-of-way for the power lines, and they tend to make very large, egregious cuts. If no pruning is done to these trees, then the power company will aggressively prune them at some point in the next four years.

Since these trees are likely doomed, very little should be done to maintenance them aesthetically, because it will only be a waste of resources to prune trees that are slated for removal.

A decision should be made whether it is worth paying to prune this stand of trees knowing there is a large possibility that they will die in the next 2 to 5 years and need to be replaced. The other alternative is to simply prune for sidewalk and power line clearance until the trees die, which could be done at a much lower cost of labor.

Maintenance: 16 hours with climber
 Next Service: now
 Priority: medium

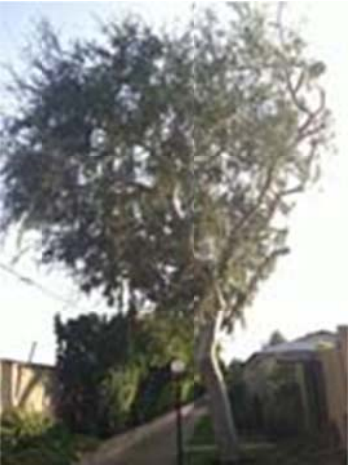
<p>Site 141 <i>Ulmus parvifolia</i> - Chinese Elm</p> <p>This Elm tree was aggressively pruned over the building in the past and is now resprouting from the stumping cuts. This tree will need to be kept clear from the power lines, and the proper way to do that is to individually cut the whips rather than cutting all branches. This is more time-consuming, but less damaging to the tree. This tree should be monitored for roof and sidewalk clearance.</p> <p>Maintenance: two hours with climber Next Service: spring Priority: medium</p>

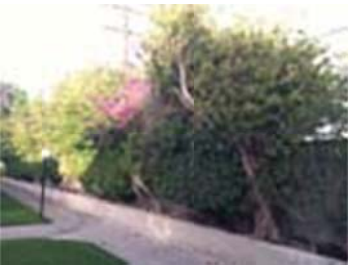
<p>Sites 142, 143, and 144 <i>Callistemon citrinus</i> - Bottlebrush</p> <p>This stand of trees serves the function of screening the mutual from Seal Beach Boulevard. It is currently being overrun by bougainvillea and other hedge plants that will need to be pruned back. Further complicating the pruning of these trees is the barbed wire fence between both sidewalks. The trees will have to be pruned one half at a time, with the crew working on the Western half and then moving to the Eastern.</p> <p>There is some significant deadwood that can be removed to improve the aesthetics of the bottlebrush at site 144. The fringe reaching over the sidewalk along Seal Beach Boulevard should be raised to head height clearance and should be maintained annually.</p> <p>Maintenance: three hours Next Service: now Priority: medium</p>

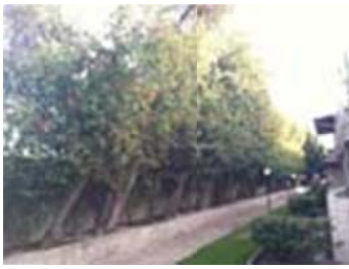
Site 146 through 168
Callistemon citrinus - Bottlebrush

This stand of trees has very little growing space and has been turned into a tall hedge. These trees need to be maintained over both sidewalks separately because they are separated by a barbed wire fence. There is significant deadwood in their canopies that could be removed for aesthetic purposes, and the lower fringe over both sidewalks needs to be maintained for clearance annually. The big challenge will be pruning over the sidewalk on the Seal Beach Boulevard side because of limited access.

A wall was recently installed to the East of these trees, severing much of their root system, and it is possible that they will decline over the next 2 to 5 years. Since they are not very tall, they wouldn't cause damage if they were to fail, so the trees don't pose much of a hazard. This stand of trees can also be considered for a staged removal where trees are only removed as they die.

Just like with the stand of Brush Cherry at sites 135-140, a decision should be made on whether to maintain these Bottlebrush trees aesthetically, or to just let them gradually die.

Maintenance: 22 hours with three men
 Next Service: spring
 Priority: medium

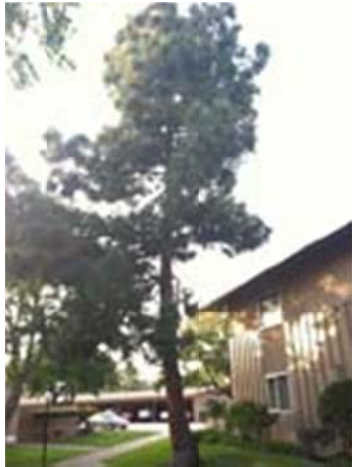
Site 170

This is a good-looking pine tree, but it may cause problems to the hard scape and the nearby building. There has already been some lifting of the sidewalk by the roots. The trunk and foliage appear to be healthy, and the tree only needs to be maintained for roof and sidewalk clearance.

Pinus canariensis is a species that grows very tall. This tree may end up growing another 20-30 feet if allowed to continue. The tree is not currently a hazard, but if anchorage roots are severed, then it will compromise the structural stability of the tree. Any and all construction or digging work around the base of this tree should be supervised by an arborist to avoid turning the tree into a hazard.

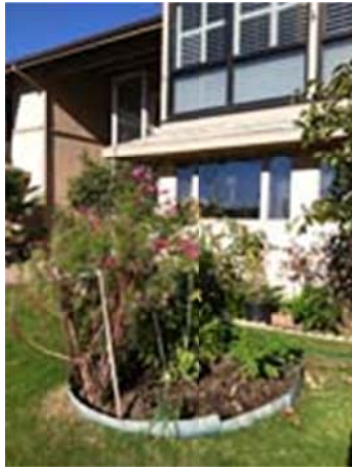
Site 4
Vacant Planting Site

This site should remain vacant until other planting sites have been filled. This planting site is currently occupied by some flowers planted by one of the homeowners. As long as a fruiting tree remains in the private zone next to the building near this site, there is no need for a tree to be planted here.

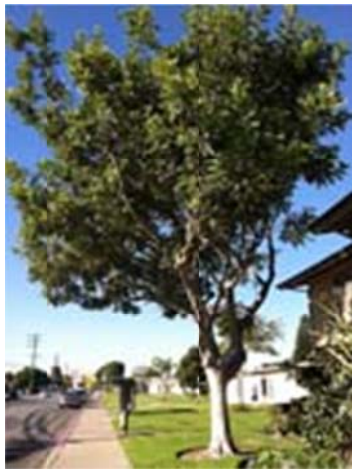
Site 5
Cupaniopsis anacardioides - Carrotwood

This Carrotwood has good branch structure and does not need much pruning at this time. It should be monitored annually for roof clearance with the adjacent building and sidewalk clearance. The canopy is slightly off-balance, and foliage can be allowed to expand towards the roof, provided that there is sufficient 5 foot clearance.

Maintenance: 30 min.
Next Service: fall
Priority: medium

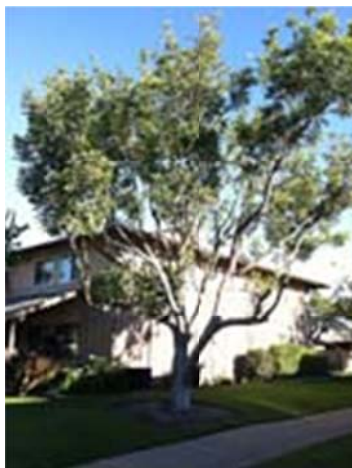
Site 6
Cupaniopsis anacardioides - Carrotwood

This tree has decent branching structure, but there is a problem with the many co-dominant leads emanating from a single point on the main trunk at around 5 feet in height. Not much should be done about this problem at this point in time though. The problem originated at the nursery when the tree was topped and encouraged to sprout many shoots. These shoots later grew together and competed with each other, causing foliage to be distributed only at the tips of the branches. There is a possibility that some of these branches could eventually become tearout hazards, but it is not a problem currently. This tree should be monitored annually for any signs of structural problems. This tree should also be monitored annually for roof and sidewalk clearance, but it does not need any pruning at this time.

Maintenance: 30 min.
Next Service: fall
Priority: medium

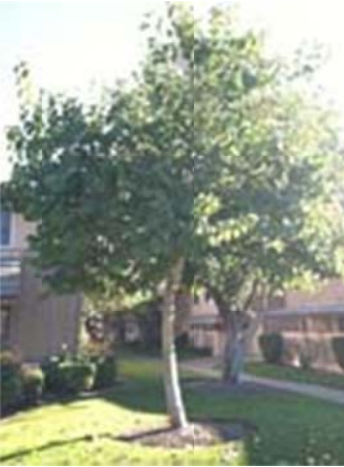
<p>Site 7 <i>Bauhinia x blakeana</i> - Hong Kong Orchid Tree</p> <p>This tree has some structural defects that include rubbing and crossing structures, and a little bit of deadwood. A light cleaning of these issues in dormancy is all this tree needs.</p> <p>Maintenance: 20 min. Next Service: winter Priority: medium</p>

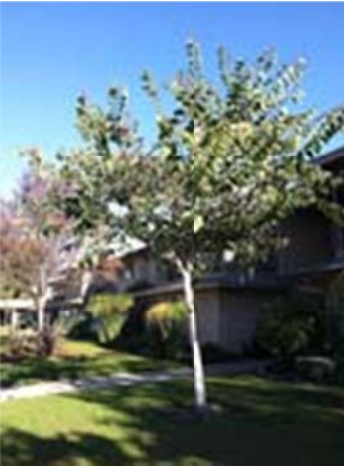
<p>Site 8 <i>Bauhinia x blakeana</i> - Hong Kong Orchid Tree</p> <p>This tree is not faring quite as well as its neighbor because it has less than ideal drainage. Historically, this mutual has had problems with over-irrigation, causing the roots of many of the trees in this region to drown. This may explain the sparseness of foliage on this Orchid Tree. This tree will still be able to pull out of its stress, but it should be monitored annually. It could stand to have some light structural pruning and deadwood removal.</p> <p>Maintenance: 10 min. Next Service: winter Priority: medium</p>

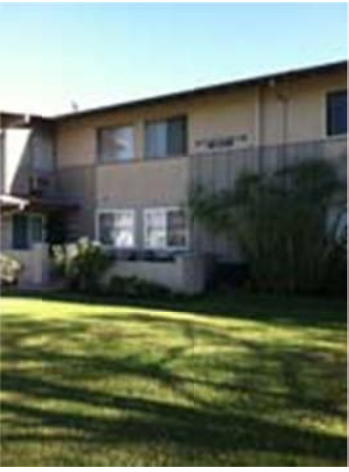
<p>Site 10 Vacant Planting Site</p> <p>This is a good site with protection from the South by building 24. It is in a slightly raised region of soil, which gives it good drainage. However, the planting site is also immediately adjacent to the irrigation line, which means that as a tree matures it would likely cause damage to the irrigation system. I recommend waiting until other planting sites have been filled before planting here. The species that is chosen should be small and not root aggressive.</p>

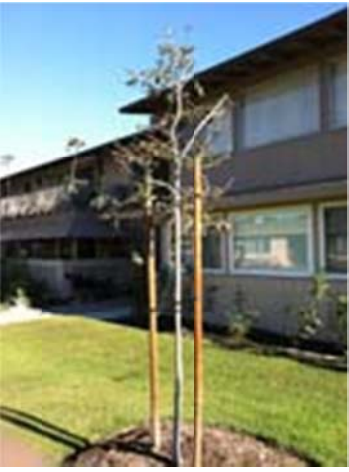
<p>Site 11 <i>Pistacia chinensis</i> – Chinese Pistache</p> <p>This young tree is in severe decline. Nearly every leaf shows signs of scorch and rust. Nearly every branch has been tipped, likely at the nursery. There is a heavy layer of mulch around the base of the tree. Though application of mulch is a healthy practice, too much mulch can encourage decay organisms to decompose the mulch and use up the beneficial nitrogen in the soil. An absence of nitrogen can stress the tree. The trunk of this planting stock is warped due to the stresses of its former planting ties. This nursery stock should have been rejected before being planted, and it is likely that this tree will die soon and have to be removed. The tree can be re-staked properly, but since it is a likely candidate for removal and replacement, it should not be a high priority.</p> <p>Maintenance: 20 min. Next Service: now Priority: low</p>

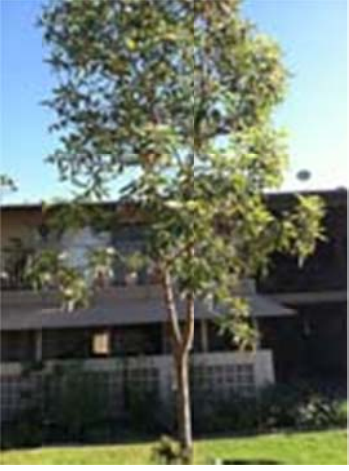
<p>Site 12 <i>Lophostemon confertus</i> – Brisbane Box</p> <p>This tree has good form, but it is immediately adjacent to the irrigation line. It is likely that the strong roots of this tree will eventually cause damage to the irrigation line. There are some exposed roots around the base of the trunk, and I recommend adding a bit of fill soil to cover them to reduce their exposure to sun scald and any mechanical damage by gardeners tending to the flowers around the base of the root crown.</p> <p>Maintenance: 10 min. Next Service: now Priority: low</p>

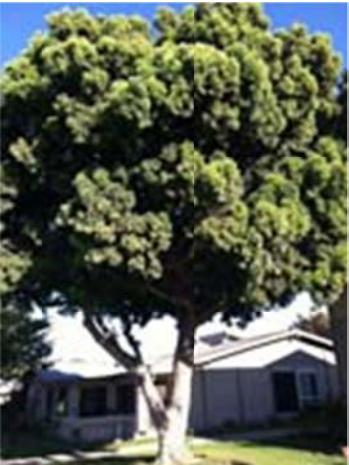
<p>Site 13 <i>Afrocarpus falcatus</i> – African Yew Pine</p> <p>This Yew Pine has been pruned correctly in the recent past. Cuts are made to the parent stem and the size of the wounds has been minimized. There is sufficient dense foliage in the crown to support its size. The planting site is sufficiently raised so that it has good drainage.</p> <p>The big problem with this tree is it is immediately adjacent to an electrical box. The roots of this tree are medium aggressive, and they will eventually cause damage to the foundation around the electrical box. The infrastructure should be monitored annually for damage, and when signs of damage appear, this tree should be considered for removal.</p> <p>Maintenance: zero Next Service: fall Priority: medium</p>

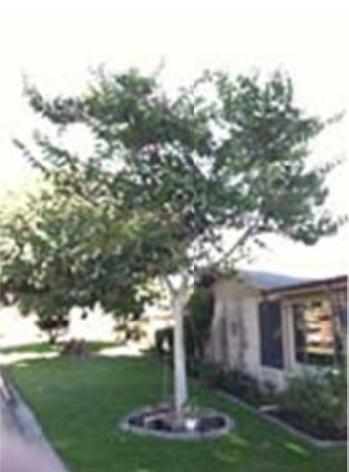
<p>Site 14 <i>Bauhinia x blakeana</i> - Hong Kong Orchid Tree</p> <p>This orchid tree has good form, and it only needs a bit of deadwooding and a few structural corrections. These can be done in the wintertime while the tree is dormant. This tree should also be watched for sidewalk clearance.</p> <p>Maintenance: 20 min. Next Service: winter Priority: medium</p>

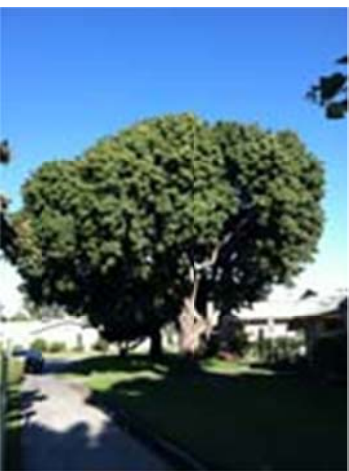
<p>Site 15 <i>Schinus terebinthifolius</i> - Brazilian Pepper</p> <p>This Brazilian Pepper has good structural form and a healthy, dense canopy. It should be monitored annually for sidewalk clearance.</p> <p>Maintenance: 30 min. Next Service: spring Priority: high</p>

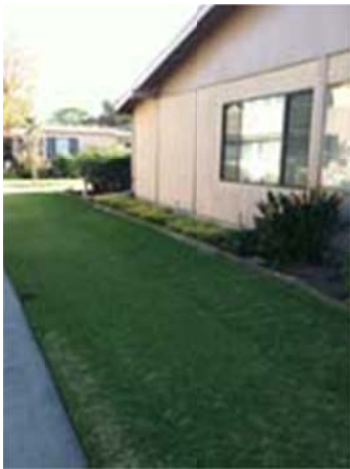
Site 19
Vacant Planting Site

There is a limited amount of space in this site between the building, the sidewalk, and the irrigation line. Furthermore, this site receives shade for much of the afternoon. Therefore, a diminutive shade loving tree could be planted here.

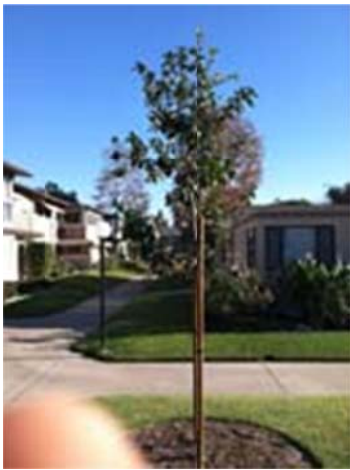
Site 20
Unknown Species

This tree has a severely kinked trunk from its care in the nursery. It is staked improperly, and the ties to the stakes are putting pressure on the trunk that is acting like a tourniquet. This tree should be re-staked with metal wires and rubber tubing to allow it more freedom to move in the wind and develop trunk taper.

Maintenance: 20 min.
Next Service: now
Priority: high

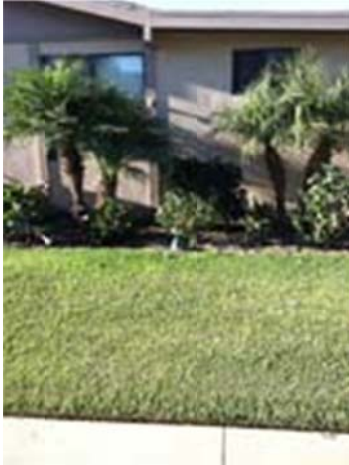
Sites 21, 22, and 23 Vacant Planting Site

These three vacant planting sites do not allow much room for tree roots to grow between the hardscape and the irrigation line. I recommend waiting to install trees on these sites until other vacant planting sites have been filled. The best choice for these sites would be diminutive species with low root aggressiveness. Chosen species should also be able to handle full sun for most of the day because these sites are South facing and do not have much shade.

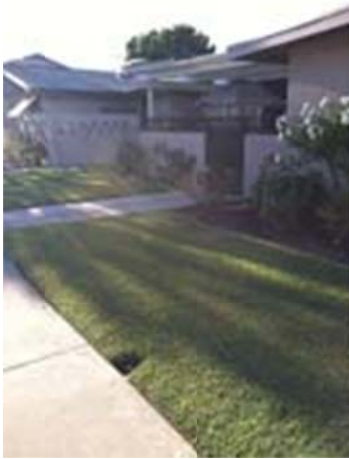
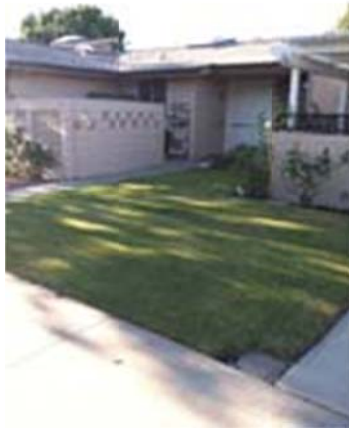
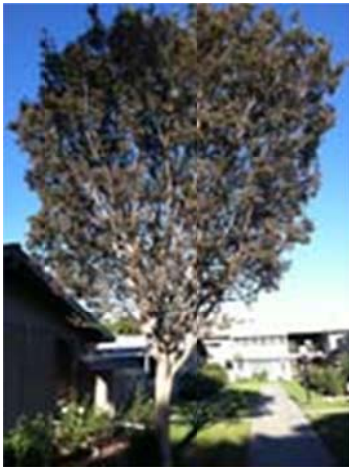
Site 24 *Lagerstroemia indica* - Crape Myrtle

This Crape Myrtle has good form and has been pruned correctly. It should be monitored annually for roof and sidewalk clearance.

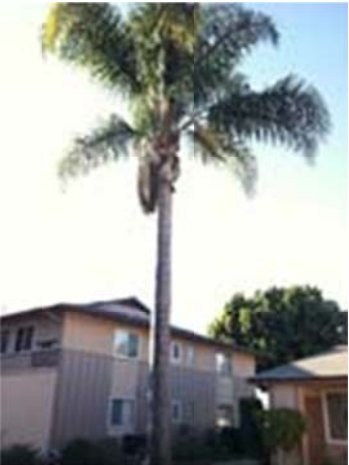
<p>Site 25 <i>Syagrus romanzoffianum</i> - Queen Palm</p> <p>This is an excellent Palm tree for the site, but it will need to be pruned to remove the fruiting bodies. These fruiting bodies can become very heavy and hazardous when they drop. The berries are also known to be slightly poisonous to pets that may eat them.</p> <p>Maintenance: 20 min. Next Service: now Priority: high</p>

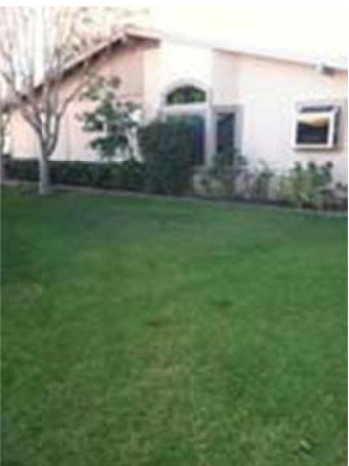
<p>Site 26 Vacant Planting Site</p> <p>This site would be good for a tree that needs space. It should be noted that the ground is still soggy 12 hours after irrigation. This means that this site has poor drainage, and a tree should be chosen that is tolerant of this condition. The site also receives afternoon shade and filtered sun through the stand of Crape Myrtles to the South.</p>

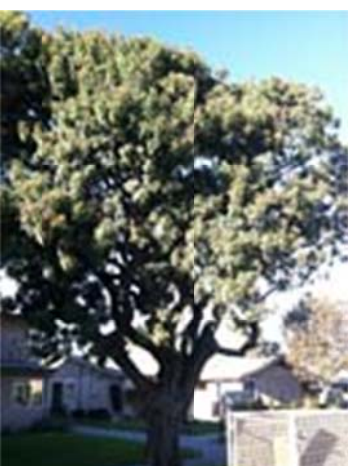
<p>Site 27 <i>Schinus terebinthifolius</i> - Brazilian Pepper</p> <p>This tree has good structure and good foliage. There is a wooden stake in the tree that should be removed. This tree is growing well with its neighbor at site 28. Since these two trees are evenly matched, they can be allowed to fight with each other for space. This will reduce the cost of pruning them and will also create a fuller canopy over the sidewalk which is more attractive aesthetically. This tree is also near the electrical box, and its roots may cause some disruption of the foundation in the next 2-5 years.</p> <p>This tree should be pruned for sidewalk clearance annually.</p> <p>Maintenance: 20 min. Next Service: spring Priority: high</p>

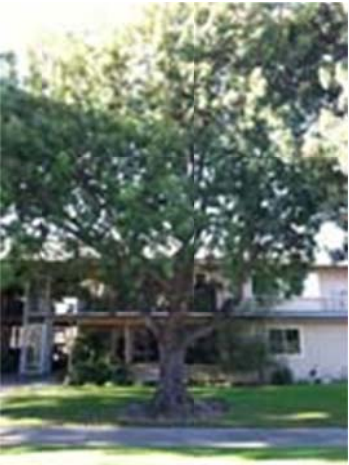
<p>Site 28 <i>Schinus terebinthifolius</i> - Brazilian Pepper</p> <p>This tree is growing well with its neighbors at sites 27 and 29. It can be allowed to compete for space with them because the competition will create a dense canopy cover over the sidewalk. It should be noted that the root system is getting fairly large, and it is close to the irrigation system. There may be some cracks in the irrigation system currently or some will appear in the near future.</p> <p>Maintenance: 20 min. Next Service: spring Priority: high</p>
