TREE INVENTORY

Prepared for
LEISURE WORLD MUTUAL 15
SEAL BEACH

Prepared by
JAMES KOMEN – CLASS ONE ARBORICULTURE
ISA CERTIFICATION #WE-9909A
(818)495-5344
CLASSONEARBORICULTURE@GMAIL.COM
DECEMBER 1, 2013

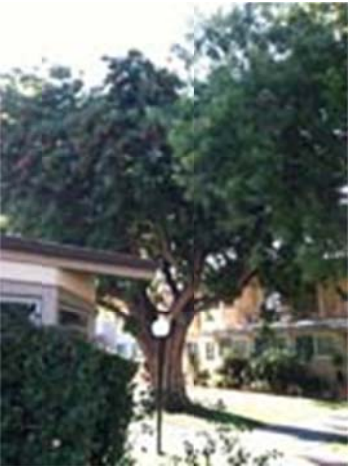
<p>Site 29 <i>Schinus terebinthifolius</i> - Brazilian Pepper</p> <p>This tree is growing well with its neighbor at site 28, but it will need to be pruned back from the Liquidambar at site 30. The Brazilian Pepper is a fast-growing species that may need to be pruned every 6 to 12 months. It should be watched for roof and sidewalk clearance.</p> <p>Maintenance 30 min. Next Service: now Priority: high</p>

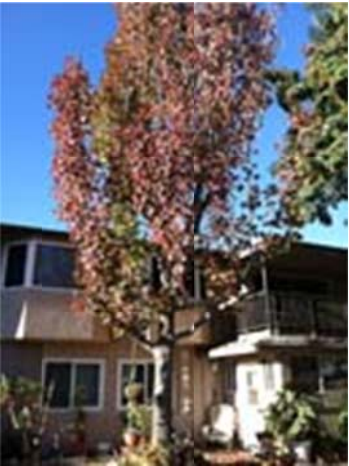
<p>Site 30 <i>Liquidambar styraciflua</i> - Sweet Gum</p> <p>This tree has good structure and should be monitored for roof clearance. Most of the branch attach points have sufficient angle of attachment and they do not pose a hazard for wind throw.</p> <p>The problem with this tree is its proximity to the foundation of the adjacent building. Liquidambar trees have moderate root aggressiveness and may cause some of the hardscape to buckle. This tree is in competition with the neighboring Brazilian Pepper, but the Brazilian Pepper should yield to the Liquidambar. This tree does not need to be pruned at this time, but it should be inspected annually</p> <p>Maintenance: zero Next Service: fall Priority: medium</p>

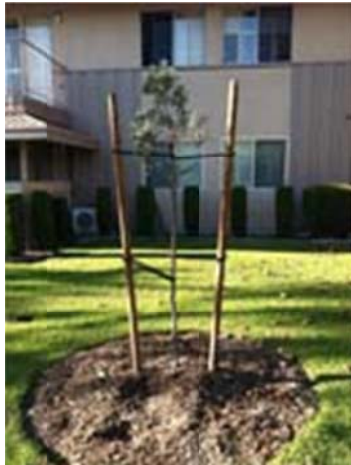
Site 31

Metrosideros excelsa - New Zealand Christmas Tree

This tree was a poor choice of nursery stock and was planted improperly. It has a small chance of survival in the long-term. The trunk is kinked from being tied to a stake in the nursery, and the stakes on this tree are very tight, causing a constriction similar to a tourniquet. This restricts the flow of water and nutrients to the foliage and will ultimately cause the death of the tree.

Nearly every little branch has been tipped, and the tree is already struggling to recover from these pruning wounds. There is an excessive amount of mulch around the base of the tree that encourages the presence of decay organisms that use up the soil's nitrogen supply, further stressing the tree. The tree has a remote chance of recovering from all of these stresses, but it would need to be staked correctly. If the tree declines further, it should be replaced.

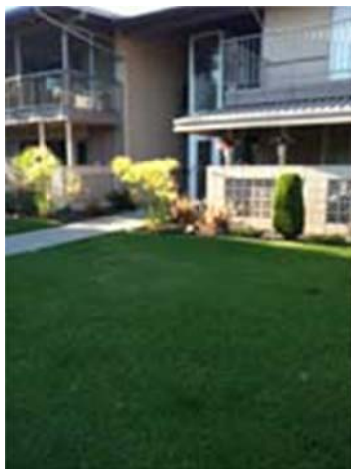
Site 32

Vacant Planting Site

This planting site is smaller than it appears because there is an irrigation line that runs straight through the center of it. With little space for root growth, the site will require a diminutive species that will not cause damage to the irrigation system. It also receives nearly full sun for most of the day, and it has the potential to get cooked during the summer. Therefore, a drought and heat tolerant tree should be selected.

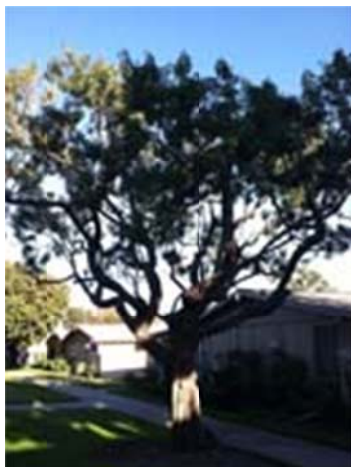
Site 33

Schinus terebinthifolius - Brazilian Pepper

This pepper tree is looking a little sparse from its previous pruning. The tree is currently in guarded condition and should be monitored annually. As little live foliage as possible should be taken off the tree at this time. It should be monitored for sidewalk and roof clearance.

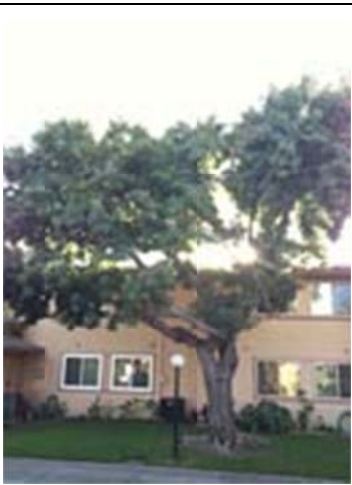
<p>Site 35 <i>Schinus terebinthifolius</i> - Brazilian Pepper</p> <p>This tree has a good structural base, and it can be maintained for years. It should be kept off the roof and above the sidewalk. Since it is a fast-growing species, it may need to be maintained every 6 to 12 months.</p> <p>Maintenance: 40 min. Next Service: spring Priority: high</p>

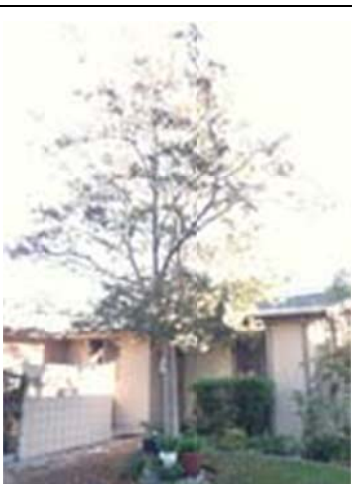
<p>Site 36 <i>Lagerstroemia indica</i> - Crape Myrtle</p> <p>This tree has a few stumps that need to be cleared up and one major crossing branch that should be removed. Roof clearance and sidewalk clearance should be maintained annually.</p> <p>Maintenance: 30 min. Next Service: now Priority: medium</p>

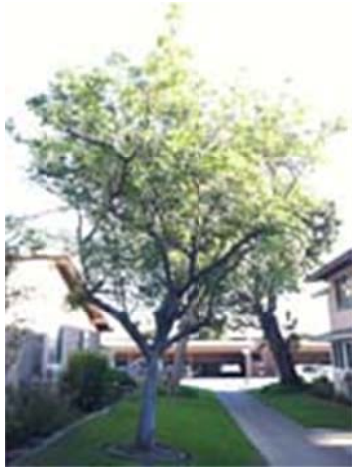
<p>Site 37 <i>Cupaniopsis anacardioides</i> - Carrotwood</p> <p>This Carrotwood has a branch that has drooped onto the roof of the adjacent building and should be removed. There are some additional sprouts that should be pruned back so they don't compete with the general canopy. This tree should be monitored annually for roof and sidewalk clearance.</p> <p>Maintenance: 20 min. Next Service: now Priority: high</p>

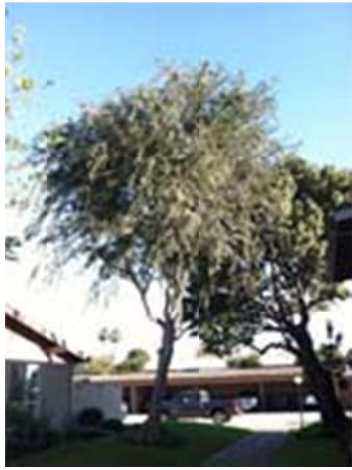
<p>Site 38 <i>Ulmus parvifolia</i> - Chinese Elm</p> <p>This tree has great structure and has achieved a pretty good height for its age. Its canopy is a bit lopsided away from the adjacent building and should be trained back towards the East. It is also in competition with the Brazilian Pepper to the West and some harmony trim is needed between the two trees. Foliage on the East side of the tree should be retained as much as possible, while foliage on the West side can be thinned. Low fringe drooping down onto the sidewalk or onto the adjacent building's roof can be pruned annually.</p> <p>Maintenance: 90 min. with climber Next Service: now Priority: low</p>

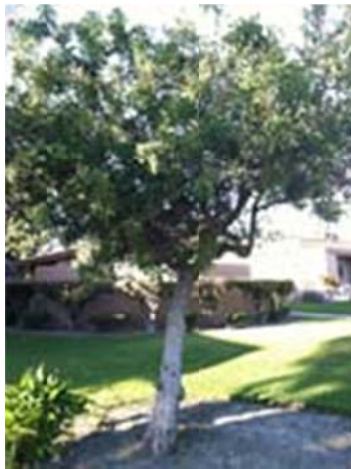
Site 43

Schinus terebinthifolius - Brazilian Pepper

Many of the leaves are showing signs of iron-induced chlorosis. This is likely caused not by a lack of iron in the soil, but by the unavailability of iron to the tree due to the alkalinity of the soil. The soil is dry and cracked, and a crusting layer of soil may be causing moisture to drain away from the root system. This tree should be monitored annually, but the only mitigation that should be done at this point is the removal of the deadwood and the correction of form.

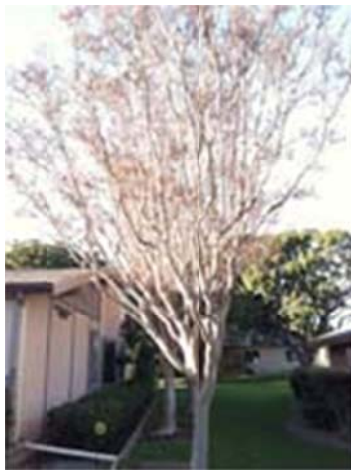
Site 44

This is a good choice of species for this location, but the manner in which this tree was pruned will be detrimental to its health. Nearly all of the branches emanate from a single point on the trunk and do not have much in the way of lateral branching. This makes them susceptible to wind throw if a gust of wind were to come in from the West. This problem originated with the nursery practice of topping the short nursery stock while young and encouraging the resprouting shoots to grow together. Not much can be done to correct this defect at this point in the tree's life, but the tree can be retained until it begins to show signs of decline. The tree is not of sufficient size to cause any significant damage if it were to drop branches, so it can be allowed to stay. No pruning is needed at this time

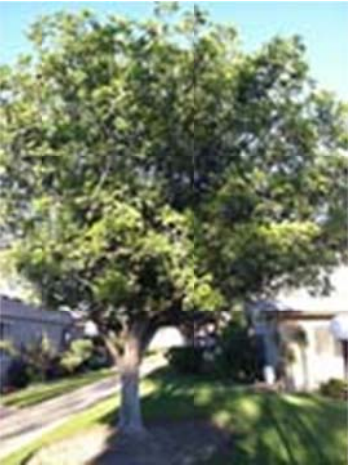
<p>Site 48 <i>Cupaniopsis anacardioides</i> – Carrotwood</p> <p>This tree has full, dense foliage indicating a healthy tree. There are many interior shoots that are beginning to compete with the main structure, and these shoots should be removed. There is some bark loss on some of the branches due to either squirrel chew or abrasion with another branch. These branches with bark loss should be monitored, and when they die they should be pruned back to their parent stem. The tree should be monitored for sidewalk clearance annually.</p> <p>Maintenance: 20 min. Next Service: now Priority: medium</p>

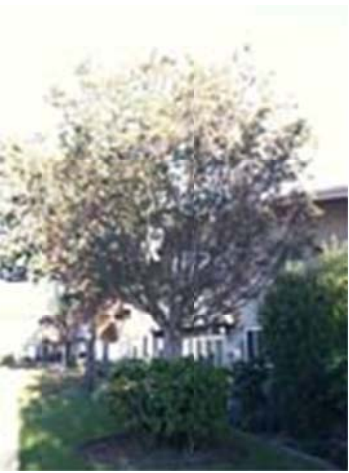
<p>Site 49 <i>Lagerstroemia indica</i> – Crape Myrtle</p> <p>This tree has good form and does not need much pruning at this time. It is possible that its root system is competing with the Jade plants around its base, but the tree appears to be reasonably healthy. The Jade plant should not be removed because it protects the tree from mechanical damage of passersby and landscape workers. This tree should be monitored annually for roof and sidewalk clearance, but it does not need any pruning at this time.</p> <p>Maintenance: 20 min. Next Service: fall Priority: medium</p>

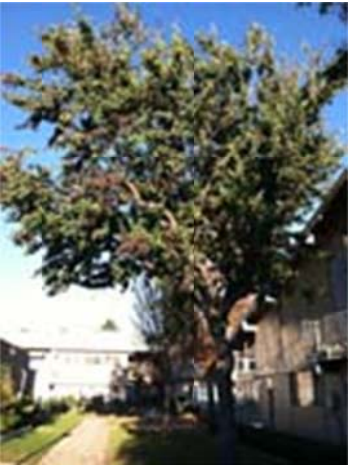
<p>Site 50 <i>Pyrus kawakamii</i> – Evergreen Pear</p> <p>This tree has fire blight which will eventually cause the death of the tree. However, it can be retained for several years as it begins its mortality spiral. Aesthetically, the symptomatic tissue can be removed, leaving the green foliage. Pruning tools should be disinfected with bleach to prevent the spread of the disease to other trees. This tree should be monitored for roof and sidewalk clearance. There is a large branch that is in heavy cantilever to the North over the sidewalk, and it should be lightened to reduce the possibility of failure onto building 27.</p> <p>Maintenance: two hours with climber Next Service: now Priority: medium</p>

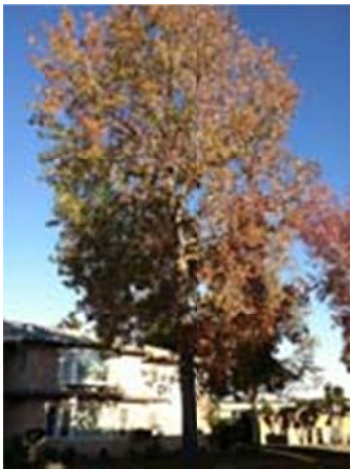
Site 52

This tree has beautiful fall foliage and it is a desirable asset to the landscape. However, it is known to have medium-aggressive roots, and it is already causing damage to the sidewalk. The tree can still be retained for some time, but it will eventually have to be removed to avoid more costly sidewalk repairs. When the sidewalk repairs are completed, a small trench along the sidewalk can be dug, and a root barrier can be installed to a depth of 12 to 16 inches. This will not prevent the advance of roots, but it will slow them sufficiently so that sidewalk damage will not occur in the life of the tree. This tree does not need to be pruned much, it just needs a bit of sidewalk clearance on the western side.

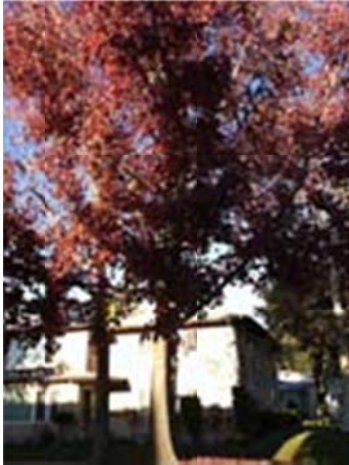
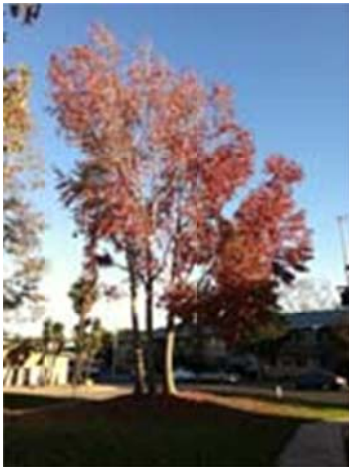
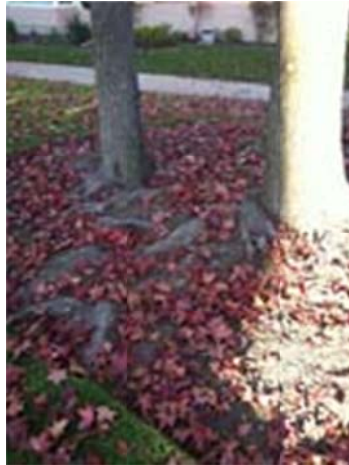
Sites 53, 54, and 55
Liquidambar styraciflua - Sweet Gum

These three Liquidambar trees are growing nicely together in a grove. They only need to be monitored for head height and sidewalk clearance. They are on top of a mound of soil, making them less likely to cause damage to the surrounding sidewalk. Their roots are girdling each other, which may end up being beneficial in the long run because it will limit their growth.

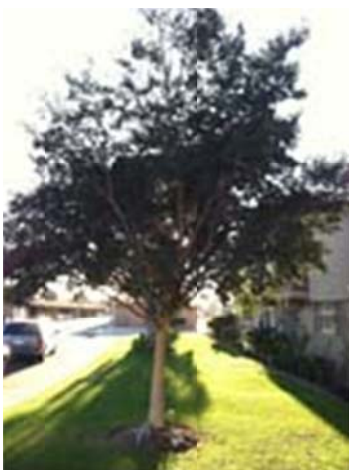
Site 56
Lagerstroemia indica - Crape Myrtle

This is a well-chosen tree for the site because the roots will not cause damage to the sidewalk or the building in the long-term. There is a little bit of deadwood cleaning that can be done to improve the aesthetics of this tree, and the fringe should be raised slightly for sidewalk and head height clearance.

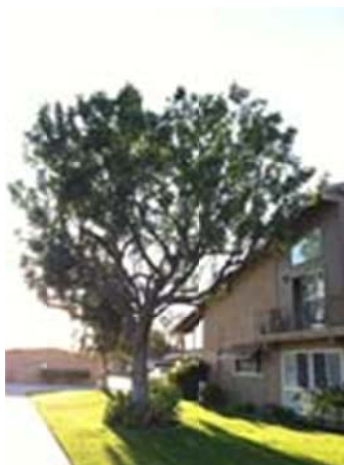
<p>Site 57 <i>Cupaniopsis anacardioides</i> - Carrotwood</p> <p>The foliage of this tree is looking a little sparse because it was overly thinned in the past. This tree should be allowed to have some time to recover from the previous pruning. There is a tearout wound over the sidewalk to South that is in the process of healing. There are some aggressive sprouts that are growing in response to the previous pruning cuts, and these sprouts should be left alone for one year and then thinned to the strongest leaders. This will help the tree recover its natural form.</p> <p>Maintenance: one hour Next Service: fall Priority: medium</p>

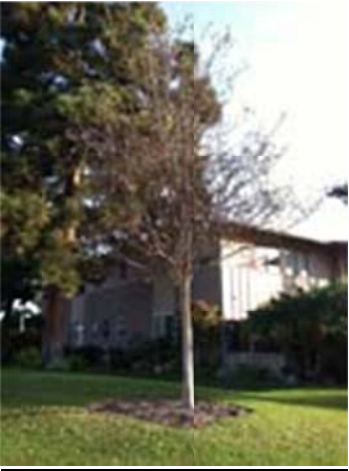
<p>Site 1 <i>Lagerstroemia indica</i> - Crape Myrtle</p> <p>This Crape Myrtle has good structure, but it is in need of a deadwood cleaning. The removal of some deadwood will free up some space for the more desirable structures to grow. The tree appears to be in a stressed condition due to an unknown cause, and it is languishing while its neighbor to the East is flourishing. One possible cause could be this tree is receiving full Southwestern exposure during the hot summer months and it partially shades its neighbor to the East.</p> <p>Maintenance: 10 minutes Next Service: fall Priority: low</p>

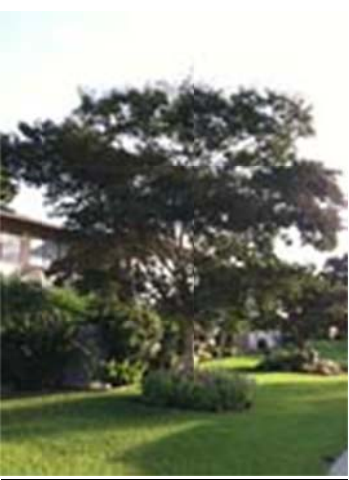
<p>Site 2 <i>Lagerstroemia indica</i> - Crape Myrtle</p> <p>This Crape Myrtle is faring much better than its neighbor to the West. The canopy is full and green, and the tree has pretty good structure. There are several tchotchkes that are tied to the trunk and low branches that should be removed immediately. One of the hooks is beginning to be impounded in the bark of a lateral branch pointing to the West. A decorative branch is tied to the trunk using nursery staking tape. This should be removed so that the ties do not constrict the vascular system of the tree.</p> <p>The Crape Myrtle sheds its bark, and much of the loose bark can be removed for aesthetic purposes. There is also some minor deadwood cleaning that could be done. This tree should be monitored for sidewalk clearance and clearance over the electrical box to the North.</p> <p>Maintenance: 20 min. Next Service: now Priority: medium</p>

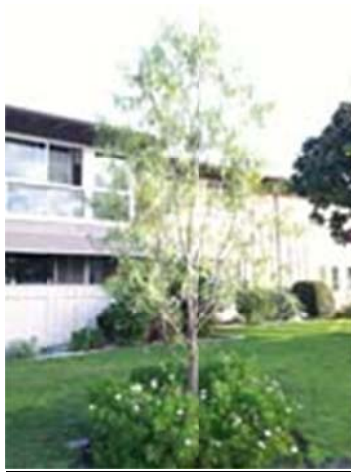
Site 4

This tree is well-chosen for the site because it is a very low maintenance species. Unfortunately, it is planted immediately adjacent to a water line, and there is a possibility that roots may have to be cut in order to access the line. This tree is less of a concern for doing root damage to the line, and more of a concern for being harmed by maintenance of the line.

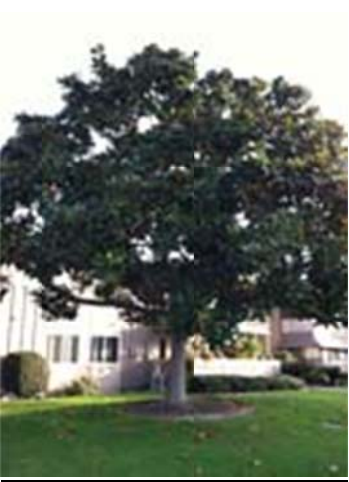
<p>Site 5 <i>Magnolia grandiflora</i> - Southern Magnolia</p> <p>This Magnolia has excellent form and has a beautiful umbrella canopy. There is some minor deadwood cleaning that should be done, but this tree does not need much pruning at this time. It should be monitored for head height and sidewalk clearance.</p> <p>Maintenance: 30 min. Next Service: spring Priority: medium</p>

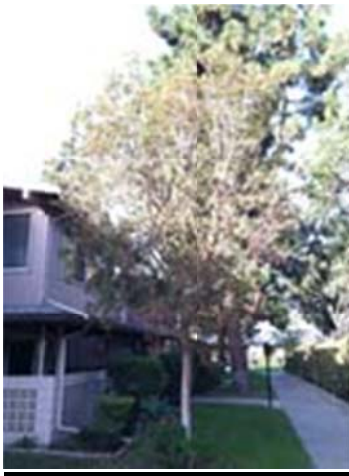
Site 14
Lagerstroemia indica - Crape Myrtle

This Crape Myrtle has fared well on this site. It has decent branching structure, and it only needs a little bit of interior deadwood cleaning. It should be monitored annually for roof and sidewalk clearance.

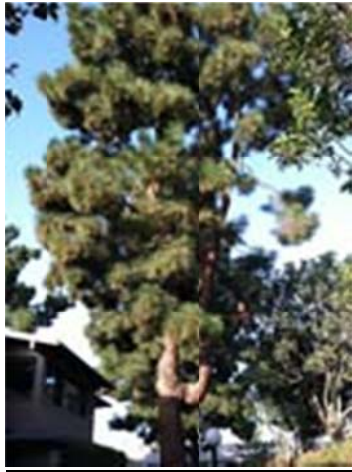
Site 15

The trunks that have a narrow angle of attachment have included bark and a branch union that does not increase in size proportionately with their increase in girth. Therefore, as this tree ages, this branch union will become weaker relative to the size of the trunks. This tree is gradually becoming a hazard, and it should be considered for removal or at least a reduction of the co-dominant trunks.

There is some minor deadwood cleaning that should be done in the short term before the dead limbs self-prune.

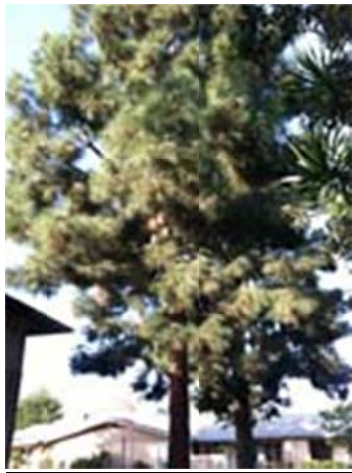
Site 16

This tree has much better structure than its neighbor to the East. However, it too has a co-dominant trunk at about 30 feet up the trunk. This co-dominant branch attach point could become a hazardous structure. One potential mitigation is to tie a safety line between the two trunks. This will not prevent the trunk from tearing out, but it will minimize the damage done when it fails. Rather than peeling out onto the building, it will stay close to the trunk and remain hanging until emergency responders can safely dismantle it. This potential mitigation could be applied to the pine tree at site 15 as well.

There is some minor deadwood that should be removed, and some hanging dead branches that could be a minor hazard for pedestrians underneath. This tree should also be monitored for roof clearance.

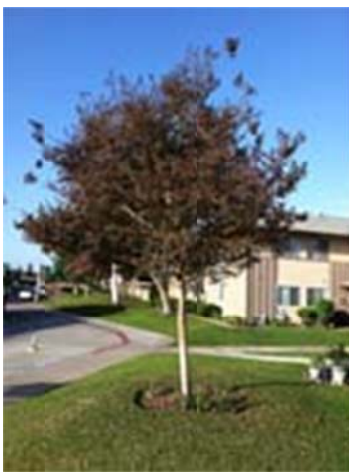
Site 22
Lagerstroemia indica - Crape Myrtle

This tree has some minor deadwood that can be cleaned out for aesthetic purposes. It has good branching structure and does not need much maintenance.

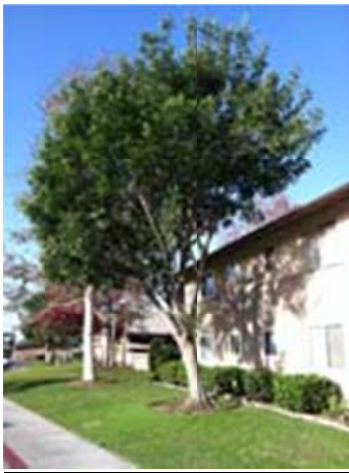
Site 24
Cupaniopsis anacardioides - Carrotwood

This tree does not have ideal structure because many of its trunks are emanating from a single point approximately 6 feet up the trunk. This originated with the nursery planting practices of heading off the nursery stock while young and encouraging many sprouts to grow at the heading off points. While the tree is in the nursery, this pruning practice makes an attractive looking young tree, but it creates long-term problems. These trunks are more susceptible to tearout.

There is already an indication of a tearout wound on the Western side of one of the trunks. This wound is currently healing and should be monitored annually for the advance of the cambium. If the cambium continues to advance, then the wound will eventually heal. If not, then decay may set in and the limb will have to be removed.

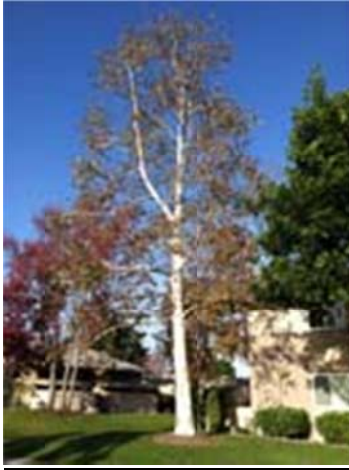
Site 25

This tree has excellent structure, but many of its branches have been tipped in the past. The tree should be allowed to recover from its previous pruning. It should be monitored for roof clearance and competition with the neighboring Carrotwood. Since the sycamore is the more valuable tree, the Carrotwood should be pruned back to make way for the Sycamore. There is no prevailing lean on the Sycamore, and there are no major defects in the trunk. This tree still has many years of life left in the landscape.

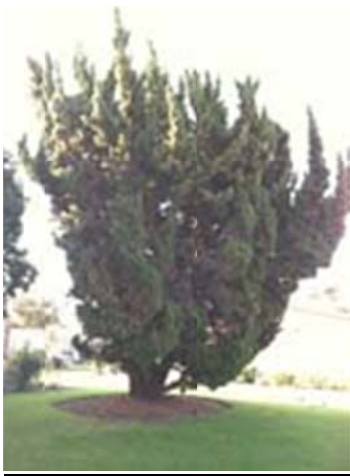
Site 27

Juniperus chinensis - Hollywood Juniper

This Juniper tree is an excellent choice of species for the landscape because it is very low maintenance. The tree only needs minor deadwood cleaning every 2 to 5 years. This tree was aggressively pruned back on its Eastern side some time ago, and these improperly pruned branches should be cut back to the parent stem. This hole in the canopy will never completely fill in. Since there is a hole in the canopy, the deadwood on the interior is more apparent, and I recommend addressing the deadwood removal sooner for aesthetic purposes.

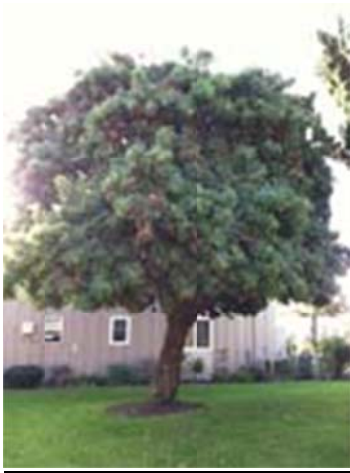
Site 28

Schinus terebinthifolius - Brazilian Pepper

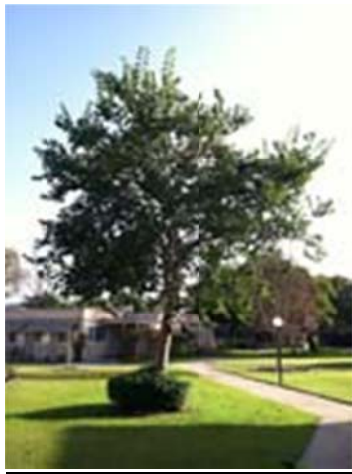
Site 29

Bauhinia x blakeana - Hong Kong Orchid Tree

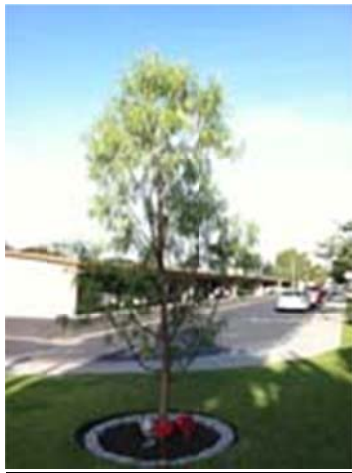
Site 30

Geijera parviflora - Australian Willow

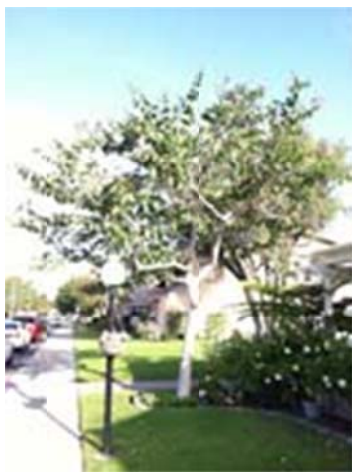
Site 31

Bauhinia x blakeana - Hong Kong Orchid Tree

This tree has some minor structural defects that should be corrected and some minor deadwood that should be removed. It should be monitored annually for clearance with the patio and the sidewalk. There is a planter that is hung correctly in the canopy. This hanging planter may stay.

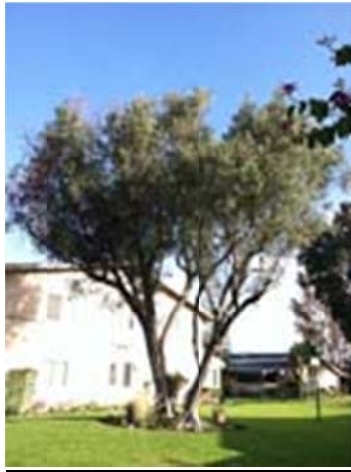
Site 32
Olea Europaea - Olive Tree

This tree is showing early signs of dieback that may be symptoms of a worse condition. It was aggressively tipped in the past, and that may have been an entry point for the disease xylella. Xylella is a systemic disease that causes a gradual browning of tissue. It causes the xylem tissue in the vascular system to swell and restrict the movement of water and nutrients much like a tree having a heart attack. It is not clear at this time whether the tree has xylella or not, but it should be monitored annually for additional signs. In the short term, the dead material can be pruned out of the tree for aesthetic purposes.

This tree may have already begun its decline spiral, and may only have another 5 to 10 years left in the landscape. After pruning the diseased tissue, arborists should sterilize their tools in bleach to avoid transmitting the disease to other trees in mutual.

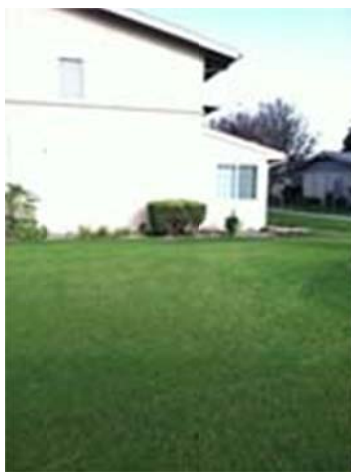
Site 33
Vacant Planting Site

There is plenty of room to plant a large growing tree on this site. The chosen species should shade the building to the north from the southern sun. This site receives full southern exposure.

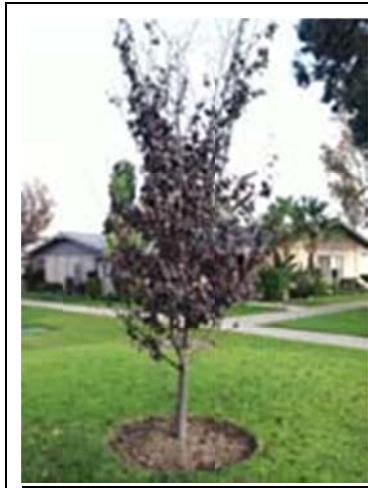
Site 34

Prunus cerasifera - Purple Leaf Plum

This tree does not need much pruning at this time. Although the tree is healthy, it was a poorly chosen tree for the site because the purple leaf plum is a small species and will never get very large. This planting site can accommodate a much larger tree, and a large shade tree would have added a summer cooling benefit to building 32 to the North. Moving this purple leaf plum at this point would be detrimental to its health and is not recommended. Rather, the space to the West of the tree should be utilized for a larger tree planting.

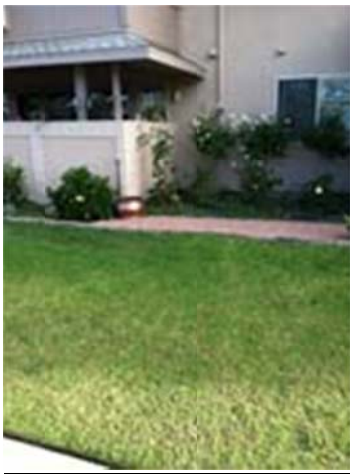
Site 35

Vacant Planting Site

This is a good site for a diminutive species that can handle summer heat.

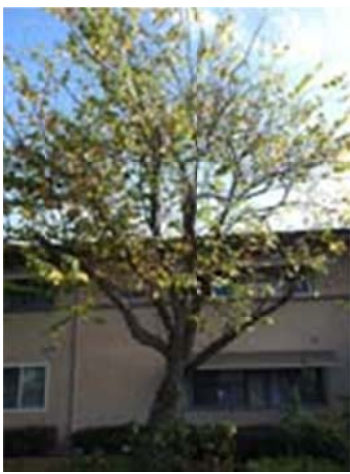
Site 36

Cercis canadensis - Eastern Redbud

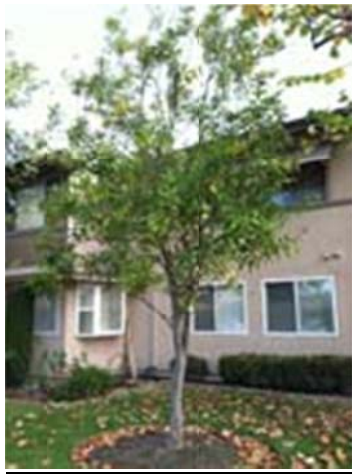
Site 37

Macadamia integrifolia - Queensland Nut

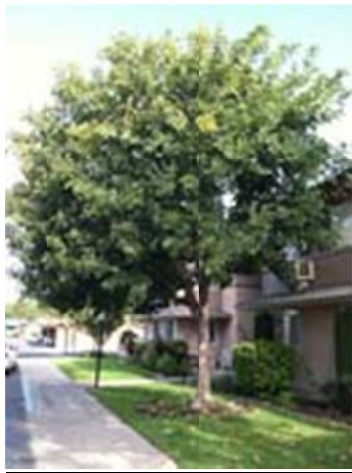
Site 38

Fraxinus spp. – Ash

This tree is going to be tall. Care should be taken never to top this tree because it has an aggressive resprouting habit. If topped, these sprouts will become wind throw hazards and will be more likely to cause damage than a mature trunk.

This tree has been improperly pruned in the past for building clearance. Many stump cuts have been left, and they should be recut back to the parent stem. The past pruning has left the tree lopsided to the West, and some of the foliage on the Western side should be reduced to compensate. The tree should be allowed to grow to the East towards the building, provided that 5 feet of clearance is maintained.

This tree will begin to cause damage to the hardscape over the next 5-10 years.

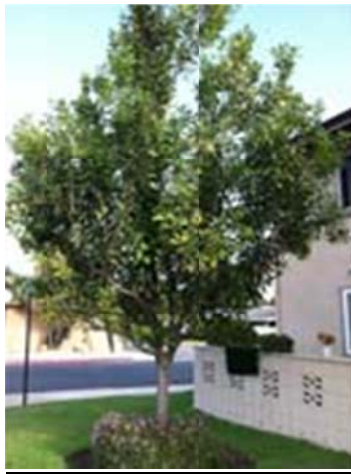
Site 39

Macadamia integrifolia – Queensland Nut

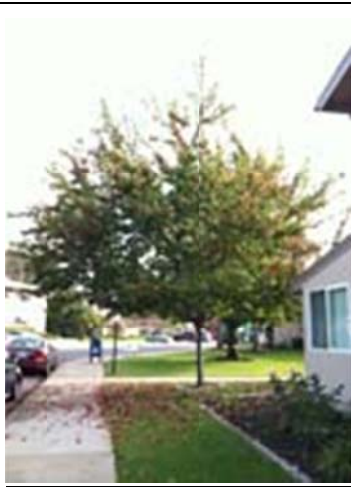
Site 40

Pyrus kawakamii - Evergreen Pear

This tree has fire blight which is a systemic condition. The fire blight will eventually kill the tree, but it can be retained in the landscape for several more years. Aesthetically, symptomatic tissue can be pruned out annually. Arborists should sterilize their tools in bleach between cuts to prevent the spread of the disease to other trees in mutual.

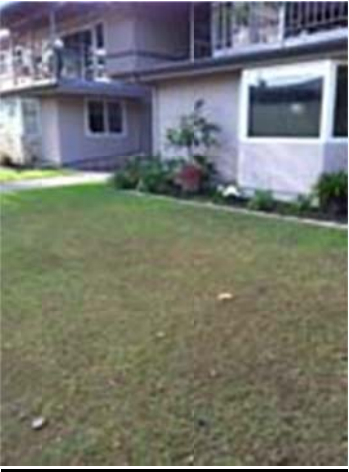
<p>Site 41 Vacant Planting Site</p> <p>This site is shaded from the West. A diminutive species that does not have aggressive roots can be planted here.</p>

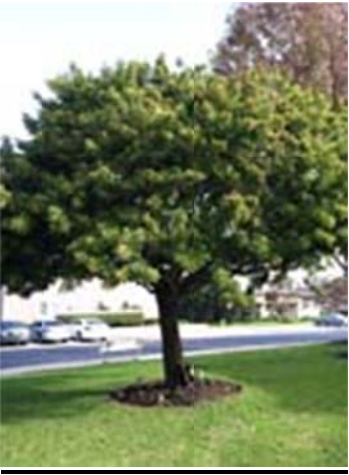
<p>Site 42 <i>Schinus terebinthifolius</i> - Brazilian Pepper</p> <p>This tree had some aggressive pruning around its fringe in the past, and these stump cuts should be pruned back to the parent stem. As a response, the tree created many new sprouts on the interior of the canopy. These shoots should be pruned away before they compete with the general canopy. There is some minor deadwood that should be pruned away as well. Since this is a fast-growing tree, the fringe will need to be maintained every 6 to 12 months.</p> <p>Maintenance: 40 min. Next Service: spring Priority: high</p>

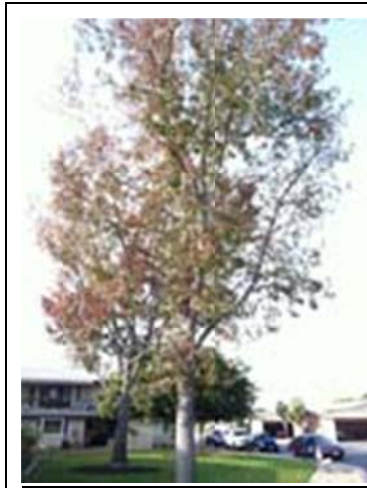
Site 44

Liquidambar styraciflua – Sweet Gum

This tree also has a co-dominant trunk emanating about 10 feet up. A safety line should be installed between it and the main stem to reduce the risk of damage if it were to tear out. The angle of attachment is large enough that it does not pose a hazard at this time. There is one anomalous branch leaning over the sidewalk to the north, and some of its foliage should be thinned to reduce the weight and the likelihood of tearing out.

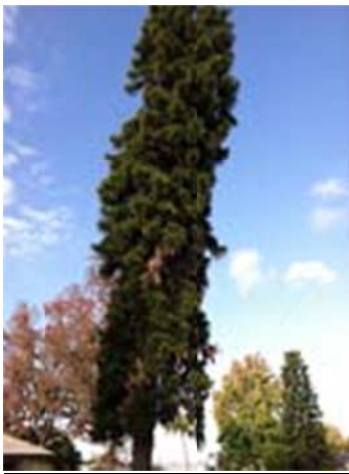
Site 45

Araucaria heterophylla - Norfolk Island Pine

This tree has a prevailing lean to the North East over the parking area. If it were to fail, it would damage the power lines, but it would not likely hit any structures or vehicles.

There is a slight indentation in the trunk on the Eastern side, and this could be an indication of internal decay. This indentation should be monitored, and if fungus fruiting bodies or stress marks appear over time, then this tree should be considered a hazard and marked for removal. The tree may currently be retained in the landscape until further signs of stress are observed.

Minor deadwooding can be done at this time for aesthetic purposes. More importantly, this tree should be inspected annually for any development of a hazard feature.

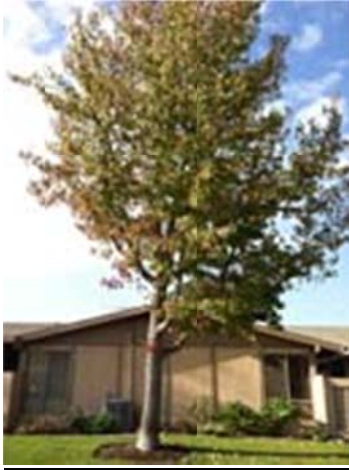
Site 46

Liquidambar styraciflua - Sweet Gum

This tree has a few branches with narrow angles of attachment, but they are not severe enough to be deemed hazards. The tree should be monitored for roof and sidewalk clearance. This tree was heavily pruned a year or two ago, and it is now sprouting new shoots in response to the cuts. The tree should be left alone for a year and monitored for new growth.

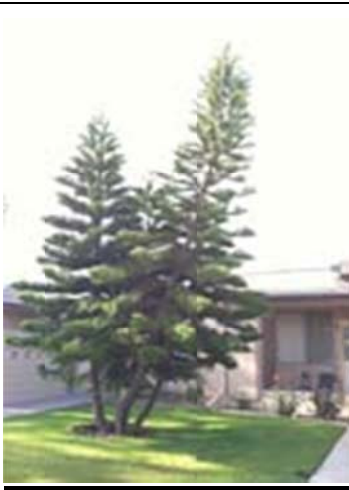
Site 47

Araucaria heterophylla - Norfolk Island Pine

Another option is to retain all four trunks for the next 5-10 years and monitor them for signs of stress at the root crown. If any signs of stress cracks appear, then the entire tree will have to be removed.

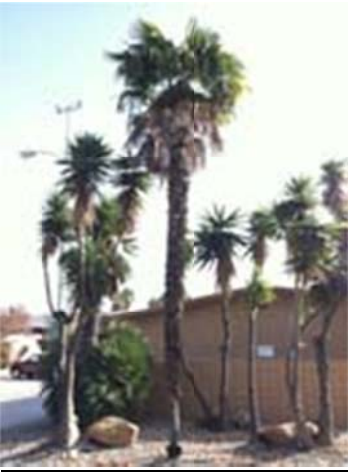
<p>Sites 48, 49, and 50 <i>Chamaerops humilis</i> – Mediterranean Fan Palm <i>Trachycarpus fortunei</i> – Chinese Windmill Palm</p> <p>These palms are currently slated for removal and replacement.</p> <p>If the plans change, and it is decided that the trees should be retained, then they can easily be maintained by removing the dead fronds annually for aesthetic purposes.</p> <p>Maintenance: 30 min. Next Service: fall Priority: medium</p>

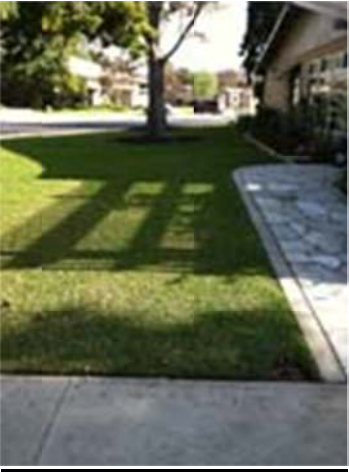
<p>Site 51 Vacant Planting Site</p> <p>This site is not large enough to handle another tree because the canopy of the neighboring Brazilian Pepper would compete with it. This site should be left empty until the pepper tree is removed.</p>

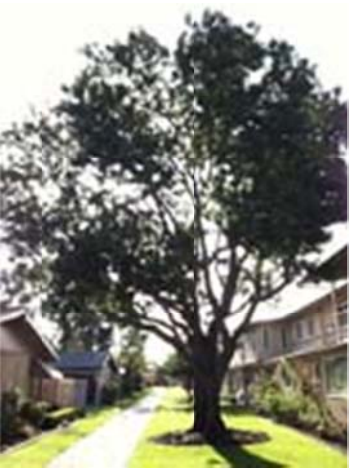
<p>Site 52 <i>Schinus terebinthifolius</i> - Brazilian Pepper</p> <p>This tree has good structural form and should be monitored annually for roof clearance. Since it is a fast-growing species, it should be maintained every 6 to 12 months.</p> <p>Maintenance: one hour Next Service: spring Priority: high</p>

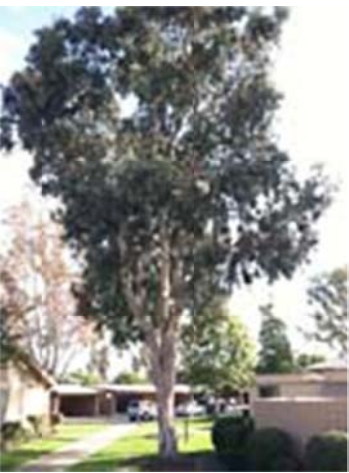
<p>Site 57 <i>Eucalyptus leucoxylon</i> - White Iron Bark</p> <p>This tree has a bit of deadwood that could be cleaned out, but it does not need much pruning at this time. It will eventually cause problems to the foundation of the nearby building with its roots. It appears to be growing well with its neighbor to the East. There are no visible defects in the trunk at this time, and this tree has many more years left in the landscape.</p> <p>Maintenance: 30 min. with climber Next Service: now Priority: high</p>

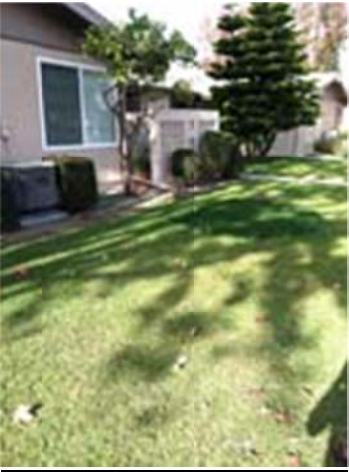
<p>Site 59 Vacant Planting Site</p> <p>This site is small and a diminutive species should be chosen for it. It receives Western shade from building 33, and a more delicate species could be chosen such as the Japanese Maple or the Purple Leaf Plum.</p>

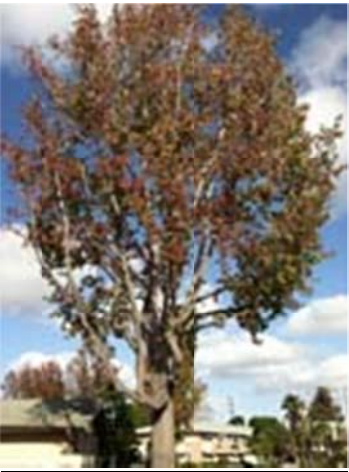
<p>Site 60 <i>Liquidambar styraciflua</i> - Sweet Gum</p> <p>This tree does not have ideal form because it was topped some years ago at approximately 15 feet up the trunk. From this point, many smaller trunks emerged that competed with each other for light. These trunks have relatively little lateral branching, and they could become hazardous as they get larger. There is one pair on the interior that has a narrow angle of attachment that is likely to tear out in a windstorm. I recommend installing a safety line around the three trunks with the narrow angle of attachment on the Western side of the tree. This safety line will not prevent them from tearing out, but it will reduce the likelihood of them doing damage to the adjacent building when they fail.</p> <p>Maintenance: 30 min. with climber Next Service: now Priority: medium</p>

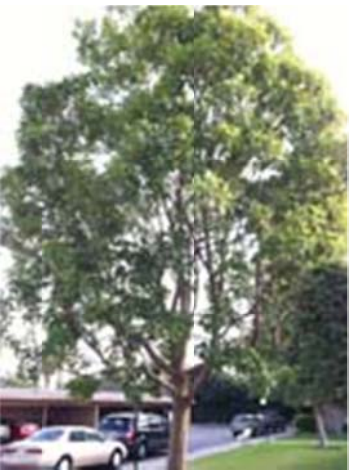
<p>Site 61 <i>Lophostemon confertus</i> – Brisbane Box</p> <p>This tree has excellent form and does not need much pruning at this time. There is a bit of deadwood that can be cleaned out for aesthetic purposes. There is a concern that the roots of this tree may affect the foundation of the adjacent building in the next five years.</p> <p>Maintenance: 15 min. Next Service: now Priority: low</p>

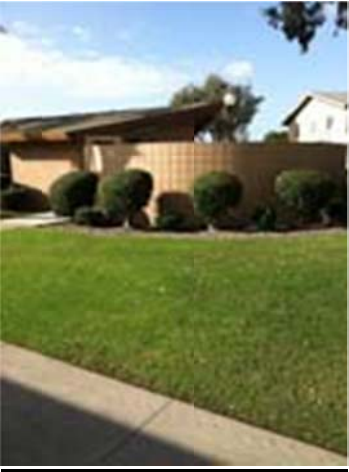
<p>Site 62 Vacant Planting Site</p> <p>There is limited space here, and the tree that is chosen for this site should be not root aggressive. The site receives mottled shade from the South from the Eucalyptus trees.</p>

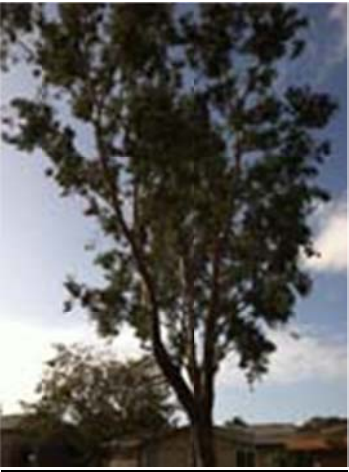
<p>Site 63 <i>Eucalyptus leucoxylon</i> - White Iron Bark</p> <p>This tree has excellent structure and can be retained in the landscape for some time. There may be some damage to the sidewalk in the near future from the root system.</p> <p>There are some minor borehole sites up and down the trunk. These borehole sites are not serious at this point in time, but they should be monitored annually. If they increase in number, then the tree can be treated for infestation.</p> <p>Maintenance: zero Next Service: fall Priority: medium</p>

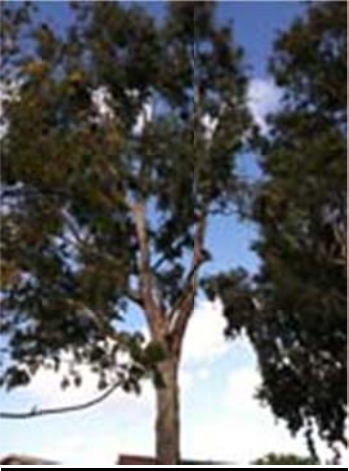
<p>Site 64 <i>Eucalyptus leucoxylon</i> - White Iron Bark</p> <p>This tree also has good form, but it will eventually cause damage to the foundation of the nearby building. There is already evidence of root damage to the sidewalk on the West.</p> <p>Maintenance: zero Next Service: fall Priority: low</p>

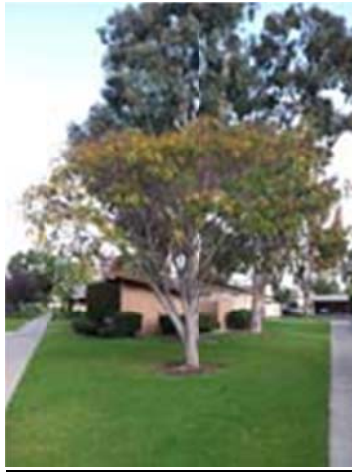
Site 65

Albizia julibrissin – Persian Silk Tree

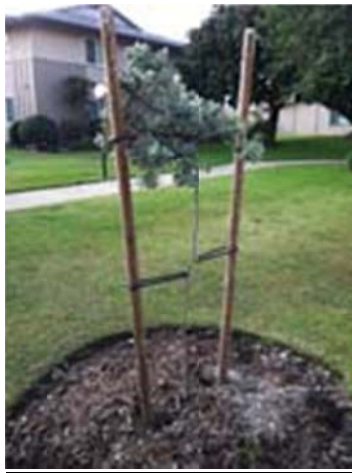
Site 66

Metrosideros excelsus - New Zealand Christmas Tree

Although this is a wonderful choice of species for this location, the choice of nursery stock was poor. This scraggly trunk has been severely deformed by high tension ties that secured it to the planting poles. This tree will have a hard time surviving with the ties constricting its vascular system, restricting the flow of water and nutrients to the canopy. The defect in form in the trunk will be retained for the life of the tree, and as it grows, it will only become hidden.

It would be a waste of time to continue to maintain this tree. Rather, it should be replaced. Removal is recommended.

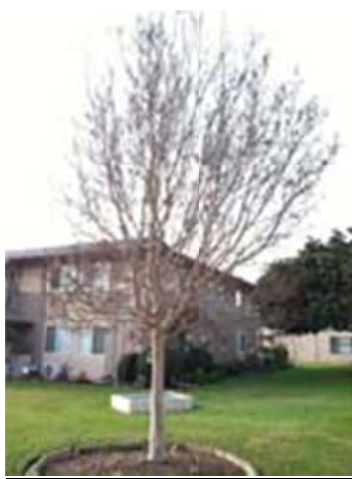
Site 67

Lagerstroemia indica - Crape Myrtle

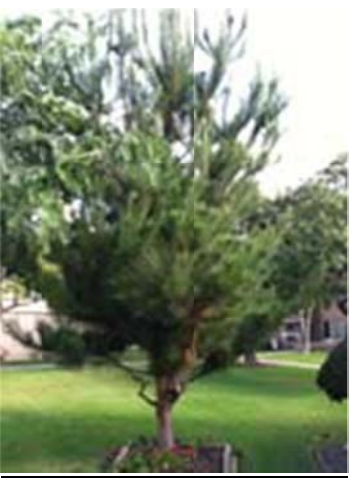
<p>Site 68 <i>Pinus pinea</i> - Italian Stone Pine</p> <p>This tree was a poor choice for this site because of its mature size. It will either have to be heavily pruned over time to keep it small, or it will cause severe root damage to the neighboring building.</p> <p>If it is to be retained in the landscape, then the neighboring Tipu tree should be pruned back to give it space, and the dead needles should be sprayed out of the canopy with a blast of water. If the tree will eventually be removed, then the Tipu tree should be allowed to grow into the space that the pine currently occupies.</p> <p>Maintenance: 30 min. Next Service: spring Priority: low</p>

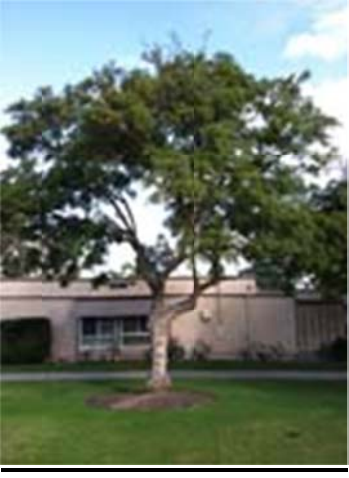
<p>Site 69 <i>Jacaranda mimosifolia</i> - Jacaranda tree</p> <p>This Jacaranda tree has some minor deadwood that should be removed, but it is in good form and good condition. It should be monitored for sidewalk clearance.</p> <p>Maintenance: 10 min. Next Service: now Priority: low</p>

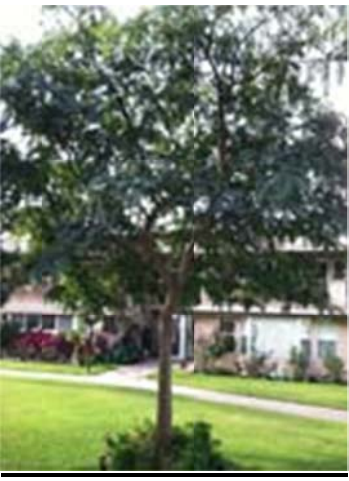
<p>Site 72 <i>Tipuana tipu</i> - Tipu Tree</p> <p>This Tipu tree is beginning to compete with its neighboring Italian Stone Pine. Depending on the decision of whether to retain or remove the stone pine, this Tipu tree should either be pruned or allowed to grow. If the stone pine is to be removed, then the Tipu tree should not be pruned back because it will eventually fill the space that the stone pine currently occupies. If the stone pine is to be retained, then the Tipu tree should be pruned back to give it a window of space. This tree should also be maintained for head height clearance annually.</p> <p>Maintenance: 20 min. Next Service: spring Priority: medium</p>

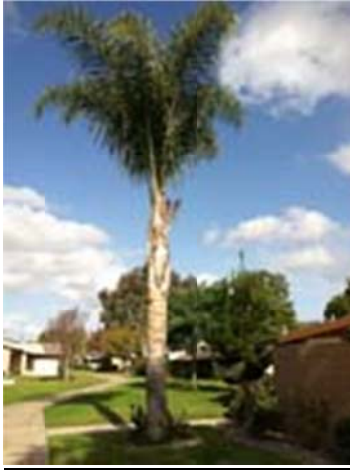
Site 74

Syagrus romanzoffianum - Queen Palm

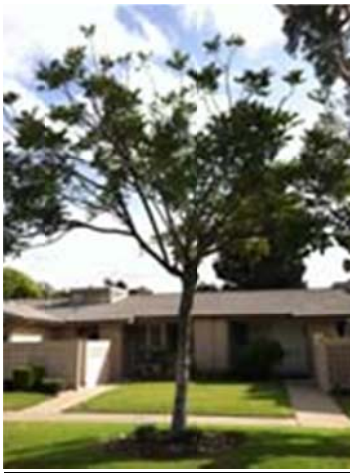
Site 75

Cupaniopsis anacardioides - Carrotwood

When this tree was pruned previously, the pruning tool tore some bark and caused excessive damage to the remaining trunks of the tree. The tree is now recovering from these injuries. The tree does not need to be pruned at this time, but it should be monitored for sidewalk clearance.

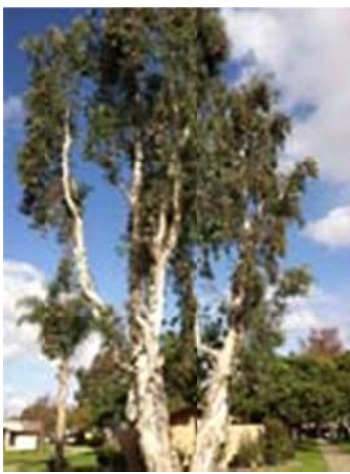
Site 76

Melaleuca quinquenervia - Paperbark Tree

This tree is an excellent choice of species for this climate zone. Unfortunately, it is planted a little too close to the sidewalk, and it may cause damage with its roots.

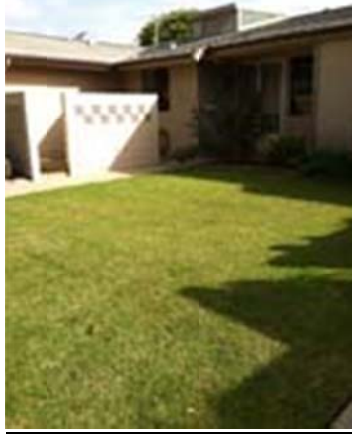
Site 77
Vacant Planting Site

This site is smaller than it appears because an irrigation line runs straight through the center of it. A shrub or small tree could be planted here, but care should be taken to not choose a species that has aggressive roots.

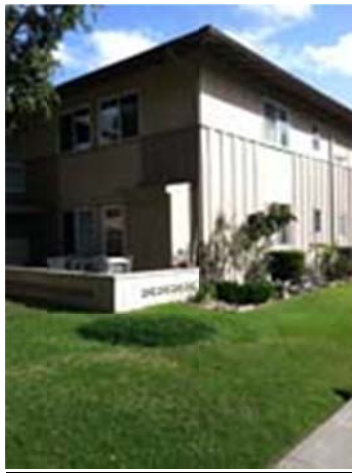
This site is very close to a patio and a *Ficus* tree. It should be left empty until the *Ficus* tree is removed. Then one single tree should be planted closer to the corner of the sidewalk and further from the patio.

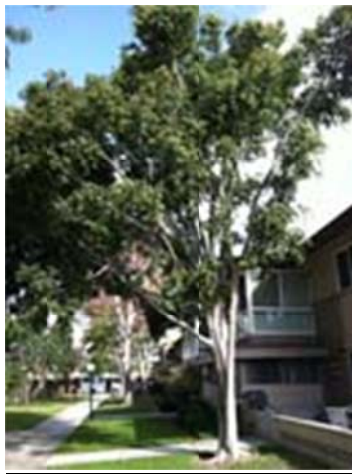
This is a poor choice of species for its location because it has aggressive roots. It will inevitably cause damage to the patio and the sidewalk around it. *Ficus* is a fast-growing tree that needs to be maintained heavily. This tree is also beginning to compete with the neighboring pepper tree.

When budget allows, I recommend removing and replacing this tree. This site should be merged with site 78 and a single tree should be planted closer to the sidewalk and further from the patio.

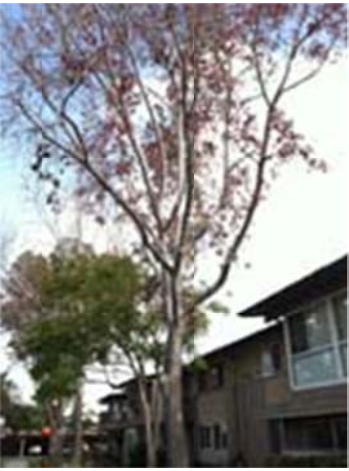
<p>Site 81 Vacant Planting Site</p> <p>This planting site has limited space, and a diminutive species should be chosen. It receives protection from the afternoon sun to the West by building 30 and protection from the sun during the day from the South by the Brazilian Pepper at site 80.</p>

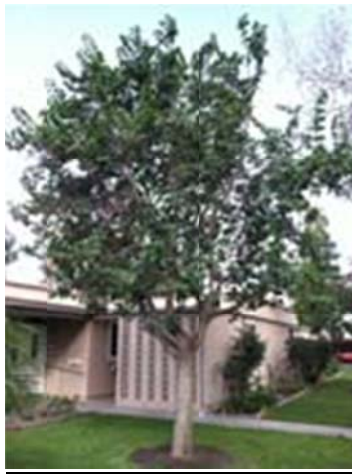
<p>Site 82 <i>Liquidambar styraciflua</i> – Sweet Gum</p> <p>This liquidambar tree has good structural form and does not need much pruning at this time. It was pruned aggressively over the roof a year or two ago, and these stumps should be cut back to the main stem.</p> <p>Maintenance: 90 min. with climber Next Service: now Priority: medium</p>

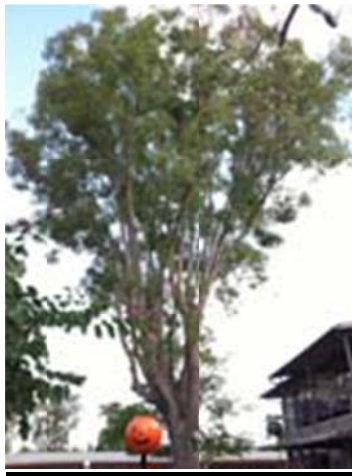
This tree has good structure that needs to be maintained for roof and sidewalk clearance. There is also some minor deadwood that could be removed.

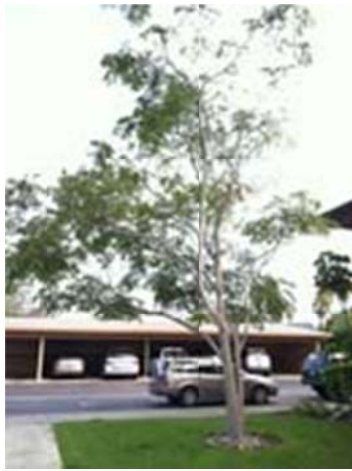
This ash tree was topped in the past and has since resprouted. Each of these new sprouts now competes with the others, leaving a sprig of foliage at each tip. There is a high likelihood of tearout in a windstorm from these branch unions because the attach points are relatively small. This tree should be gradually trained back into strong structural form by thinning out the competing leaders over the next three years.

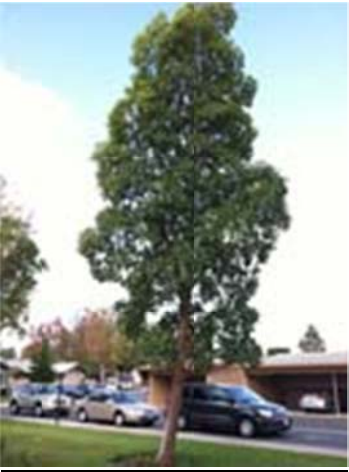
This tree has good form, but it is a bit lopsided to the North. It should be allowed to grow towards the South to reduce its cantilever. It does not need much pruning now, but in the spring or fall, the northern side should be thinned to reduce the amount of cantilever. This tree should also be maintained for sidewalk and roof clearance.

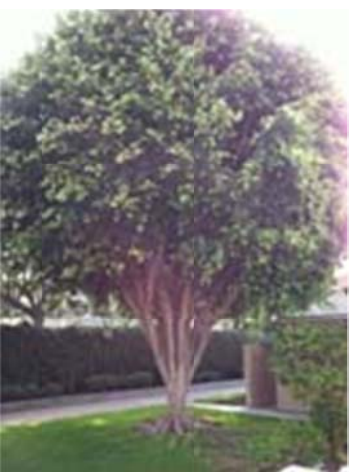
<p>Site 89 <i>Lophostemon confertus</i> – Brisbane Box</p> <p>This tree has some vertical cracks along its trunk that indicate torsional loads from the wind. This tree should be monitored for any increase in size of these cracks. If they do increase in size, then the tree may need to be removed before it becomes a hazard. There is minor deadwood in the canopy that can be removed for aesthetic purposes.</p> <p>Maintenance: 10 min. Next Service: now Priority: low</p>

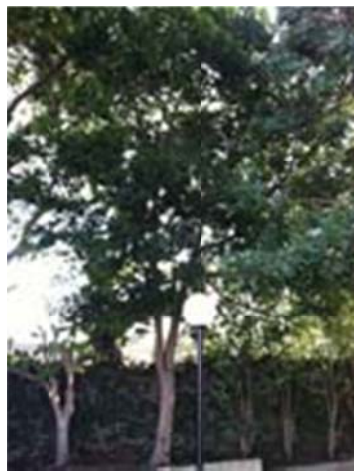
This pepper tree's canopy is a bit lopsided because it was heavily pruned away from the building. The incorrect pruning of the past left many stump cuts that need to be recut back to the parent stem. If not recut, then the stumps will become entry points for decay organisms. This tree is also beginning to grow into the canopy of its neighboring tree to the East. It should be pruned back for sidewalk clearance.
