TREE INVENTORY

Prepared for
LEISURE WORLD MUTUAL 15
SEAL BEACH

Prepared by
JAMES KOMEN – CLASS ONE ARBORICULTURE
ISA CERTIFICATION #WE-9909A
(818)495-5344
CLASSONEARBORICULTURE@GMAIL.COM
DECEMBER 1, 2013

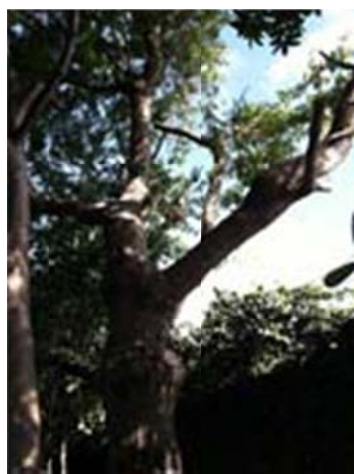
Site 95

This Kaffir Plum tree has some injuries at the root crown on the Western side. The advance of these injuries should be monitored. If they increase in size, then the tree should be marked as a hazard. The tree is beginning to compete with the Brazilian Pepper trees to the North and to the South of it. It is also growing into the hedge. Care should be taken when pruning space for all three of these trees.

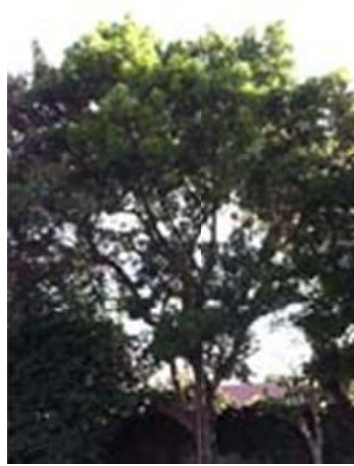
Site 96

This tree is out-competing its neighboring plum. A decision should be made whether to retain the Kaffir plum and prune space for it or to remove the Kaffir plum and allow the pepper tree to take over the space. The pepper tree will provide ample shade and canopy cover, but there roots tend to be a bit more aggressive and may cause problems to the surrounding planter box. Already, there is evidence of root damage to the sidewalk. This tree will be a challenge to maintain because of the barbed wire fence running beneath it. Maintenance times will be higher because crews will have to service each side of the tree separately.

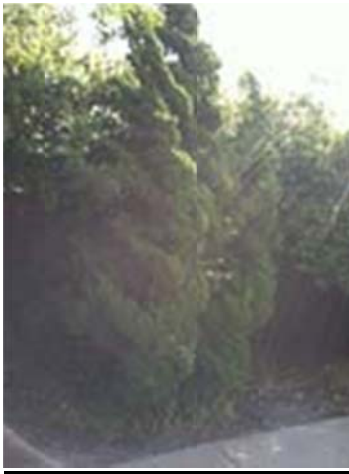
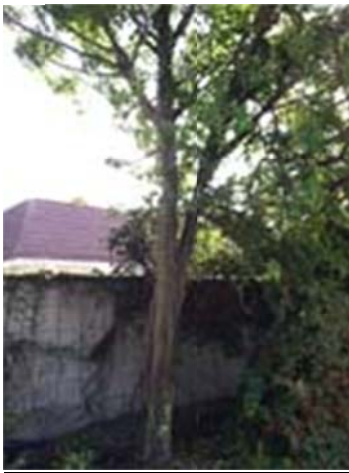
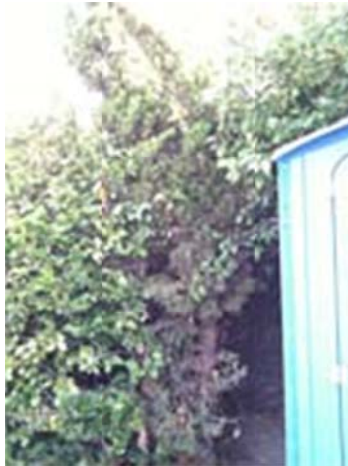
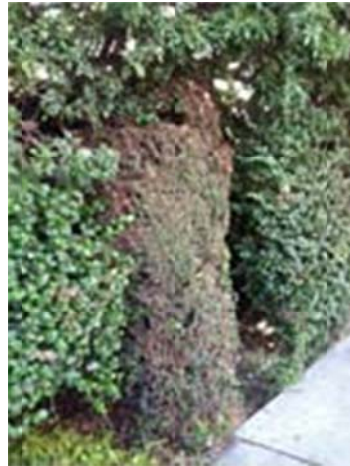
Site 98 through 105

This hedge is a mix of species that are not growing in harmony together. The Brazilian Peppers are aggressively shading out the other species. The Kaffir Plum trees are serving their purpose as a hedge, but the junipers are being overrun and shaded out.

The Carrotwood at site 105 is being invaded by a creeping vine that should be pulled down from the trunk. All of these trees should be maintained for sidewalk clearance. They will be a challenge to maintain because there is a barbed wire fence underneath them, and crews will have to prune the Eastern and Western sides separately.

There is significant deadwood that could be cleaned out for aesthetic purposes, but if cost is an issue, the hedge can still serve its landscape function without removing the deadwood.

If the wall behind the hedge is going to be replaced, then these trees should not be aesthetically pruned because they will likely need to be removed to install the wall. A decision to prune these trees should wait until after the decision to install the wall is made.

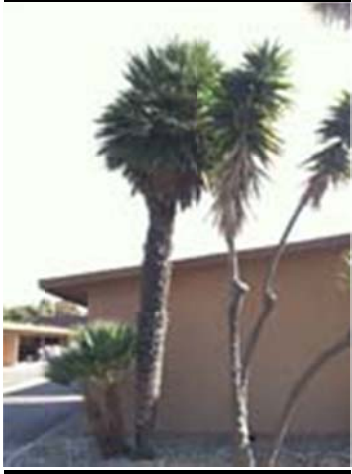
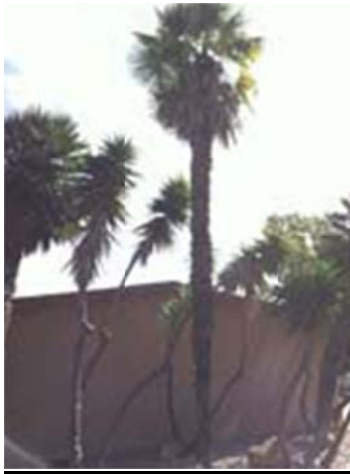
Site 106 through 108

These three palms are slated for removal because of their damage to the concrete in the adjacent parking structure. If these trees were to be retained, they would need to have their dead fronds removed annually for aesthetic purposes.

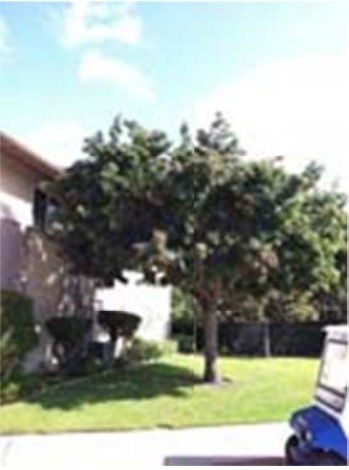
<p>Site 1 <i>Schinus terebinthifolius</i> - Brazilian Pepper</p> <p>This tree has decent form, but it will need to be maintained every 6 to 12 months for roof and sidewalk clearance.</p> <p>Maintenance: 40 min. Next Service: now Priority: high</p>

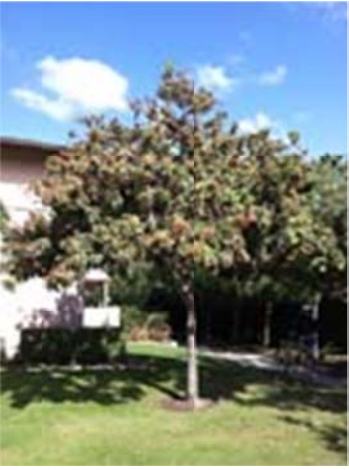
<p>Site 2 <i>Schinus terebinthifolius</i> - Brazilian Pepper</p> <p>This tree has good structure but the foliage is looking a bit sparse. The tree has been aggressively pruned the past and is currently in recovery mode. The tree should be allowed to grow into an even umbrella canopy. It should be monitored every 6 to 12 months for roof and sidewalk clearance.</p> <p>Maintenance: 20 min. Next Service: spring Priority: high</p>

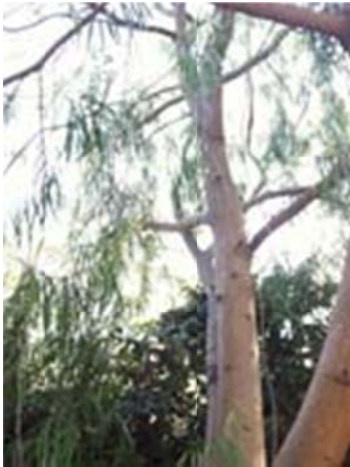
Site 3 through 12
Geijera parviflora - Australian Willow

These Australian Willows are a good choice for the landscape because they are low maintenance. There have been some improper cuts on the Eastern border of the mutual, and these cuts should be recut back to the parent stem. These trees should be pruned for sidewalk clearance lightly. There is also some minor deadwood that can be removed.

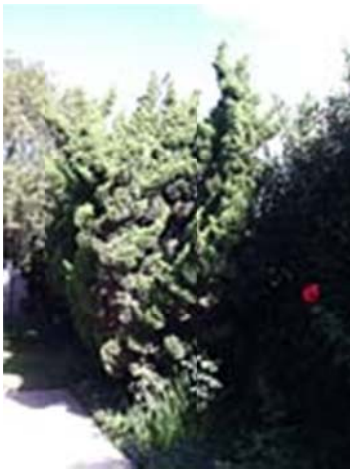
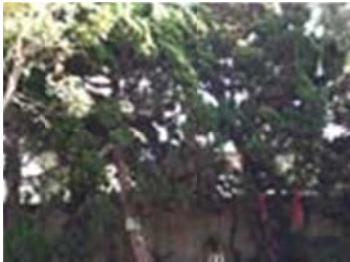
Site 15
Callistemon citrinus - Bottlebrush

This bottlebrush is beginning to grow into the Juniper hedge and it should be pruned back. It should also be maintained for roof clearance with the adjacent building. It has been aggressively pruned back in the past and is resprouting in response. The sprouts should be trained back to the strongest leaders to restore the tree to a healthy canopy. Because of the limited space, this tree will be a higher maintenance specimen than other Bottlebrush trees in the mutual because its drooping fringe will need to be pruned back from the junipers regularly.

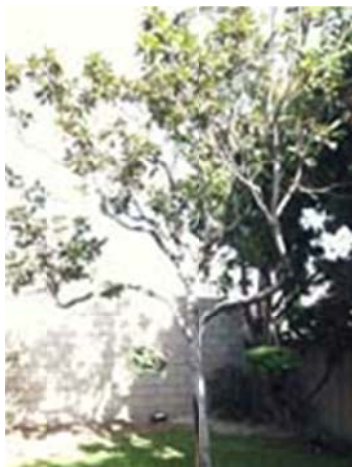
Site 21

There are two hanging pots in this tree, and the chains are doing minor damage to the bark. I recommend putting a soft padding beneath the chain to protect the upper side of the bark of the limbs that the pots are hanging from.

There is a large weeping site low on the Western side of the trunk that appears to have a fungal infection. The weeping site follows a crack that looks to be caused by torsional stress from wind loads. It is possible that the brush cherry hedge along the north wall created a wind tunnel effect, accelerating gusts of wind past the northern half of the tree and causing it to twist clockwise. This twisting action may have created a crack that subsequently became infected.

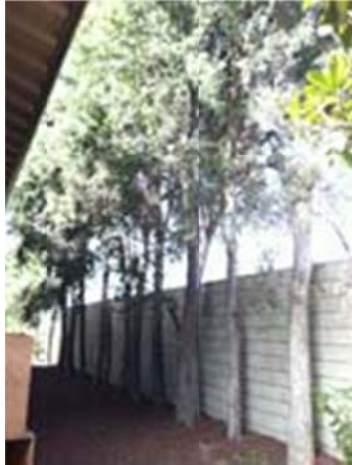
Site 22 through 35

This stand of brush cherry is still sufficiently functioning for its intended purpose of blocking the view of Northgate Road. However, a wall was recently installed behind them, and in order to install the wall, a trench was dug. This trench may have removed up to 40% of the root systems of each of these trees, predisposing them to decline and death. Since the installation of this wall was recent, the trees are not showing symptoms yet. It can take 2 to 5 years for root damage symptoms to manifest themselves in a canopy. Therefore, these trees can be retained until they decline and die. Then, they can gradually be removed one by one. When the whole stand has been removed, it can be replanted with a uniform hedge again. For now, these trees should be monitored for signs of decline.

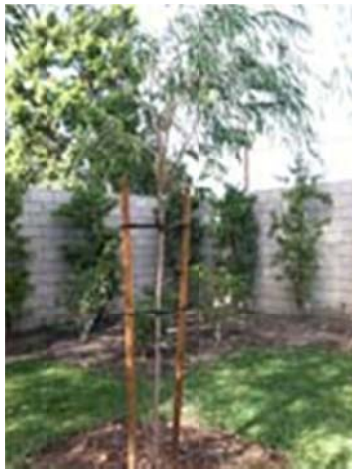
Site 37
Agonis flexuosa - Peppermint Willow

This tree needs to be re-staked immediately because the ties are causing damage to the trunk. Already, the trunk is warping due to the pressure the ties are putting on it. The ties are also constricting the vascular system of the tree like a tourniquet, reducing the tree's ability to transport water and nutrients to the leaves. The stakes should be moved further apart, and the ties should loosely support the trunk from falling over without putting any tension on it. The choice of nursery stock was not ideal because there is a small spring of foliage atop a spindly trunk, but it is possible for this tree to recover and grow out of this defect in form.

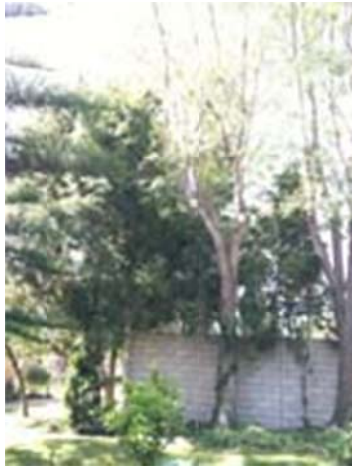
Sites 38 through 51
Multi-Species Hedge

This stand of trees contains Ash, Cupressus, and Brush Cherry. The biggest problem with this hedge is the recent installation of the wall behind them. The trench that was dug to install the wall must have cut 40% of the anchorage roots of all of these trees, predisposing them to falling to the East. It would not be wise to spend an excessive amount of money pruning these trees if they're only going to decline and die in the next 2 to 5 years. They should be monitored annually for signs of decline and then gradually removed one by one.

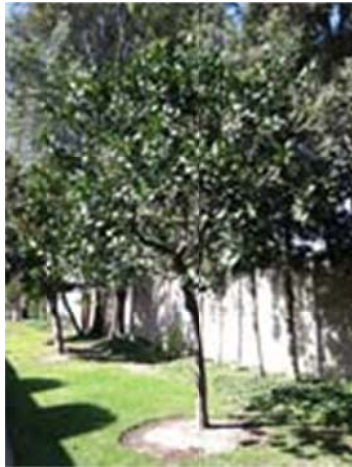
Site 53
Unknown Species

This tree is in good form and does not need any pruning at this time. It should be monitored for sidewalk clearance.

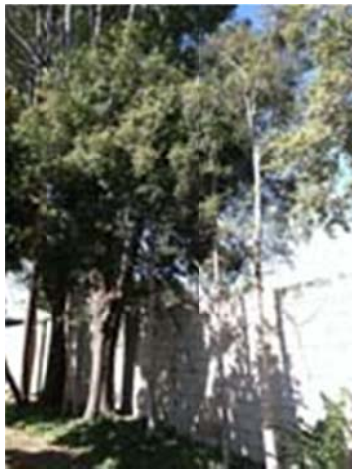
Sites 52, 54, 55, 56, 57, 58, 59, 60, 63
Syzygium paniculatum - Brush Cherry

This stand of brush cherry has a similar problem to the previous hedge. Up to 40% of each tree's root system may have been lost during the installation of the wall behind them. These trees should not be maintained too heavily because there is a likelihood that they will be declining and dying in the next 2 to 5 years. They should be removed as they die. Once the entire stand has been removed, a new uniform hedge can be planted here.

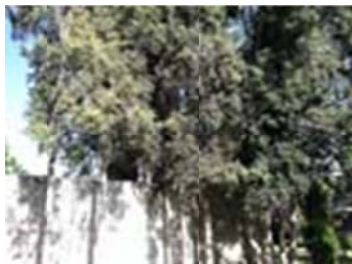
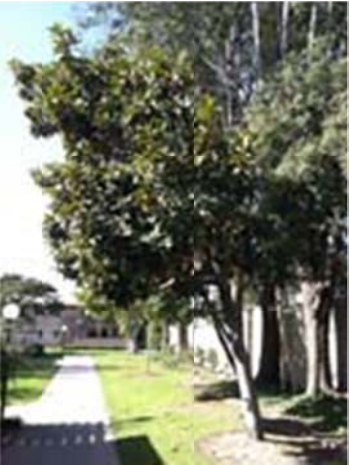
<p>Site 61 <i>Magnolia grandiflora</i> - Southern Magnolia</p> <p>This Magnolia's canopy is a bit lopsided away from the hedge to the North and is leaning towards the building to the South.</p> <p>It has been aggressively pruned back in the past and should be allowed to regrow a canopy on the North side. There is some bark loss on the top surface of some of the lateral branches, and there is a major tearout wound on the Western side of one of the branches. This tree should be lightened on the southern side and allowed to grow on the northern side to compensate for its lean.</p> <p>Maintenance: 30 min. Next Service: now Priority: medium</p>

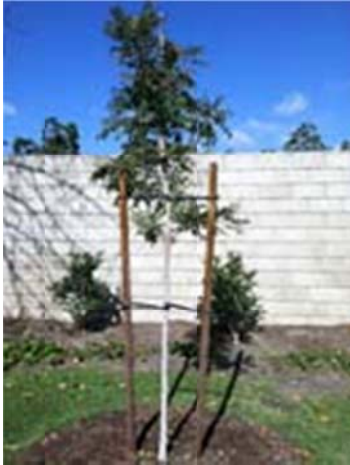
Sites 64 and 65

The ties on these Chinese Pistache trees need to be removed, and the trees need to be re-staked properly. The ties are cutting off circulation and causing long-term damage to the trunks of trees.

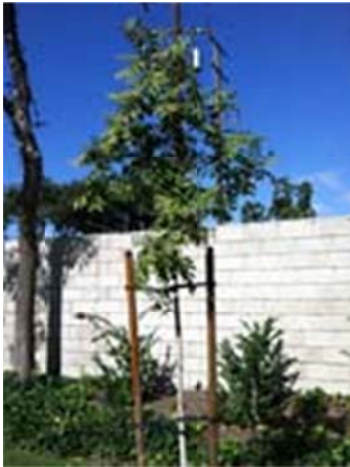
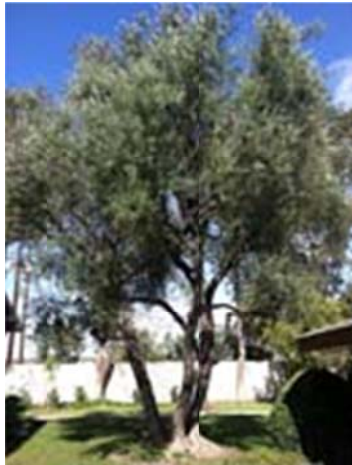
Site 74
Olea europaea - Olive tree

This olive tree was heavily pruned in the past, and the tipping wounds have put stress on the tree. In response, many shoots have sprouted from these tipping points, and they should be thinned to the strongest leaders to restore the tree to a viable structure. This tree will need to be pruned for roof clearance.

There is evidence of boring insect damage and Fusarium fungus infection. There are several weeping sites up and down the Western trunk. The Fusarium fungus is a localized fungus so it will not spread throughout the tree. However, if it were to girdle the trunk of the tree, it would restrict the flow of water and nutrients and the trunk would die back. This tree should be monitored for the advance of the boring insect infestation. If it becomes serious, then the tree should be removed before the insects can affect other trees in the mutual.

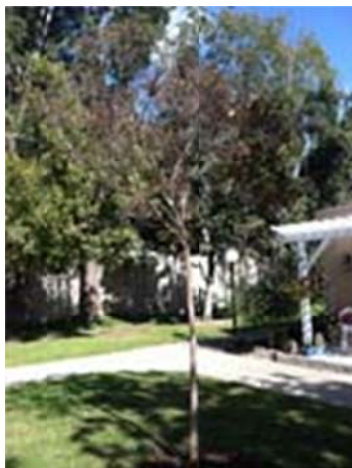
Site 75
Lagerstroemia indica - Crape Myrtle

This tree is well-chosen for this site because its roots are not invasive and its canopy does not get very large. This low-maintenance landscape tree does not need any pruning at this time.

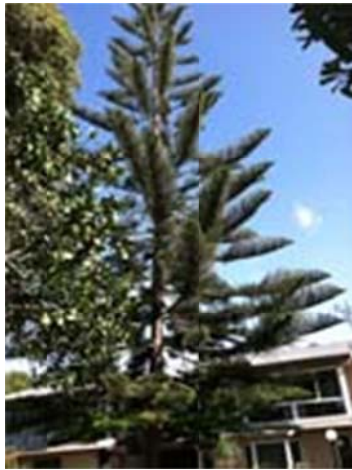
Site 77

Araucaria trees get tall, and this one is no exception. It will continue to grow for another 20 to 30 feet or more. The trunk should be monitored annually for the development of any defects that could turn this tree into a falling hazard.

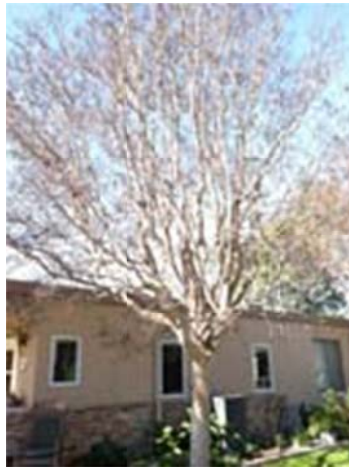
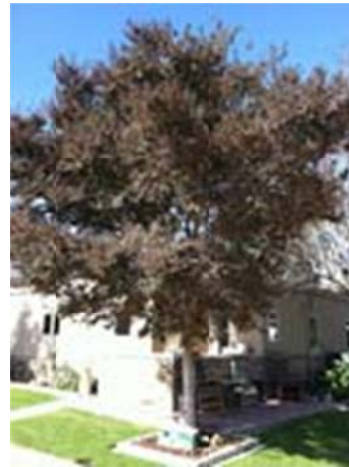
<p>Site 80 <i>Geijera parviflora</i> - Australian Willow</p> <p>This is a well-chosen species for this location because it is low maintenance. Some of its low fringe should be cut back away from the Palm. This tree originally had a co-dominant stem that was removed about a year ago, and some of that stem has become impounded in the bark of the main trunk. This wound serves as an entry point for decay, and it should be monitored annually.</p> <p>Maintenance: 5 min. Next Service: now Priority: low</p>

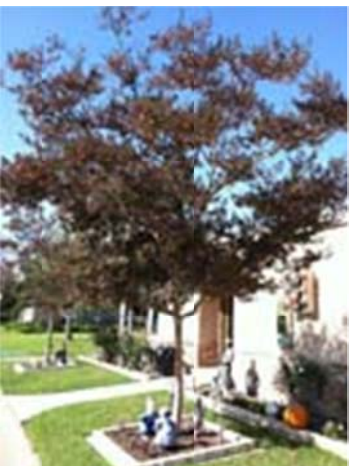
<p>Site 85 <i>Lagerstroemia indica</i> - Crape Myrtle</p> <p>This tree is a good choice of species for this location, and it does not need any pruning at this time. There are some garden tchotchkes beneath it that are being held up by wire that is tightly wrapped around two of the branches. The wire is constricting the vascular flow of water and nutrients in these branches. However, it should not be removed because it has already become impounded in the bark. Removing the wire would damage the bark that has grown around it, creating a larger wound that would become an entry point for disease and decay. The best course of action is to wait for these branches to die and then prune them out of the tree.</p> <p>Maintenance: 10 min. Next Service: spring Priority: low</p>

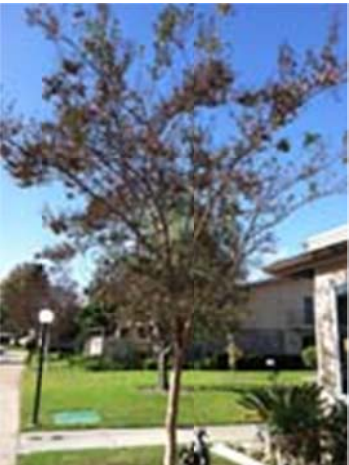
<p>Site 86 <i>Lagerstroemia indica</i> - Crape Myrtle</p> <p>This is a well-chosen tree for the site. There is one structural correction the needs to be made on this tree: a branch is crossing the main trunk. The tree should be monitored for roof and sidewalk clearance.</p> <p>Maintenance: 10 min. Next Service: now Priority: low</p>

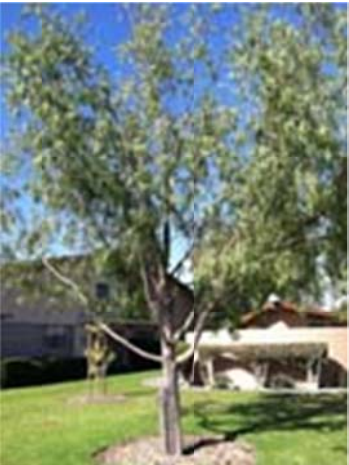
<p>Site 87 <i>Geijera parviflora</i> - Australian Willow</p> <p>This Australian Willow is infected with a bark fungus. If this bark fungus completely girdles any one of the trunks, then the stem will completely die back. However, the tree is not a hazard and it still provides aesthetic value to the landscape. Therefore, it can be retained until it begins to die.</p> <p>Maintenance: 15 min. Next Service: spring Priority: low</p>

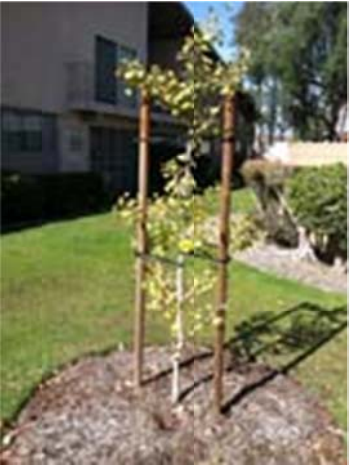
<p>Site 88 <i>Ginkgo Biloba</i> - Maidenhair Tree</p> <p>This ginkgo tree needs to be re-staked immediately. The ties are beginning to cause deformation of the trunk and are cutting off the supply of water and nutrients to the upper canopy.</p> <p>This was a good choice of nursery stock because there is branching nearly all the way to the ground. All of these branches should be retained as the tree grows because they will develop trunk taper which is necessary to evenly distribute the force of the wind as the tree matures.</p> <p>Maintenance: 20 min. Next Service: now Priority: high</p>

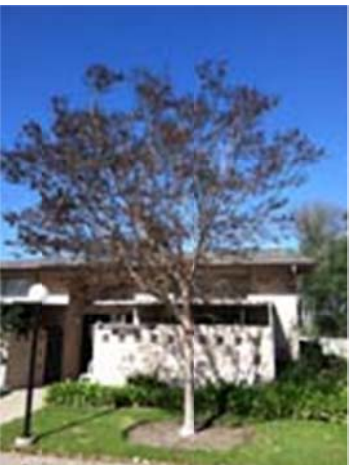
<p>Site 89 <i>Lagerstroemia indica</i> - Crape Myrtle</p> <p>This is a good choice of species for this location. It should be monitored for roof and sidewalk clearance.</p> <p>Maintenance: 10 min. Next Service: fall Priority: low</p>

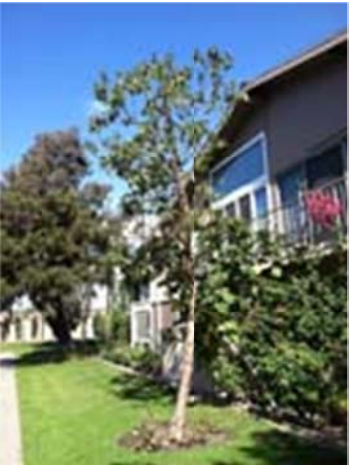
<p>Site 93 <i>Lophostemon confertus</i> – Brisbane Box</p> <p>This Brisbane Box tree may end up causing damage to the surrounding hardscape in the next 5 years. There is some deadwood that can be cleaned out of the canopy for aesthetic purposes. This tree has a prevailing lean to the East towards building 36 that could become a problem later in the tree's life. For now, it can be allowed to grow temporarily, but as it gets larger, it may need to be considered for removal.</p> <p>Maintenance: 5 min. Next Service: spring Priority: medium</p>

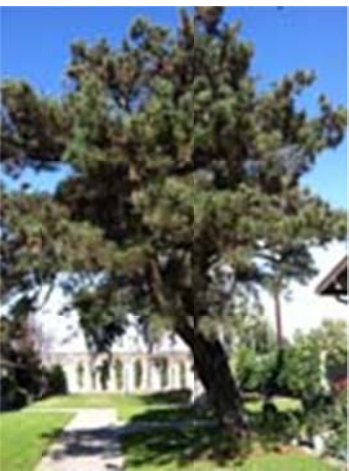
<p>Site 94 <i>Pinus radiata</i> - Monterey Pine</p> <p>This pine is an attractive landscape feature, but it was planted a bit too close to the building. It may end up causing problems to the hardscape. There are many sites up and down the trunk that are exuding sap. The pine should be monitored annually. If the weeping gets worse, then this may be indicative of a larger problem.</p> <p>In the short run, this tree can be sprayed with water to knock out the dead needles in the canopy. This will improve sunlight penetration, thereby increasing the tree's photosynthetic potential. It will also improve the tree aesthetically. There is some minor deadwood that can be removed.</p> <p>Maintenance: one hour Next Service: now Priority: low</p>

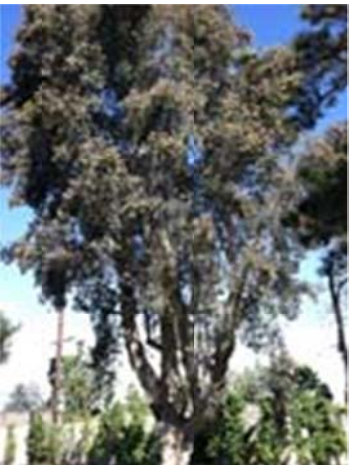
<p>Site 95 <i>Melaleuca quinquenervia</i> - Paperbark Tree</p> <p>This is a well-chosen species. The tree does not have ideal form because there are several co-dominant trunks, but there is a large enough angle of attachment that they do not pose a hazard at this time. The low hanging fringe should be pruned back for sidewalk clearance. This tree also has a prevailing lean to the West, and I recommend thinning some of the extreme tips on the Western side.</p> <p>Maintenance: three hours with climber Next Service: now Priority: medium</p>

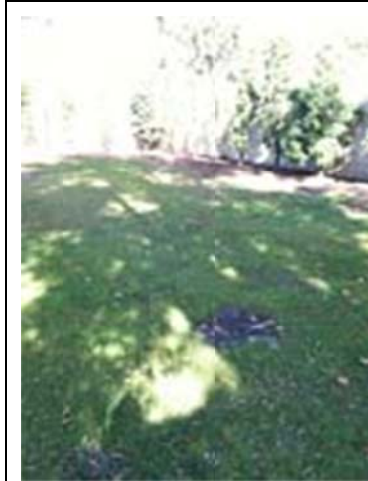
Site 96
Vacant Planting Site

This site should remain empty as long as the *Melaleuca* is alive. Planting a new tree here would cut significant anchorage roots for the *Melaleuca* tree. Rather, this planting site should be relocated about 30 feet to the north. There, a large shade tree can be planted without harming existing trees. Care should be taken to avoid the electrical line serving the light pole in the center of the open area.

If at some point in the future the electrical line is serviced, it may be advisable to relocate this light post closer to the sidewalk to make more room for the roots of a large tree to be planted here.

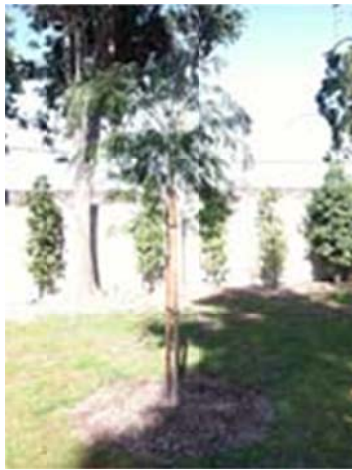
Site 97
Agonis flexuosa – Peppermint Willow

This tree should be re-staked immediately because the ties are beginning to cause trunk deformation and are cutting off the water and nutrient supply to the vascular system.

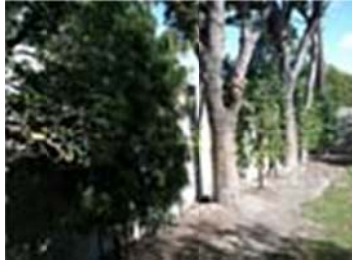
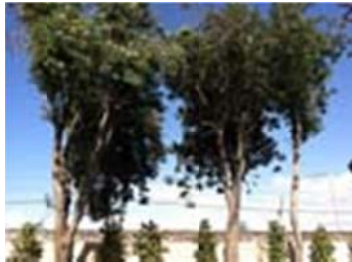
Sites 98, 99, 100
Fraxinus velutina - Modesto Ash

These three ash trees have suffered root cutting from the installation of the wall behind them. They are already beginning to show signs of decline, and there is deadwood in their canopies that should be pruned out before it self-prunes in a windstorm. On the ash tree at site 99, there is a significant load of dead English Ivy that is hanging in the canopy.

The ash tree at site 100 and has some significant foliage that is leaning over Northgate Road. This should be lightened before it cracks and falls over the street.

Since these three trees will likely be dead in 2 to 5 years, it does not make sense to prune them for aesthetic purposes. Rather, they should be pruned for safety until they gradually decline and die. At that point, they should be removed and replaced.

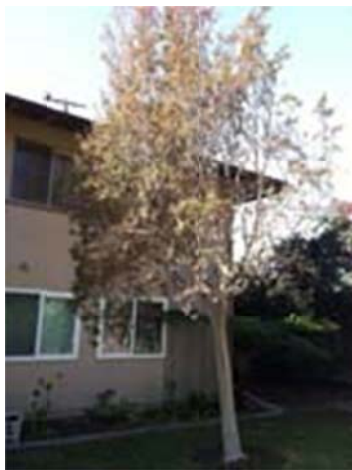
Site 101
Lagerstroemia indica - Crape Myrtle

This is a well-chosen tree for the site, and the tree appears to be doing well. It should be monitored for roof clearance annually.

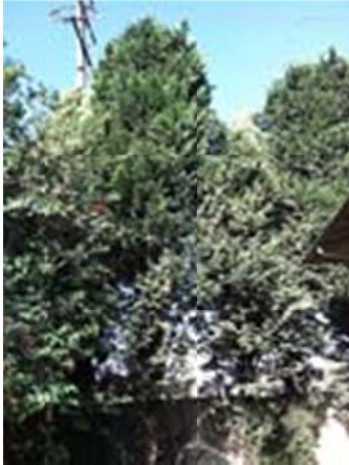
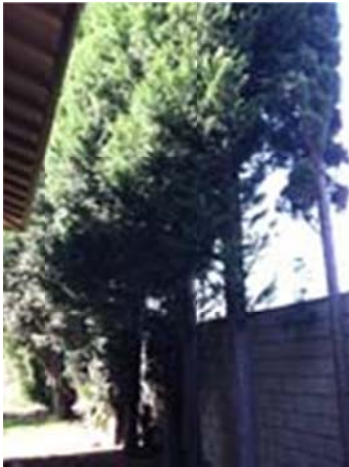
Sites 102 through 113
Thuja plicata - Red Cedar

The Cedars all have a similar problem to the other hedge trees: 40% of their roots have been cut to install the wall behind them. The root cutting symptoms may manifest themselves in the canopy over the next 2-5 years.

Another problem that these trees have is they are tall, excurrent species growing directly beneath power lines. Eventually they will run into problems with line clearance. If they grow too tall, the electric company will have to come through and top them with disregard to their health because the power company's responsibility is to maintain line clearance. This problem originated when these trees were planted – a species that is shorter at maturity should have been selected for this site.

There is some bougainvillea colonizing the canopies of these trees. If they are to be retained in the landscape, the bougainvillea should be removed.

It is likely that these trees will decline and die over the next five years, so it does not make sense to spend much time on maintaining them aesthetically. However, since the anchorage roots on the North side of these trees have been severed, they do pose a small hazard in a windstorm. My recommendation is to monitor these trees annually. If they show signs of decline, then they can be gradually removed one by one.

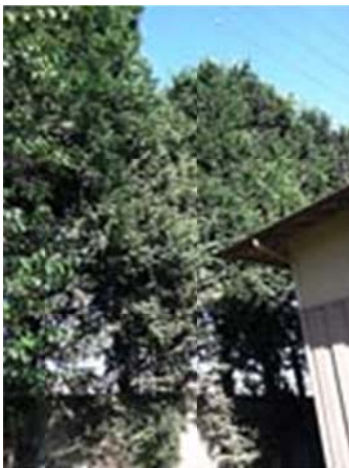
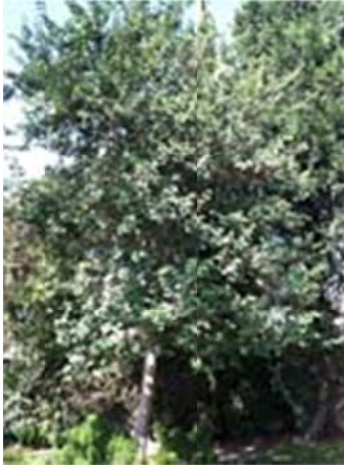
<p>Site 114 <i>Bauhinia x blakeana</i> - Hong Kong Orchid Tree</p> <p>This orchid tree is a good choice of species and appears to be doing well on site. There have been some improper cuts around the low fringe that should be recut back to the parent stem. There is also some interior deadwood that should be removed. Other than that, the tree doesn't need much maintenance at this time.</p> <p>Maintenance: 15 min. Next Service: winter Priority: low</p>

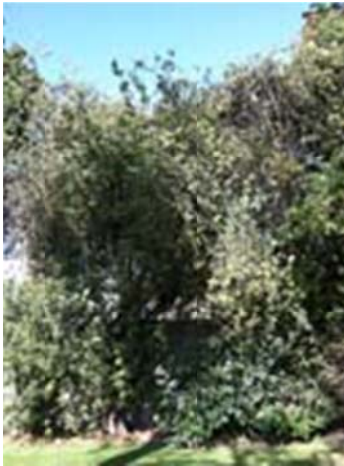
<p>Sites 117, 118, and 119 <i>Callistemon citrinus</i> - Bottlebrush</p> <p>These bottlebrush trees have a similar problem to the other trees along this wall. When the wall was installed, 40% of the trees' roots may have been cut which will eventually lead to their decline and death.</p> <p>There is already some deadwood in their canopies. I don't recommend putting too much work into these trees at this time because there is a good possibility they will be removed in the next 2 to 5 years. They should simply be maintained for head height clearance. They are being colonized by bougainvillea from the North side. If it is decided that they will be retained in the landscape, then the bougainvillea should be pruned out.</p> <p>Maintenance: 20 min. Next Service: spring Priority: low</p>

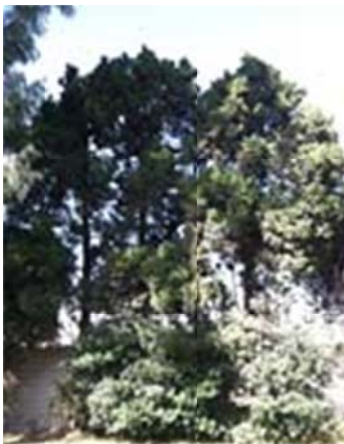
<p>Sites 120, 121, 122, and 123 <i>Thuja plicata</i> - Red Cedar</p> <p>The Cedars have the same problem that the other trees along the wall have. Up to 40% of the roots may have been lost during the installation of the wall. These cedars should be monitored for signs of decline but do not need any pruning at this time.</p> <p>Maintenance: zero Next Service: spring Priority: low</p>

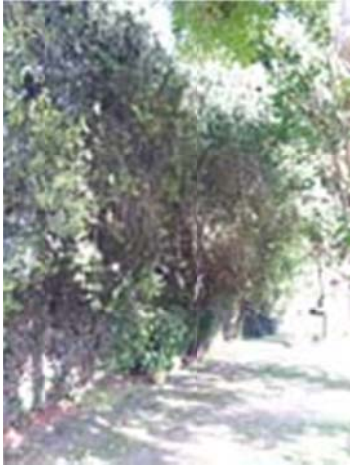
Site 124 through 127
Callistemon citrinus - Bottlebrush

These bottlebrush trees are likely going to suffer the same fate as the other bottlebrush trees along the fence line. Because much of their root system was lost, they are showing signs of decline. They should be pruned back for head height clearance, but not much else should be done at this time.

If they decline and die, they can be removed and then replaced with a uniform planting along the back wall.

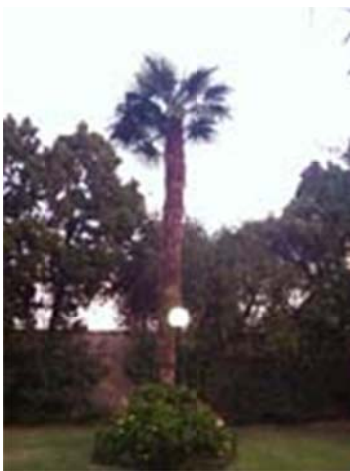
Site 128
Trachycarpus fortunei - Chinese Windmill Palm

This palm tree is in good form and should just have its dead fronds removed annually.

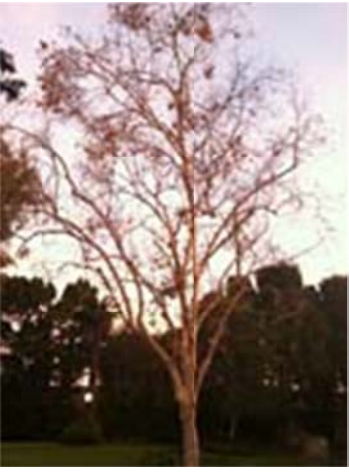
<p>Site 129 <i>Platanus racemosa</i> - California Sycamore</p> <p>This Sycamore has good structure, but it has been aggressively pruned in the past. It is now resprouting up and down its trunks in response. These new sprouts should be thinned to the strongest leaders to help the tree culture a new canopy.</p> <p>Maintenance: three hours with climber Priority: medium Next Service: fall</p>

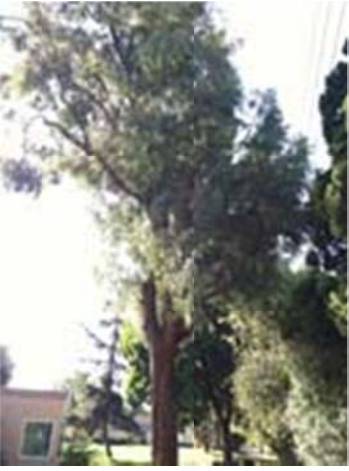
<p>Site 130 <i>Eucalyptus sideroxylon</i> – Red Iron Bark</p> <p>This tree is planted very close to the building and the sprinkler system. There is a possibility of damage to the foundation of the building in the next 5 to 10 years. This tree is also getting to be tall and is growing towards the power lines. Currently, it does not need to be pruned away from the power lines, but it should be noted that there will need to be some pruning for line clearance in the next couple years. This tree has good branching structure and does not appear to have any major defects that would predispose it to falling. It does not need any maintenance at this time, but it should be inspected annually.</p> <p>Maintenance: zero Next Service: fall Priority: medium</p>

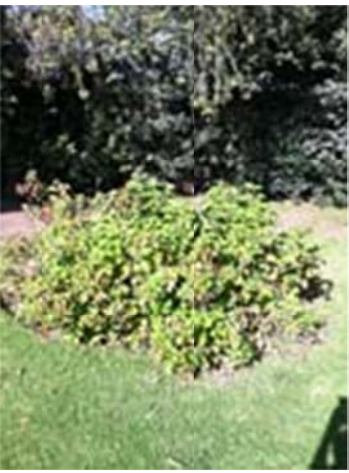
<p>Site 131 Vacant Planting Site</p> <p>This is the site of a former Red Ironbark Eucalyptus. Planting here in the short run will likely cause damage to the nearby Red Ironbark trees. It should remain vacant until the Eucalyptus at site 132 is removed.</p>

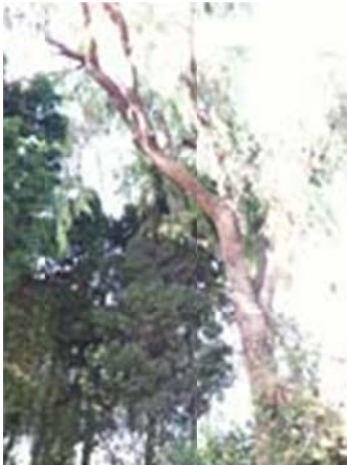
<p>Site 132 <i>Eucalyptus sideroxylon</i> - Red Ironbark</p> <p>This Eucalyptus tree is competing with the neighboring <i>Afrocarpus</i> tree. The limb that is going to the West over the upper part of this tree should be removed, and the dead limb below it should also be removed. This tree suffered major root loss when the rear wall was installed, and it poses a hazard of falling.</p> <p>If the tree is to be removed, then the pruning does not need to be done because it will be an excessive expense. However, if the tree is to be retained for longer than one year, then the pruning over the <i>Afrocarpus</i> should be done sooner rather than later.</p> <p>Maintenance: two hours with climber Next Service: now Priority: high</p>

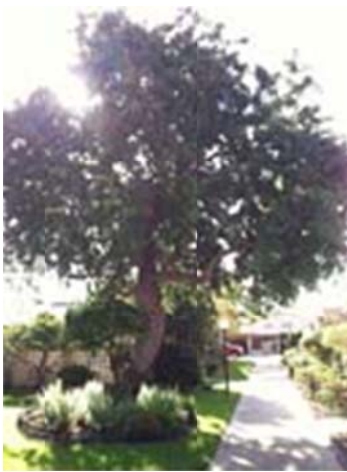
<p>Site 133 <i>Schinus terebinthifolius</i> - Brazilian Pepper</p> <p>This tree has good structure and should be maintained every 6 to 12 months for sidewalk clearance.</p> <p>Maintenance: 30 min. Next Service: spring Priority: high</p>

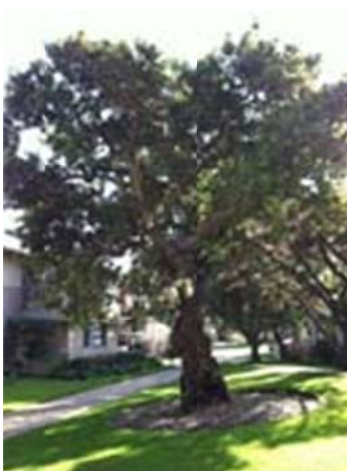
<p>Site 134 <i>Schinus terebinthifolius</i> - Brazilian Pepper</p> <p>This tree has aggressive resprouting as a result of a hard pruning in the past. The interior shoots should be retrained so that they do not compete with the more desirable upper canopy. The tree should also be pruned for sidewalk clearance every 6 to 12 months.</p> <p>Maintenance: 40 min. Next Service: now Priority: medium</p>

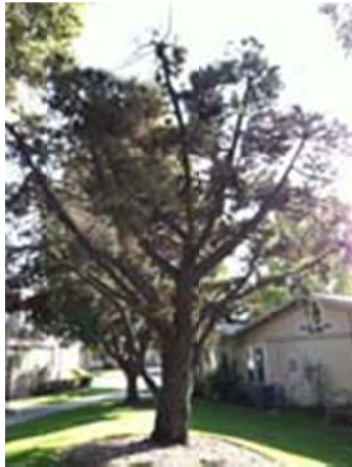
Site 135

Pinus radiata - Monterey Pine

This pine was severely pruned in the past, and this pruning will likely be the cause of the tree's death. Every branch was tipped, and pine trees are not tolerant of tipping cuts. There are several dead stumps in the canopy that should be recut back to the main stem. After deadwood is removed, the tree should be sprayed with water to remove the needles and improve light penetration in the tree. Spraying the tree with water has an added benefit of increasing the aesthetic beauty of the tree in the short run.

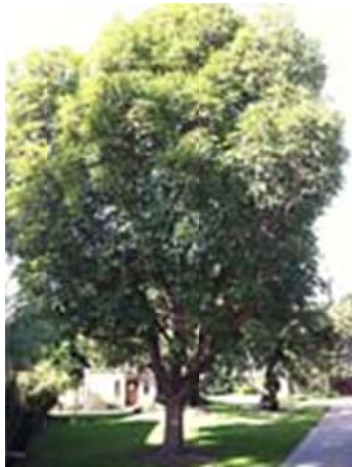
Site 136

Lophostemon confertus - Brisbane Box

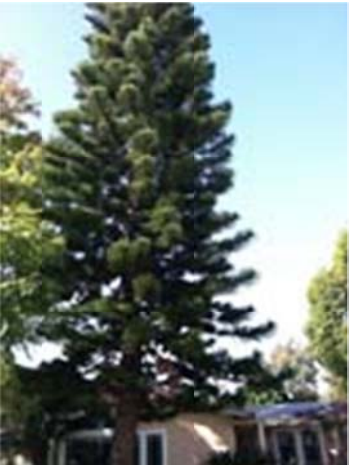
<p>Site 137 <i>Araucaria heterophylla</i> - Norfolk Island Pine</p> <p>This tree needs some minor deadwood cleaning for aesthetic purposes but does not need much pruning at this time. This tree has a prevailing lean to the West but is not showing signs of stress on the Eastern side of the trunk. The tree should be monitored annually for any signs of stress that may appear, but it can be retained until it shows a possibility of failure.</p> <p>If the tree were to fail, it appears that it would miss the adjacent building, but shareholders should be advised to not park near the tree during a windstorm.</p> <p>Maintenance: 10 min. Next Service: now Priority: low</p>

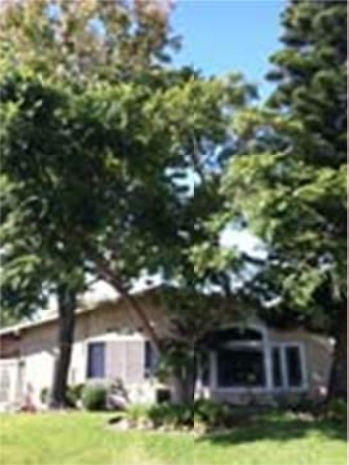
<p>Site 138 <i>Jacaranda mimosifolia</i> - Jacaranda</p> <p>This Jacaranda has some structural issues that need correcting. Is also a fast grower and its low fringe should be maintained annually. It is beginning to compete with its neighboring <i>Araucaria</i> and <i>Liquidambar</i>. There is a large trunk that is growing out to the South over the sidewalk that looks to be gaining too much weight and cantilever. This fringe should be thinned to reduce the likelihood of failure.</p> <p>Maintenance: one hour Next Service: now Priority: medium</p>

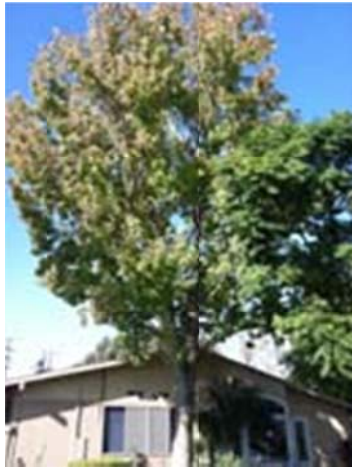
Site 139

Liquidambar styraciflua - Sweet Gum

The tree has a major weeping site at the intersection of two major trunks approximately 10 feet up. This weeping site is indicative of stress. What is likely occurring is the two major trunks are oscillating back and forth in the wind and causing the branch union to pull apart, creating a wound site that is not able to heal. This weeping site is an early warning sign of the potential failure of one of the trunks. The trunk that will likely fail first would be the one to the North West. This trunk could fail and cause significant damage to building 38. Therefore I recommend that a safety line be installed approximately 2/3 of the way up the canopy to support this trunk if it were to fail. The safety line would not prevent the failure of the trunk, but it would mitigate any damage that would occur because the trunk would be held to the remaining portion of the tree until emergency responders were able to safely dismantle it.

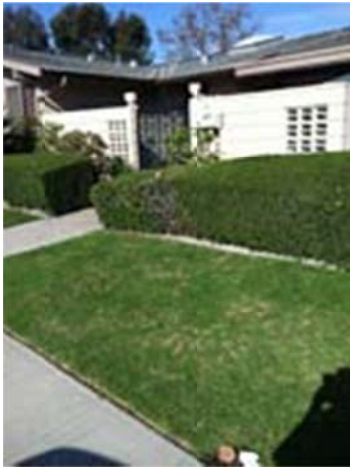
Site 141
Vacant Planting Site

This site is too small to plant a tree and should be left empty.

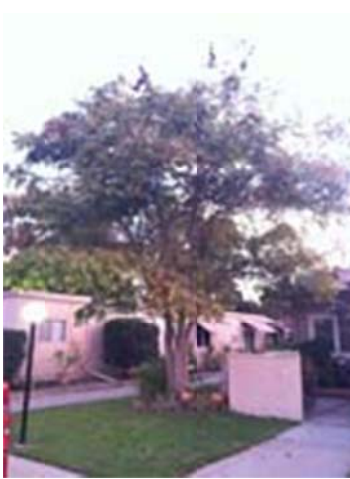
Site 142
Koelreuteria paniculata - Golden Rain Tree

This tree is planted too close to the patio, and the patio may experience some root heaving over the next 5 to 10 years. This tree should be maintained for head height clearance over the patio and the sidewalk. There is some deadwood in the canopy that can be removed for aesthetic purposes.

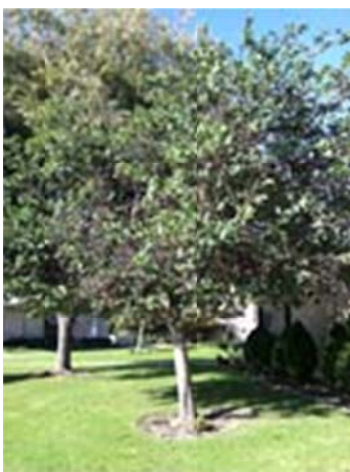
Site 143
Bauhinia x blakeana - Hong Kong Orchid Tree

This tree has a few minor structural issues that should be corrected with rubbing and crossing branches. There is also some deadwood that should be removed. There are some sprouts that are beginning to compete with the general canopy that should be removed.

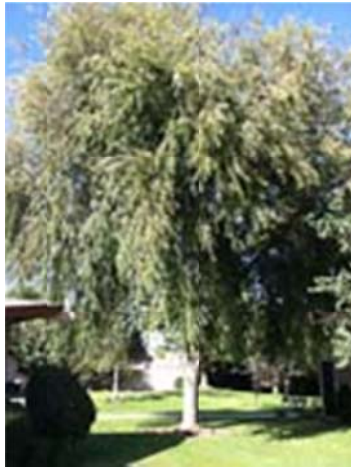
Site 144
Salix babylonica - Weeping Willow

This Weeping Willow is planted too close to the buildings. It will gradually cause problems with its roots because the species is known to be very root aggressive. This tree also has had problems with roof clearance of the nearby building, and previous pruning crews have left stump cuts. These stumps need to be recut back to the parent stem, otherwise the tree will not be able to heal them. This tree is also beginning to compete with the understory orchid tree, and the branch that is competing with that orchid tree should be removed. The low fringe of this tree will need to be maintained annually.

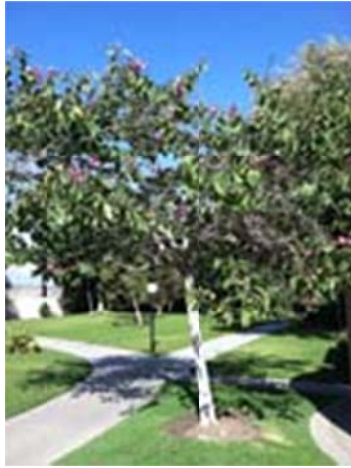
Site 145
Bauhinia x blakeana - Hong Kong Orchid Tree

This orchid tree needs to be pruned back for sidewalk clearance. There is also some deadwood in the canopy that should be removed for aesthetic purposes.

Further up the trunk, there is another weeping site. This site is indicative of a boring insect that has transmitted the Fusarium fungus. This tree should be monitored for the spread of this disease, and if more weeping sites appear, it may need to be removed.

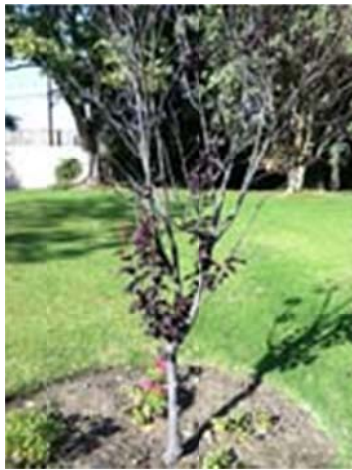
Site 147

Prunus cerasifera - Purple Leaf Plum

This tree is languishing because it is receiving full afternoon sun. Its exposure is likely causing the foliage to cook in the summer heat. It is possible that this tree will die and need to be replaced. However, at this time no pruning is necessary.

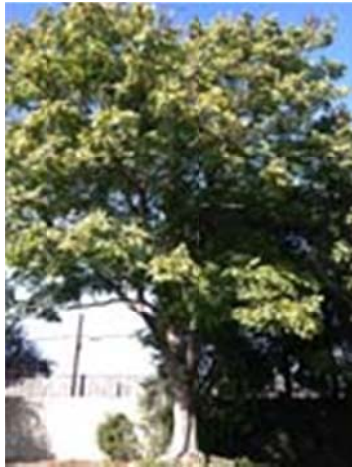
Site 149

Koelreuteria paniculata - Golden Rain Tree

There is a staghorn fern that is nailed to the trunk. Inserting nails in the trunk of a tree create sites that predispose the tree to decay organisms. Decay can enter through the interface between the nail and the wood and eventually spread through the heartwood of the tree. Annual inspection is necessary to ensure that a record is kept of the status of decay in this tree.

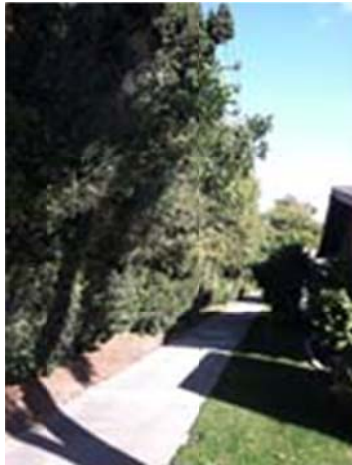
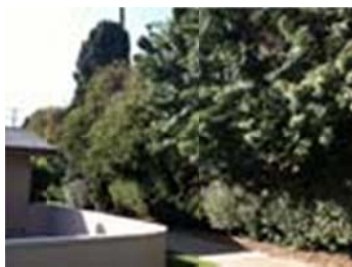
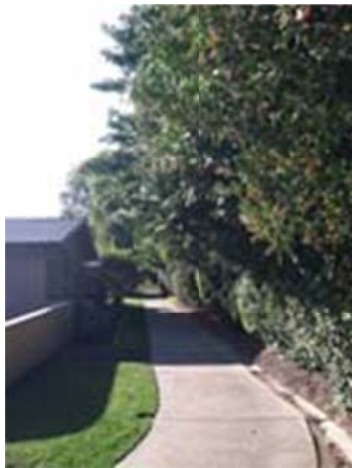
Site 157 through 186 Multi-Species Hedge

Following the major root cutting from the installation of the wall, many of these trees have become potential hazards. The hedge should be maintained for sidewalk clearance every 3-6 months. Further aesthetic pruning does not make sense until a decision is made about retaining or removing the trees along this wall.

Therefore, the shareholders living near the back wall should be involved in the decision-making to remove and replace the trees along the back wall. They should be informed that these trees are now a hazard and will need to be replaced with a new hedge. This process can be done gradually or all at once. Currently, most of the trees appear healthy and do not appear to be in any imminent danger of failing. However, there is a reasonable likelihood that there will be more failures along this hedge over the next two years. It is recommended for the board to consider gradual removal of these affected trees.

No aesthetic pruning should be conducted until a decision is made on the future strategy of the maintenance of this back wall. If no pruning is done and the trees are intended to be kept, then the shareholders will have to deal with aesthetic issues such as deadwood. If the trees are pruned aesthetically and then it is decided that they will be removed, then the funds used to prune them will have been wasted.

A separate estimate should be written up for the treatment of this hedge after a decision by the board.

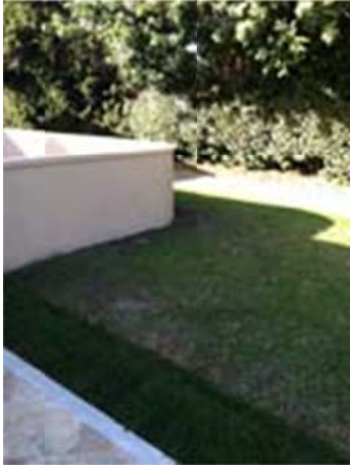
Site 187
Vacant Planting Site

The homeowner has recently expanded his patio into this planting space and there is now no longer room for a tree.

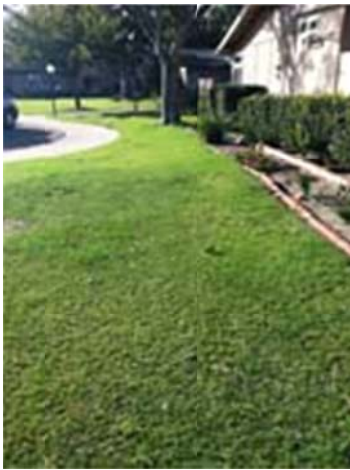
Site 188
Vacant Planting Site

There's not much space for a tree here because of its proximity to the electrical box. I recommend leaving this site empty.

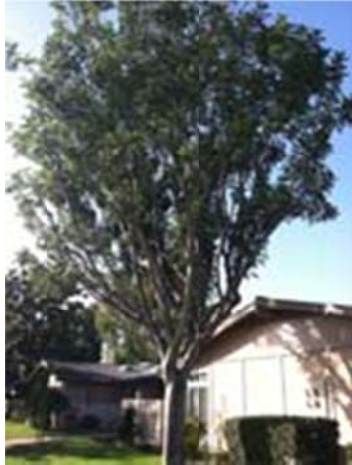
Site 189
Cupaniopsis anacardioides - Carrotwood

Some minor correctional cuts should be made to remove the interior sprouts and keep them from competing with the general canopy. This tree does not have ideal form because it has many leaders without much lateral branching.

There is significant fluting on the North side of the tree which may indicate that there was severe root damage in the past. It is possible that major roots were cut on the North side of the tree, and this may have caused decay to develop on the interior the tree. Since then, the tree has rolled a cambium callous over this die back. However, if the cambium completely covers this cavity, it will still exist as a defect on the interior of the trunk, invisible on the outside. This may make the tree hazardous in the future. The tree does not need to be removed at this time, but it should be noted that there may be an interior defect. This defect may limit the tree's lifespan to another 5 to 10 years.

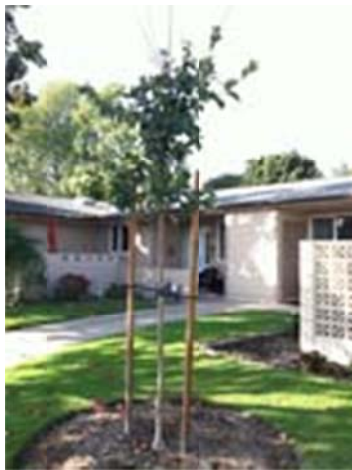
Site 190
Unknown Species

This tree needs to be re-staked immediately. The ties are tightly wound around the trunk of the tree and are restricting the flow of water and nutrients to the canopy. This nursery stock should have been rejected at the nursery because it only has foliage in the upper one third of the canopy. This leaves a long spindly trunk that is susceptible to breakage in wind. There is no foliage low on the trunk to help the tree develop trunk taper that is necessary for it to be able to stand on its own.

This tree stands a pretty good chance of growing out of its structural defects, so it can be retained. However, it should be monitored quarterly after being re-staked.

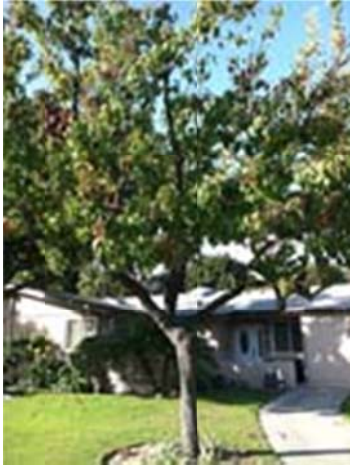
Site 191
Pyrus kawakamii - Evergreen Pear

This tree was aggressively pruned in the past, and the pruning wounds are likely how the tree acquired fire blight. Fire blight will eventually be the cause of the tree's death, but until then, the tree can be retained by removing symptomatic tissue every year. When pruning this tree, the arborists should disinfect their tools in bleach between cuts to prevent the spread of the disease to other trees in the mutual.

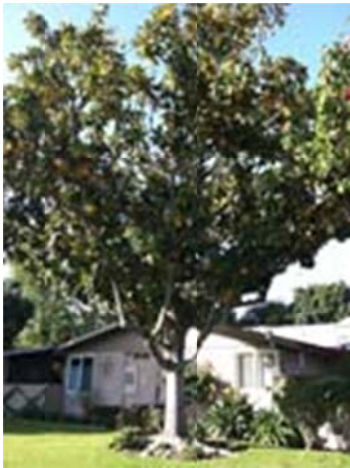
Site 192
Magnolia grandiflora - Southern Magnolia

This Magnolia tree does not have ideal form because it does not have a single leading trunk. However, this is not a fatal flaw of this tree; it can be grown as a hybrid single/multi-trunk specimen, but it will have a shorter eventual lifespan. The foliage in the upper canopy looks a bit sparse, and the tree should be allowed to regrow its canopy. It should be maintained only for roof clearance and contact with any neighboring trees.

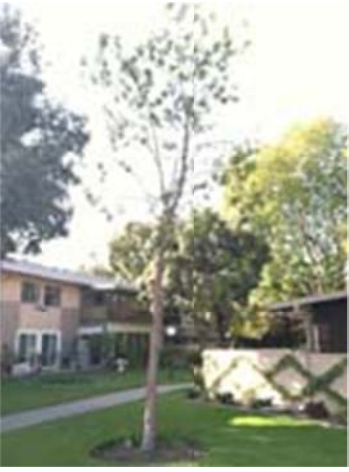
<p>Site 194 <i>Lophostemon confertus</i> - Brisbane Box</p> <p>This tree has a bit of deadwood that should be removed for aesthetic purposes. It appears to be languishing because of the shade of the New Zealand Christmas Tree to the West.</p> <p>Maintenance: 20 min. Next Service: now Priority: low</p>

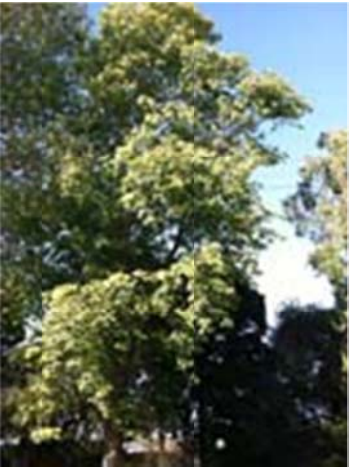
<p>Site 195 <i>Fraxinus velutina</i> - Modesto Ash</p> <p>This ash tree is far enough from the wall that it has retained most of its structural roots. However, it should still be monitored for any problems that may manifest themselves in the canopy over the next 2 to 5 years. There are some major branches that are leaning to the west that should be removed. They are high in the canopy and will require significant time spent by a climber.</p> <p>There are no major defects in the trunk, and this tree can be expected to have some more time in the landscape.</p> <p>Maintenance: four hours with climber Next Service: winter Priority: medium</p>

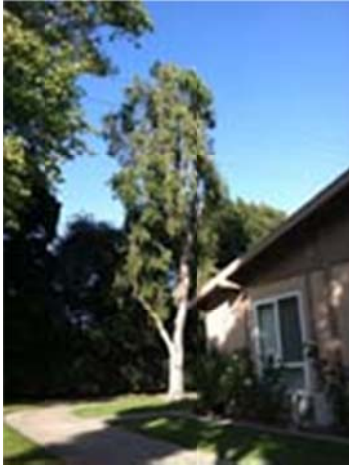
Site 196

Callistemon viminalis - Bottlebrush

There is a major tearout on the southern side of the main trunk of this tree. This injury should be monitored for decay. If decay advances, then this tree may need to be taken out. However, it appears that a cambium callous is starting to roll over the wound and close. If the wound closes, then the tree will be able to continue in the landscape.

The tree has two co-dominant stems, and it appears to have had a third co-dominant stem that was removed a few years ago. This means that there is a significant weak point approximately 5 feet up the trunk. This could predispose the smaller trunk to fail towards the West. There is no target below this trunk, and it can be allowed to fail. If it does, arborists can clean up the wound on the tree and evaluate whether the remaining portion of the tree is safe to remain in the landscape.
