TREE INVENTORY

Prepared for
LEISURE WORLD MUTUAL 15
SEAL BEACH

Prepared by
JAMES KOMEN – CLASS ONE ARBORICULTURE
ISA CERTIFICATION #WE-9909A
(818)495-5344
CLASSONEARBORICULTURE@GMAIL.COM
DECEMBER 1, 2013

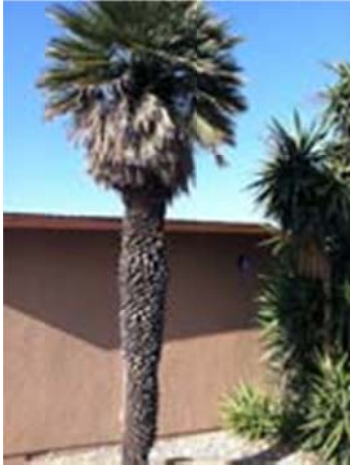
Site 197 198 199 200
Trachycarpus fortunei - Chinese Windmill Palm

The first three Chinese Windmill Palms are acceptable in the landscape. They will need to be maintained annually to remove their dead fronds for aesthetic purposes. The Palm at site 200 has a severe lean to the West and should be considered for removal.

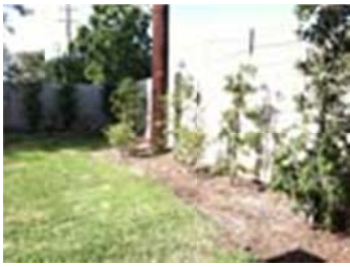
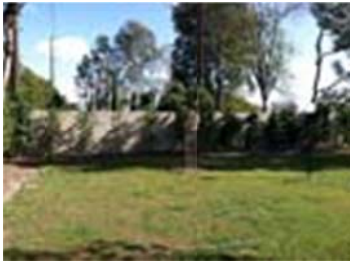
Podocarpus Hedge
Podocarpus gracilior - Fern pine

This stand of *Podocarpus* trees was a poorly chosen species for planting next to a wall because *Podocarpus* trees are known for their root aggressiveness. If allowed to grow much larger than the height of this wall, these trees will eventually cause damage to the irrigation system and the wall behind.

They are all tightly tied to stakes that are pressed up against the trunks. All of these stakes should be removed, and the trees that are not able to stand on their own should be re-staked properly, allowing freedom to move in the wind. Every year, these trees must be reduced at their top to minimize the size of pruning wounds. Large pruning wounds will be detrimental to the health of the trees and serve as entry points for decay organisms. These trees can be grown into an attractive hedge, but the hedge will be relatively high maintenance.

Each of these trees should be pruned immediately to reduce their height.

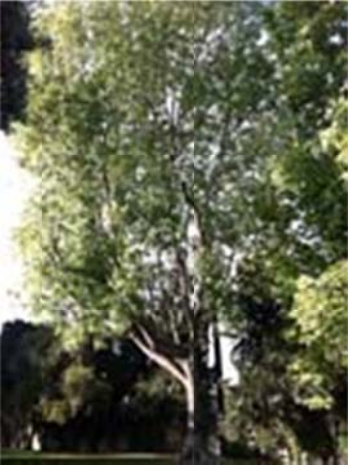
<p>Site 1 <i>Fraxinus uhdei</i> – Shamel Ash</p> <p>This ash tree is fairly close to the back wall, and many of its roots may have been cut. It is possible that this ash tree has sustained significant damage, though not as bad as the trees immediately against the wall.</p> <p>The tree has some stumps that need to be recut back to the parent branches. The tree should also be kept away from the power lines in the long term. There is a slight imbalance of the canopy towards the South because the tree has been pruned so heavily away from the power lines in the past. To compensate for this, foliage from the southern side of the tree should be thinned to reduce the weight on the southern half of the tree. If there is too much weight on the southern half of the tree and not enough anchorage roots on the North side of the tree, then the tree will be predisposed to falling to the South. There is a large branch on the South Eastern side that is curving into the canopy of the neighboring Shamel Ash. This branch should be removed.</p> <p>Maintenance: six hours with climber Next Service: winter Priority: low</p>

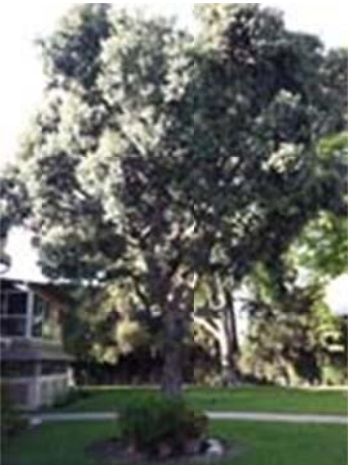
<p>Site 2 <i>Metrosideros excelsus</i> - New Zealand Christmas Tree</p> <p>This tree was pruned hard and is now currently recovering. Live foliage should not be removed from this tree at this time. The fibrous structures in the canopy are aerial roots that the tree produces to supply more water to its vascular system. The aerial roots close to the trunk of the tree can be retained, but the aerial roots that are further from the trunk should be pruned if they get down into the head clearance zone.</p> <p>Maintenance: 15 min. Next Service: fall Priority: low</p>

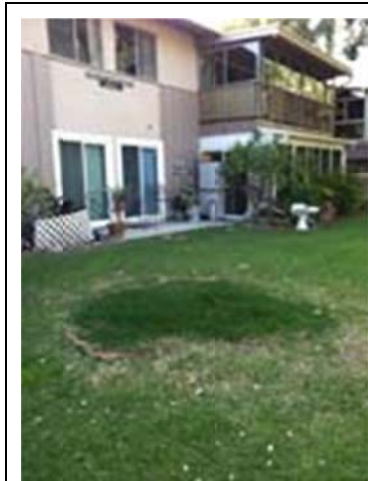
Site 3
Vacant Planting Site

This would be an excellent opportunity to plant a matching New Zealand Christmas Tree between sites 2 and 4. This site is shaded by building 42 in the afternoon and by the neighboring New Zealand Christmas Tree to the South. This would also be a good spot for a Japanese maple because it is protected from the hot summer afternoon sun

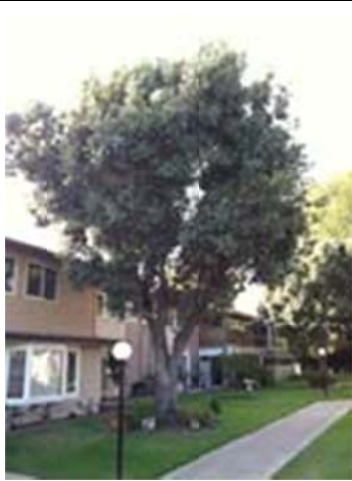
Site 4
Metrosideros excelsus - New Zealand Christmas Tree

This tree needs to be pruned for roof clearance. There are aerial roots that can be left alone until they grow down into the head height clearance zone. Except for roof clearance, live foliage does not need to be removed from the canopy at this time.

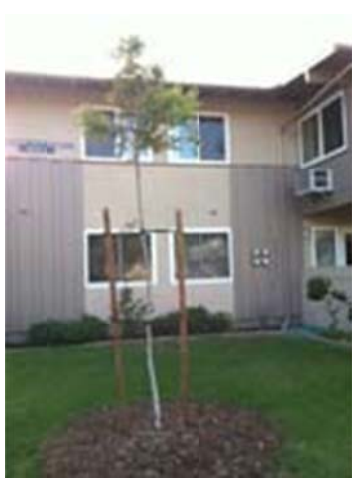
Site 5
Pistacia chinensis - Chinese Pistache

This tree should have been rejected the nursery. It has a long, spindly trunk with a small sprig of foliage at the top. The trunk is also being deformed by its ties. These ties are cutting off the circulation to the tree because they are so tight. This tree should be re-staked properly, giving it room to move in the wind. It is possible that this tree will die in the next year and to need to be replaced. Many of the branches have been tipped unnecessarily, further stressing the tree.

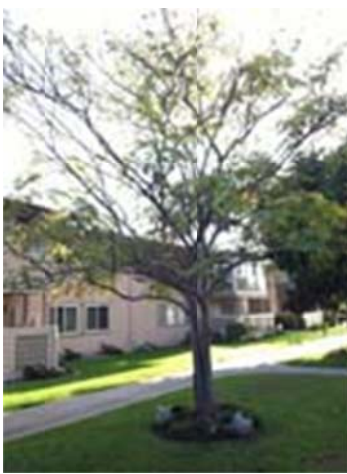
<p>Site 7 <i>Koelreuteria paniculata</i> - Golden Rain Tree</p> <p>This tree appears to be struggling in the same manner as its neighbor at site 6. The interior deadwood should be removed for aesthetic purposes. The tree should be monitored quarterly to see how symptoms develop. There is some dieback at the tips of many of the leaves that appears similar to leaf scorch. However, where scorch affects the leaf margins, this dieback is beginning at the tips and following the veins of the leaves. This tree should be monitored quarterly to see how symptoms develop, and perhaps a diagnosis can be made at a later time.</p> <p>Maintenance: 40 min. Next Service: now Priority: low</p>

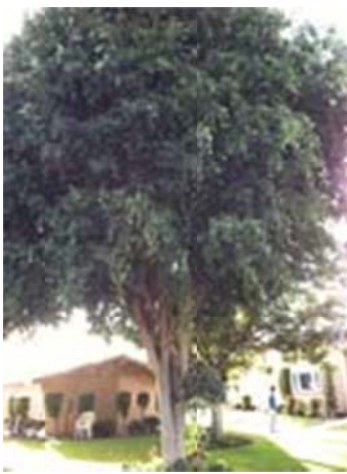
<p>Site 9 <i>Ficus benjamina</i> - Weeping Fig</p> <p>This fig is going to cause problems with the sidewalk and nearby building foundations. <i>Ficus</i> trees are known to have aggressive roots that can lift and buckle hardscape. Furthermore, <i>Ficus</i> trees are aggressive growers and need to be pruned frequently.</p> <p>If the tree is to be retained, the fringe will need to be pruned every year. The <i>Ficus</i> tree is beginning to compete with the nearby Carrotwood, and it is shading out its neighboring pine.</p> <p>Maintenance: two hours Next service: now Priority: medium</p>

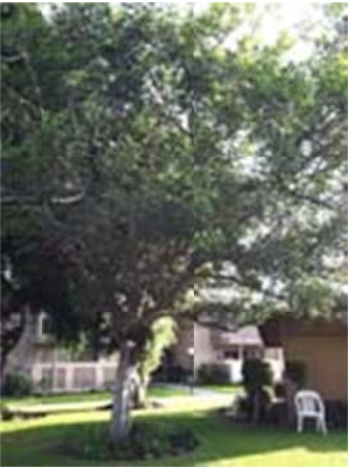
<p>Site 10 <i>Cupaniopsis anacardioides</i> - Carrotwood</p> <p>This Carrotwood needs to have its interior shoots removed before they compete with the outer canopy. It should also be monitored for roof and sidewalk clearance. It is being shaded out by the neighboring <i>Ficus</i> trees, and it will grow better when they are removed.</p> <p>Maintenance: 20 min. Next Service: now Priority: low</p>

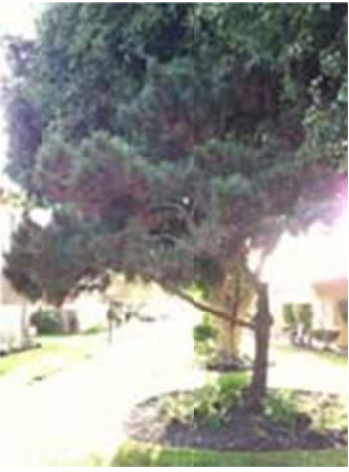
<p>Site 11 <i>Pinus radiata</i> - Monterey Pine</p> <p>This pine is being crowded out by the <i>Ficus</i> trees. It is forced to grow into heavy cantilever to the South East to get its light. This tree will likely fare better after the <i>Ficus</i> trees are removed. Short term maintenance should be spraying the canopy of this pine with water to remove the dead needles and improve sunlight penetration. A wash-down will also improve the aesthetic appearance of the tree.</p> <p>Maintenance: 20 min. Next Service: now Priority: low</p>

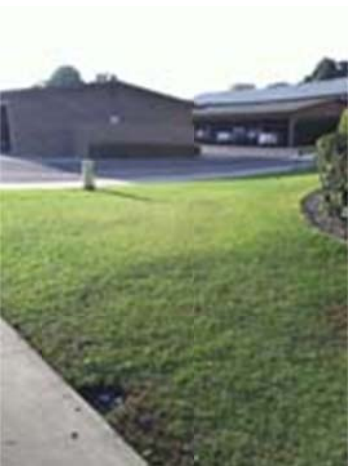
<p>Site 14 Vacant Planting Site</p> <p>There is plenty of room at this site for a medium size tree. I recommend a matching Magnolia or a pepper tree. Care should be taken when digging around the water main.</p>

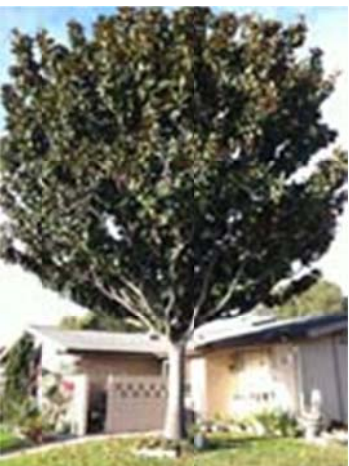
<p>Site 15 <i>Magnolia grandiflora</i> - Southern Magnolia</p> <p>This Magnolia has a beautiful, full canopy. However, its structure is not ideal. It has many trunks emanating from a single point approximately 8 feet up the trunk. This will ultimately make the tree more susceptible to tearout and wind throw. This defect originated in the nursery when the tree was pinched at a particular height and allowed to re-sprout from that point. Each of those resprouts have since grown into mature trunks that compete with each other for light. This has made the tree grow into the lollipop shape that it is in today. Not much can be done to correct the structure at this point in the tree's life. Rather, the tree should be allowed to grow for several more years, and then it will eventually have to be removed.</p> <p>Maintenance: 20 min. Next Service: fall Priority: low</p>

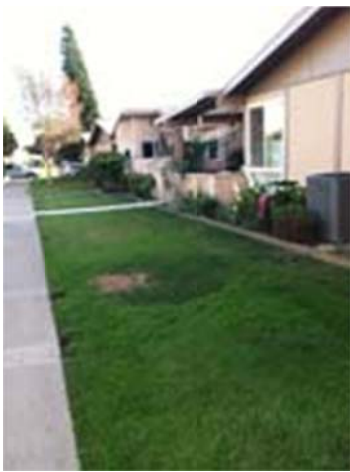
Site 17

This site receives shade from the Western afternoon sun. It would be a good site for a diminutive species with low root aggressiveness that needs protection from the sun such as a Purple Leaf Plum.

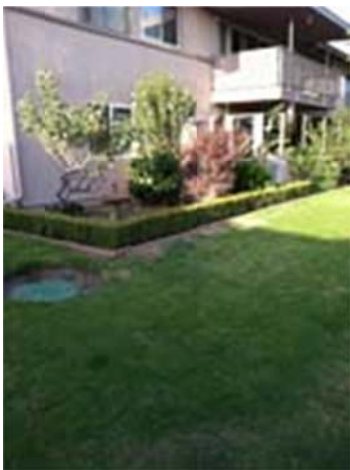
Site 18

This site is next to a sewer manhole cover and is not recommended for planting. Leave this site empty.

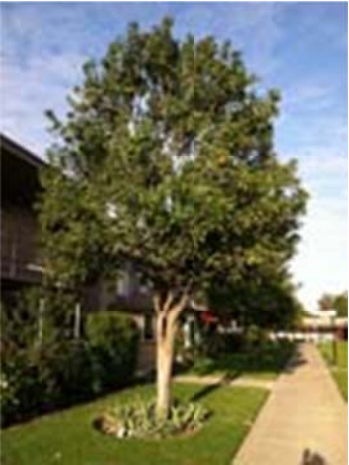
<p>Site 19 <i>Macadamia integrifolia</i> - Queensland Nut</p> <p>This tree has a borer infestation. There are several weeping sites up and down the trunk that are indicative of a boring beetle and the Fusarium fungus. This fungus is not systemic, so the tree has some time before it will be overrun by it. However, the tree should be monitored quarterly for any advance of the disease. If it becomes too serious, the tree may have to be removed. If the tree is retained, it should be pruned for sidewalk and roof clearance.</p> <p>Maintenance: 10 min. Next Service: winter Priority: high</p>

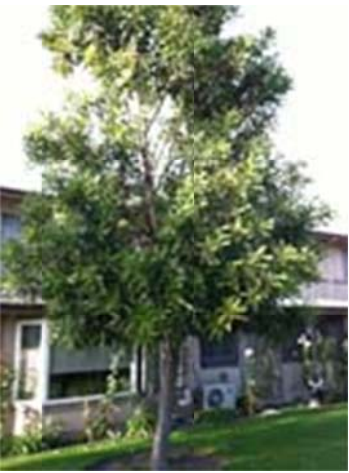
<p>Site 20 <i>Macadamia integrifolia</i> - Queensland Nut</p> <p>This tree has similar problems to its neighbor at site 19. It should be monitored quarterly for the infection of the Fusarium fungus and the boring beetle infestation. If the tree is retained, it should be pruned for sidewalk and roof clearance. It has some rubbing and crossing structures that could be corrected for long-term structural health.</p> <p>Maintenance: 30 min. Next Service: winter Priority: high</p>

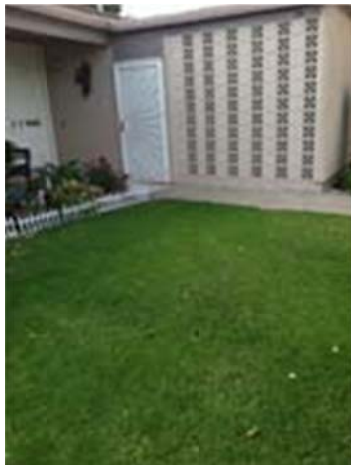
Site 28
Vacant Planting Site

This site is smaller than it appears because it is near an underground electrical conduit. The site should be planted with a shrub or a small tree that has roots that are noninvasive.

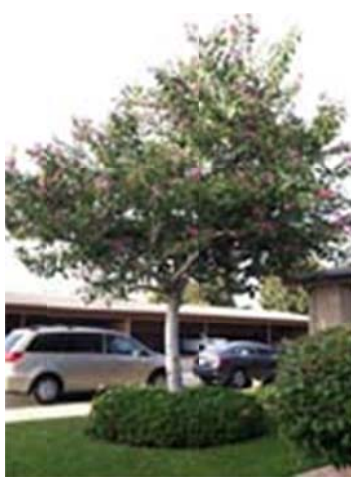
Site 29
Bauhinia x blakeana - Hong Kong Orchid Tree

This tree has some sprouts that are beginning to compete with the general canopy and should be removed. This tree should also be pruned for roof and sidewalk clearance.

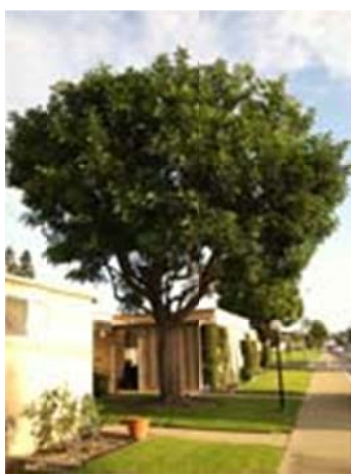
Site 30
Cupaniopsis anacardioides - Carrotwood

This tree does not have ideal structural form, but it is too late in the tree's development to make correctional cuts. It should be maintained for roof and sidewalk clearance. The adjacent shareholder requests its removal due to the nuisance of fruit drop.

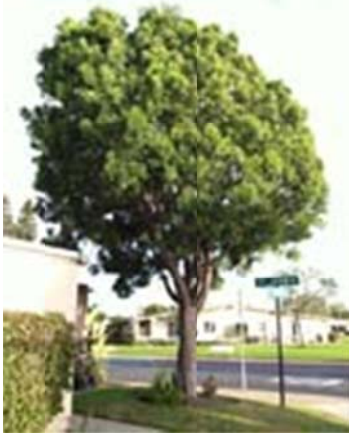
Site 31

This tree is not the ideal species for this location because it is known to have aggressive roots. It will likely cause problems with the sidewalk and building foundations. However, it is a showy, attractive landscape tree on the street corner. It can be retained for several more years by pruning for roof and sidewalk clearance.

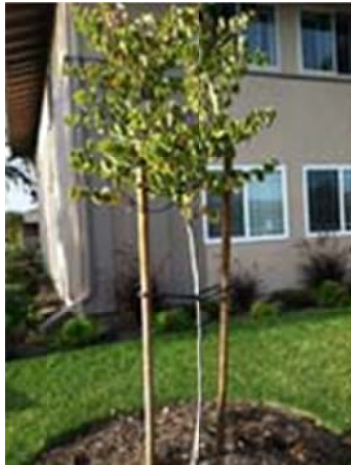
Site 36

This tree needs to be re-staked immediately. The ties are causing constriction on the trunk that is limiting the water and nutrients that can flow to the top of the canopy. There is a significant wound at the very base of the root crown, likely from abrasion with a stake that was pressed up against the trunk while the tree was in the nursery. This wound will stay with the tree for its entire life, and it may become a point of failure late in the tree's life. This is not going to be a tall tree at maturity, so it can be retained because the defect will not turn into a significant hazard.

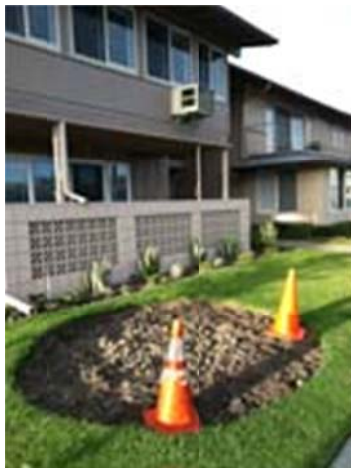
Site 37

This is the former site of an Ornamental Pear tree that was infected with fire blight. Another Ornamental Pear tree should not be planted here. Rather, a tree that is resistant to fire blight should be planted. This site also receives southern exposure, so the tree should be tolerant of summer heat.

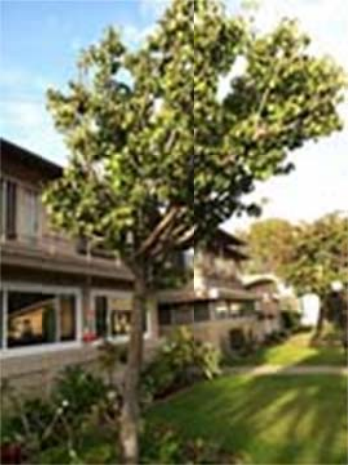
<p>Site 40 <i>Pyrus kawakamii</i> - Evergreen Pear</p> <p>This pear tree does not have good structural form. It has many shoots all originating from the same point and competing with each other. Furthermore, each of these shoots has been tipped in a pruning event in the past. This has created an artificially V-shaped canopy that is susceptible to wind throw and tearout. This is one of the few pear trees in mutual 15 on which I do not see symptoms of fire blight. This tree should be allowed to grow without major pruning so it may develop some lateral branches.</p> <p>Maintenance: 10 min. Next Service: fall Priority: low</p>

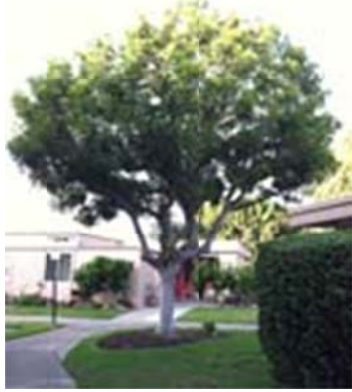
<p>Site 42 <i>Cupaniopsis anacardioides</i> – Carrotwood</p> <p>This tree's structure is not ideal because it has many trunks emanating from a single point. However, it is too late in the tree's life to make any corrective cuts to fix this. The tree should simply be pruned for sidewalk and roof clearance.</p> <p>Maintenance: 20 min. Next Service: spring Priority: medium</p>

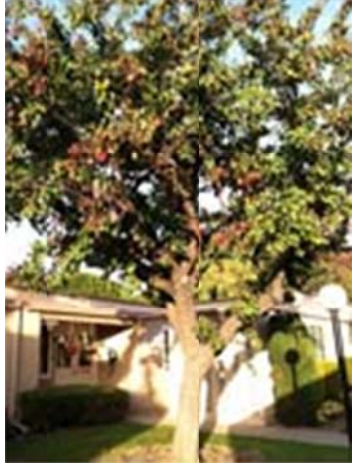
<p>Site 43 <i>Pyrus kawakamii</i> - Evergreen Pear</p> <p>This pear tree has fire blight. The fire blight will eventually kill the tree, but it can still be retained in the landscape for several more years. Arborists can prune out the symptomatic tissue while sterilizing their tools between cuts to prevent the spread of the disease to other trees in the mutual. This tree was aggressively pruned back some years ago, and this is likely when it acquired the disease.</p> <p>Maintenance: 10 min. Next Service: now Priority: low</p>

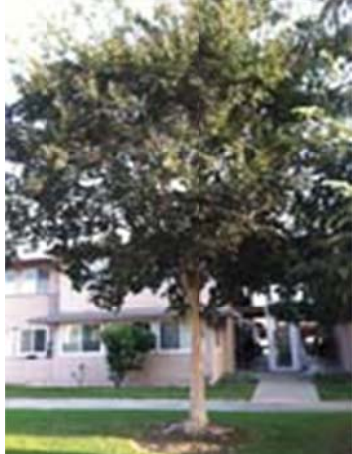
<p>Site 44 <i>Lagerstroemia indica</i> - Crape Myrtle</p> <p>This tree is a good choice for this site and it is doing well. It should be monitored for contact competition with the Deodar Cedar to the West. The Deodar is a much more valuable tree, and the Crape Myrtle should be pruned to give the Deodar space.</p> <p>Maintenance: 20 min. Next Service: now Priority: medium</p>

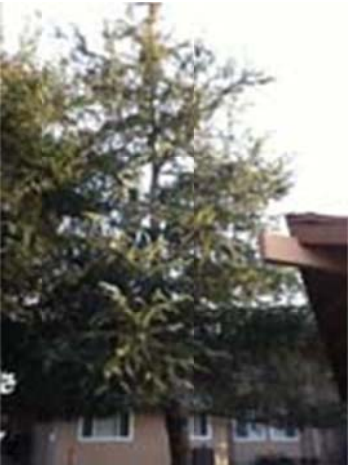
<p>Site 45 <i>Cedrus deodara</i> - Deodar Cedar</p> <p>This is the most valuable species in the mutual. It should be preserved as much as possible. There are some dead limbs that should be pruned out and some sidewalk clearance that should be clipped. However, this is an extremely low maintenance tree and should not be pruned unless absolutely necessary. Most cuts should be made with a hand clipper. The Crape Myrtle to the East should be pruned back to yield to the Deodar.</p> <p>Maintenance: 20 min. Next Service: now Priority: medium</p>
 	<p>Site 46 <i>Juniperus chinensis</i> - Hollywood Juniper</p> <p>This is an excellent choice for the landscape because it is so low maintenance. The interior deadwood will need to be cleaned out every 2 to 5 years. There is also an understory <i>Ficus</i> that should be removed before it competes with the more valuable juniper.</p> <p>Maintenance: 60 min. Next Service: now Priority: medium</p>

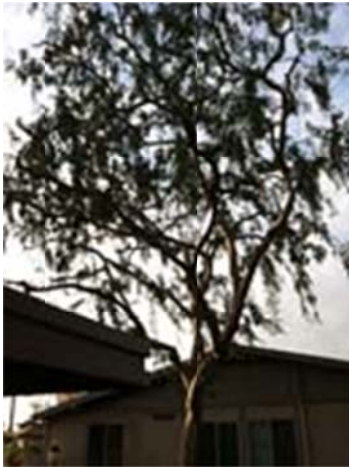
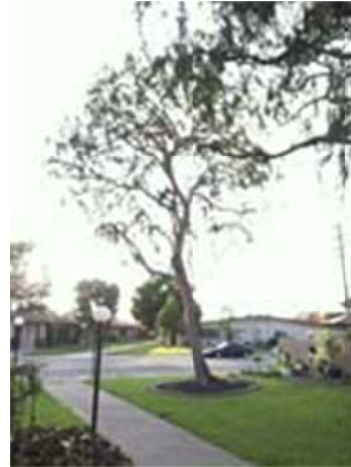
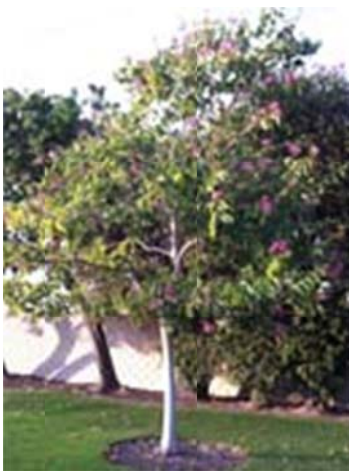
Sites 48, 49, and 50
Ulmus parvifolia - Chinese Elm

These three trees were very aggressively pruned in the recent past. They are currently in recovery mode. They should be allowed to regrow their natural canopy. The new sprouts that are growing in response to the aggressive pruning should be thinned to the strongest ones. This will help retrain the trees into a more stable canopy. Following restoration, the trees will only need to be pruned for sidewalk clearance. If allowed to grow into their natural form, these trees will make an attractive canopy cover for the sidewalk and building to the North. No pruning should be done on these trees at this time.

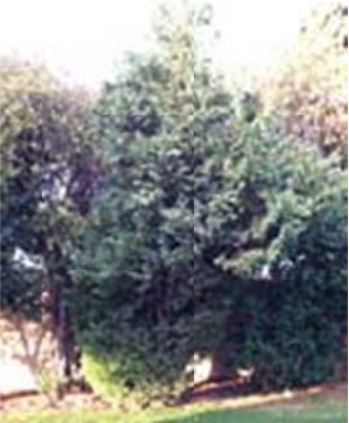
<p>Site 55 <i>Thuja plicata</i> - Red Cedar</p> <p>This tree has severe cantilever to the South because it is avoiding the shade of the hedge to the North. This tree will eventually grow so large that it will fail to the South. It is likely that many of its roots were cut when the North wall was installed, and this tree should be marked as a medium hazard. No pruning is necessary at this time, but this tree should be evaluated whether it should be removed.</p> <p>Maintenance: zero Next Service: winter Priority: high</p>

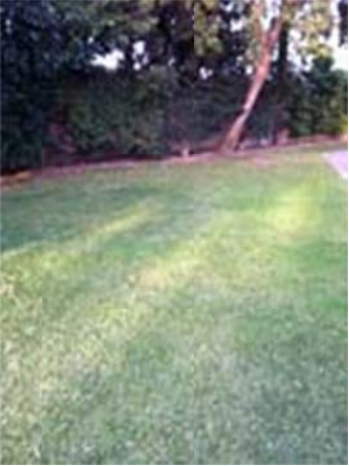
<p>Site 56 Vacant Planting Site</p> <p>This site should not be planted until a decision is made about what to do about the trees along the back wall. If the trees along the back wall will be removed, then this site can be planted after they are removed.</p>

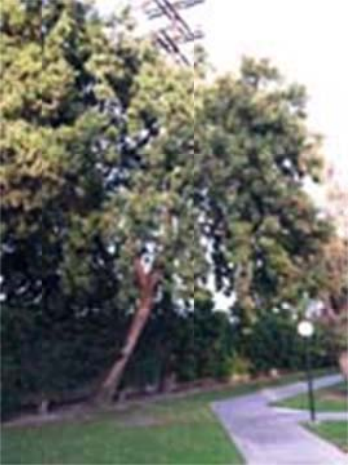
<p>Site 57 <i>Schinus terebinthifolius</i> - Brazilian Pepper</p> <p>This tree has good form, but it will need to be maintained for sidewalk clearance.</p> <p>Maintenance: 20 min. Next Service: now Priority: medium</p>

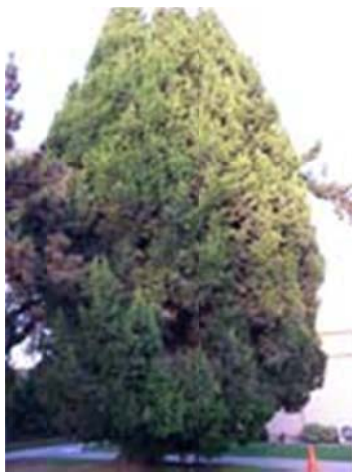
<p>Site 61 <i>Thuja plicata</i> - Red Cedar</p> <p>This tree has some significant interior deadwood that could be cleaned out for aesthetics. One branch has developed an anomalous lean away from the trunk, exposing the deadwood-filled interior. This branch should not be pruned back because it will create a larger hole in the canopy that will only make the aesthetics of the tree worse. However, there are a few branches high in the canopy that should be removed because they are growing downward, away from the natural form of this tree.</p> <p>Maintenance: two hours Next Service: now Priority: medium</p>
 	<p>Site 62 <i>Juniperus chinensis</i> – Hollywood Juniper</p> <p>This young Juniper is doing just fine. It needs no pruning at this time.</p> <p>Maintenance: zero Next Service: fall Priority: low</p>

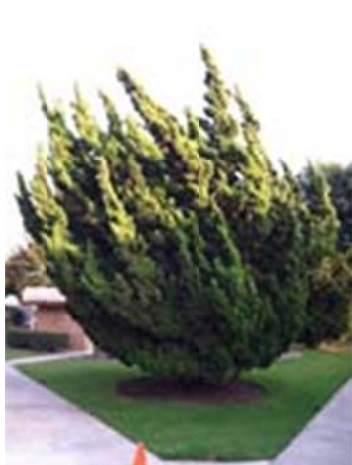
<p>Site 63 <i>Juniperus chinensis</i> - Hollywood Juniper</p> <p>This is an excellent choice of species for the location and does not need any pruning at this time. This species only needs a minor deadwood cleaning on the interior every 2 to 5 years.</p> <p>Maintenance: 40 min. Next Service: fall Priority: low</p>

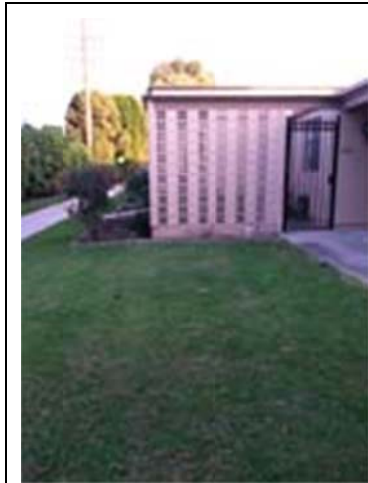
Site 64
Vacant Planting Site

This site should be utilized by a small bush or shrub – not a tree.

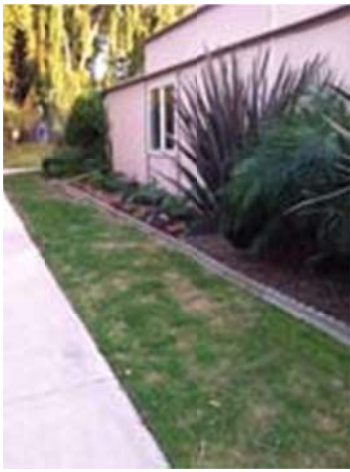
Site 65
Vacant Planting Site

This site is far too small for a tree. I suggest leaving it empty.

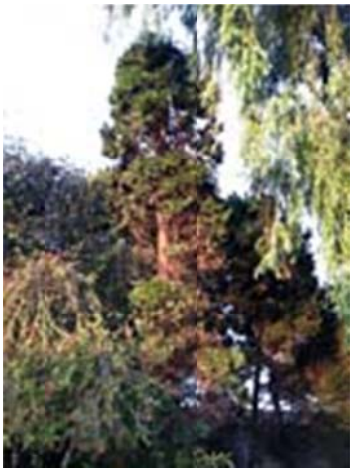
Site 66
Calocedrus decurrens – Incense Cedar

This is a great species with an unfortunate planting site beneath power lines. It will eventually grow tall enough to interfere with these lines. There is some deadwood up and down the trunk that can be removed in the short run. The northern co-dominant trunk should be removed, allowing the southern trunk to remain. This will reduce the likelihood that the tree will interfere with the power lines in the near future.

Eventually, the entire tree will have to be removed due to root loss from the installation of the north wall.

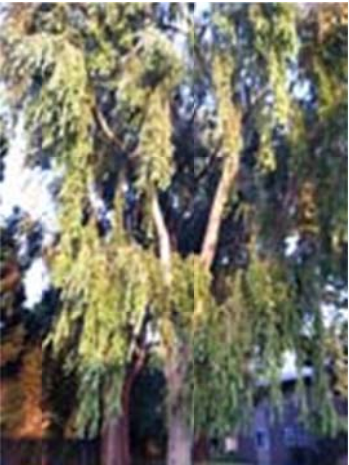
<p>Site 67 <i>Eucalyptus viminalis</i> - Manna Gum</p> <p>This Eucalyptus tree has been hit hard by woodpeckers. There are woodpecker holes up and down many of the trunks in a characteristic horizontal line pattern. Many of these wound sites are weeping, and it appears that the tree has acquired a fungus. As much live foliage should be left on the tree as possible to help the tree cope with these injuries. There are also some larger holes lower on the trunk in sets of three that are not due to woodpeckers. They appear to be due to boring insects.</p> <p>This tree recently had a branch fail in a windstorm, and the stump that was left should be recut back to the main stem on the Western side of the tree. The fringe will need to be maintained for head height clearance.</p> <p>Maintenance: two hours with climber Next Service: now Priority: medium</p>

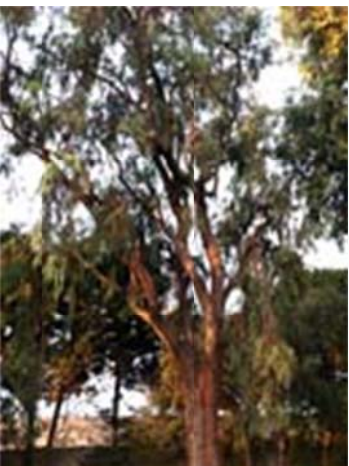
<p>Site 68 <i>Eucalyptus sideroxylon</i> - Red Ironbark</p> <p>This tree has been aggressively pruned back in the past out of fear that it was headed towards the power lines. The tree is still recovering from those pruning wounds by growing new sprouts. These sprouts should be gradually thinned to the strongest leaders to help regrow a canopy. The tree will have to be maintained on a regular basis to keep it clear of the power lines. Unfortunately, the previous pruning will actually make the tree's response shoots grow towards these power lines more quickly, requiring more frequent and costly maintenance.</p> <p>There is a significant amount of bark loss on the northern half of the root crown. This is indicative of root loss due to the installation of the wall behind tree. This bark loss should be monitored quarterly. If it advances, it will be a sign that the tree is going to fail soon.</p> <p>I do not recommend pruning for aesthetics of this tree because it looks like the tree is going to die the next 2 to 5 years</p> <p>Maintenance: zero Next Service: winter Priority: high</p>

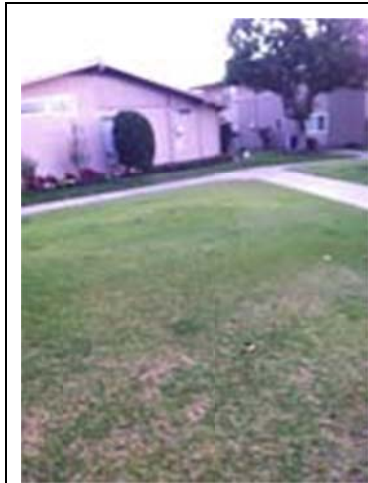
Site 69
Vacant Planting Site

There is a nice large planting site with plenty of room for a large shade tree to grow. This site receives full southern exposure.

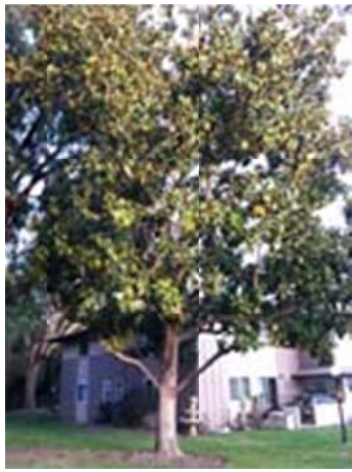
Site 70
Magnolia grandiflora - Southern Magnolia

This Magnolia has excellent form and does not need pruning at this time. It should be monitored for sidewalk clearance.

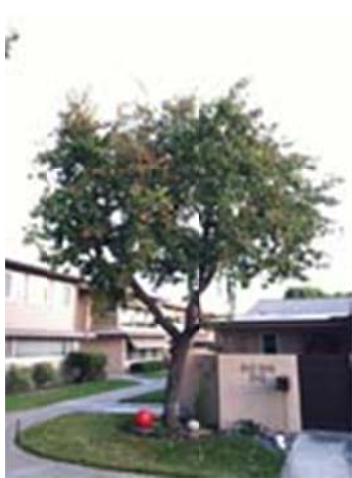
Site 71
Pyrus kawakamii - Evergreen Pear

This tree has fire blight. It likely acquired this fire blight during its aggressive pruning several years ago. The fire blight will eventually kill the tree. However, the tree can be retained the landscape for the next 2 to 5 years. Arborists can prune out the symptomatic tissue while sterilizing their pruning tools with bleach between cuts to prevent the spread of the disease to other trees in the mutual.

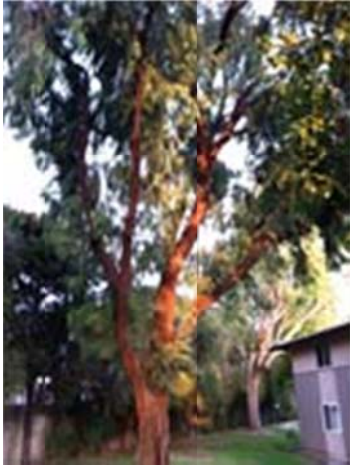
Site 72

This Eucalyptus tree has a tearout wound on the southern branch approximately 30 feet up. This wound should be monitored for the advance of any decay. On the northern side of the tree's trunk, there is a site that is exuding sap. This weeping site should be monitored quarterly as well. It is possible that when the north wall was installed, this tree could have sustained sufficient root loss to predispose it to fall to the South.

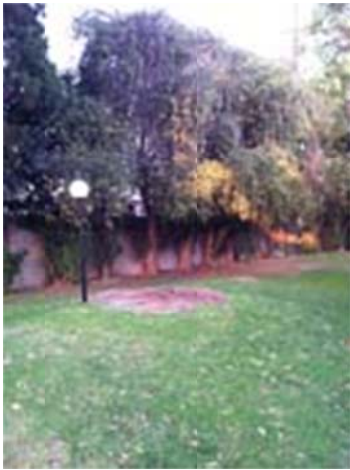
Site 73 Vacant Planting Site

A tree should not be planted in this site because of its proximity to the irrigation system and the electrical line. This site is better suited for a shrub or bush.

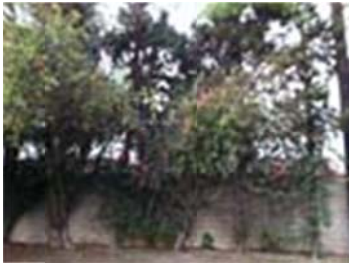
Site 74 through 92
Multi-Species Hedge

These trees are all victims of the root cutting for the installation of the north wall. They should be monitored for decline and left alone until they began to die. Gradually, the trees that fail or die can be removed. These trees are far enough from the buildings that they will not cause damage if they were to fall. Therefore, it is not a problem if they are left in the landscape with known root issues. If a windstorm blows them over, emergency responders can dismantle them.

In the short term, the bottlebrush trees will need to be maintained for head height clearance. There is also some deadwood that could be pruned out for aesthetics, but it is not advisable to prune out deadwood if the trees are intended to be removed.

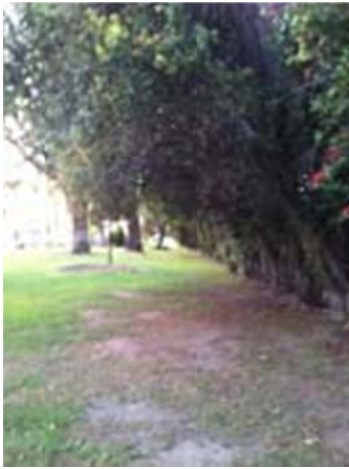
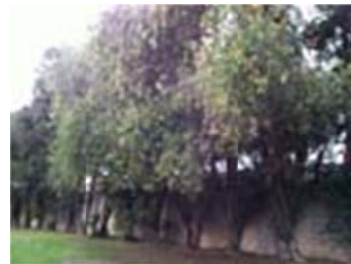
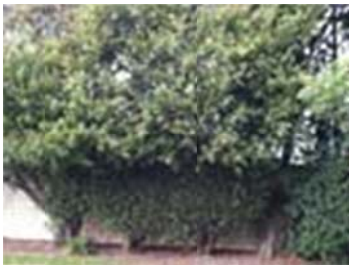
Site 93 through 110
Multi-Species Hedge

Nearly all of these trees lost most of their root systems when the North wall was installed. They should be monitored for signs of decline and replaced gradually as they die off. None of them are tall enough to reach building 45 or pose much of a hazard. Therefore, they can be retained until they fail structurally or die completely. In the short run, the bottlebrush and the pepper tree will need to be maintained for head height clearance over the sidewalk.

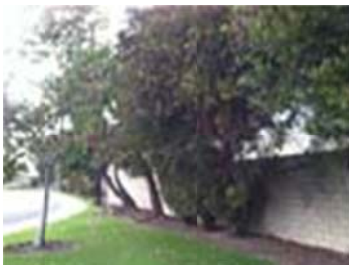
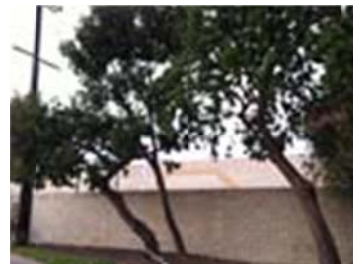
<p>Site 111 <i>Lophostemon confertus</i> - Brisbane Box</p> <p>This tree needs to be re-staked immediately. It is tightly tied to a stake that is pressed up against its trunk. The ties are constricting the vascular flow of water and nutrients to the canopy, and the stake is causing the tree to develop a lean away from it. This setup will cause the tree to become stake-dependent. Rather, the tree should be double staked with wire and hose, giving it room to move and develop trunk taper. This is a good choice of nursery stock, but it was planted a little bit too close to the building. In about 5 to 10 years, the roots may begin to cause some damage to the foundation.</p> <p>Maintenance: 20 min. Next Service: now Priority: high</p>

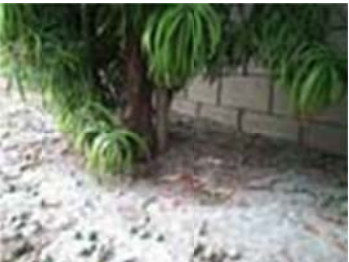
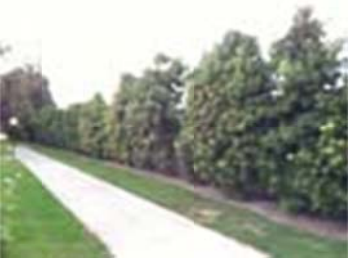
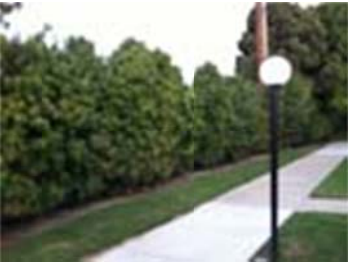
<p>Podocarpus Hedge</p> <p>This hedge needs maintenance now. Podocarpus is a known root heaver, and if these trees are left alone, they will cause costly damage to the newly installed wall behind them. The way to minimize the damage is to keep these trees small by carefully heading them back to subordinate leaders. This can become an attractive hedge, but it will be expensive to maintain.</p> <p>Many of the trees are still tied to stakes that should be removed immediately. The ties are constricting the vascular system, and if these trees continue to grow while being constricted, the ties will create breaking points that will predispose the trees to structural failure in the wind.</p> <p>The sidewalk side of the hedge should not be sheared with electric clippers. Rather, it should be pruned manually with hand clippers, reducing each growing tip back to a live compound that is large enough to assume dominance. If done correctly, no stumps will be visible, and the hedge will remain dense and full.</p> <p>Maintenance: eight hours Next Service: now Priority: high</p>
